Page: [REDACTED] CQIS DETAIL REPORT [REDACTED]

SYMPTOM: [REDACTED] START/RUN/MOVE FLUIDS  
FUEL VISIBLE LEAK  
Additional Symptom: fuel leak from filter housing  
Other Veh. With Concern: Severity Rating - Customer: Engineering:

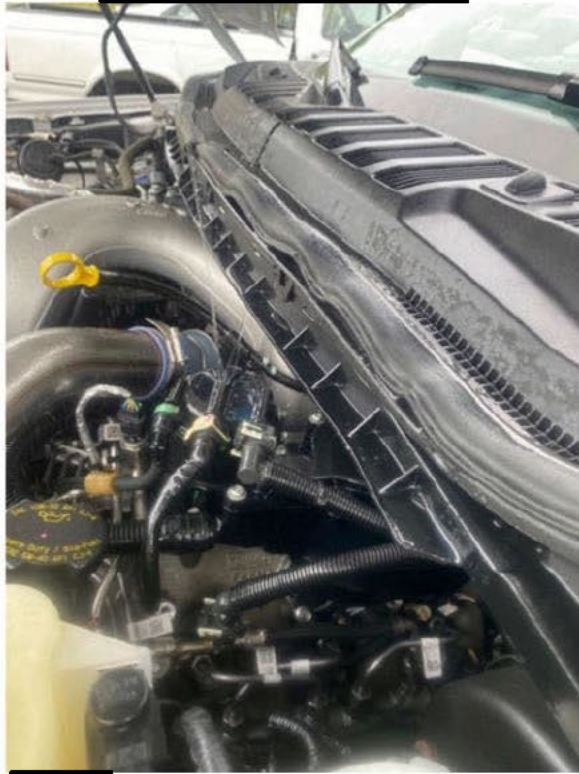
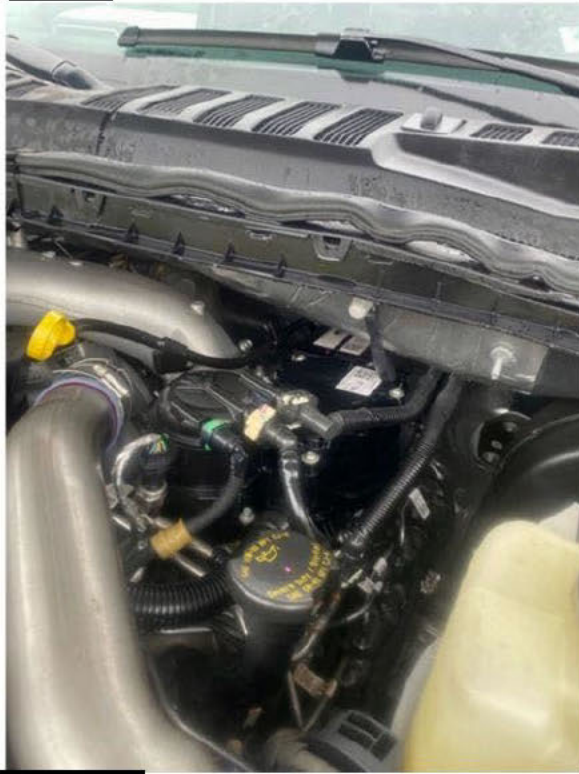
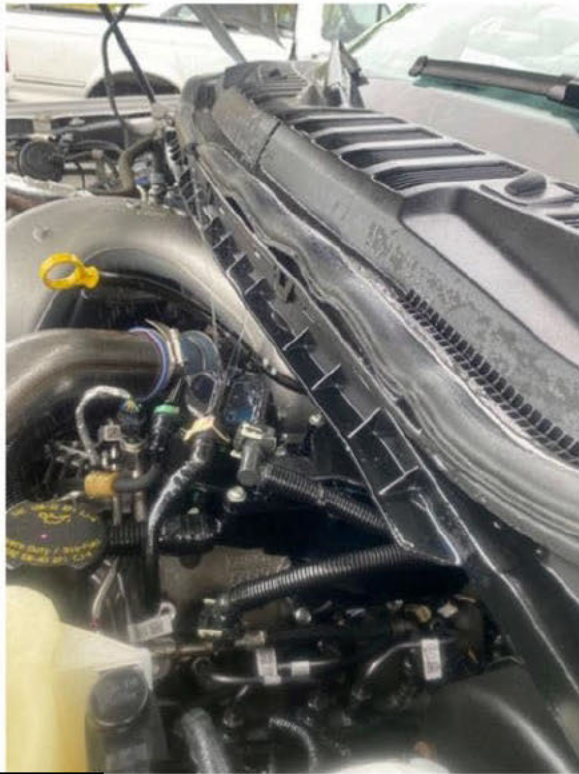
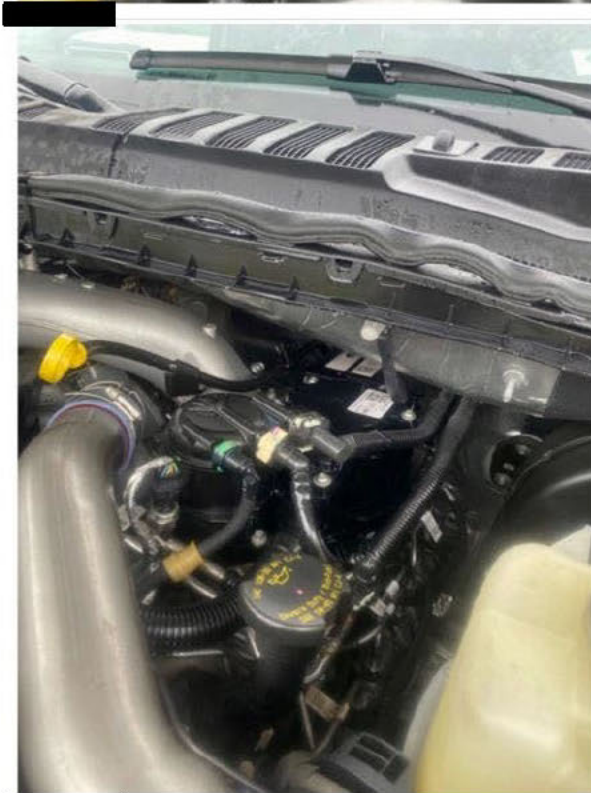
CONCER [REDACTED]  
RO: [REDACTED] RO Date: [REDACTED] Warranty Type: FWR SPW Install Mileage:  
SPW Install Date: Please describe customers concern. Include as many  
details as possible. customer states leaking fuel on motor fuel filter  
housing tech inspected and found upper fuel filter leaking through  
moulding ran parts coverage [REDACTED] is covered under power train  
coverage would this upper filter be covered under power train Please  
enter the Engine Hours below, if available. [REDACTED] What are the Total  
Hour and Idle Hour readings from the Instrument Cluster? engine hours  
[REDACTED] idle hours [REDACTED] Please list the qualifying base part number which  
was replaced previously that makes this repair eligible for SPW  
coverage: Please describe why the component(s) is being replaced.  
Include any other causal component(s) and/or system(s) that caused  
component damage/failure. Provide supporting PPT test results from

PC/ED and/or the Workshop Manual. upper filter leaking fuel Are there  
indications of Vehicle or Component Abuse, Modifications, or Lack of  
Maintenance? If so please continue to the Warranty  
Cancellation/Reinstatement Request Form. To get to this form proceed  
to [REDACTED] and follow these steps: <ol> <li>Select Parts and  
Service tab</li> <li>Select Warranty Administration & Warranty Parts  
Return from the left navigation menu</li> <li>Select Warranty  
Cancellation/Reinstatement Request Form (right side of the screen,  
near the bottom)</li> <li>Complete the form, including photo uploads  
and detail about failure and reason for warranty denial request</li>  
</ol> None Provide any additional details necessary. Please include  
any technical information that you feel will help the Technical  
Assistance [REDACTED] process your prior approval request. tech inspected  
found upper filter leaking through housing

RECOMM [REDACTED]  
[REDACTED], We understand there is a fuel leak at the fuel filter/water  
separator housing as shown in the images provided. Review of these  
images showcase no obvious signs of outside source influence, such as  
stress marks in the plastic or damage to the top of the housing, that  
could have caused this concern. However, it is important to ensure the

--TYPE-- ----- COMMENT TEXT -----  
filter housing failure was not caused by outside source influence  
filter housing failure was not caused by outside source influence  
(I.E. improper filter replacement during normal maintenance, impact  
damage from outside source influence, etc.) which would make this  
condition a non-warrantable concern. If no signs of outside source  
influence/improper filter replacement procedures are found upon  
review, our team would support warranty coverage of this filter  
assembly under the powertrain warranty coverage supplied for this  
component. DCPA Prior Approval Not Necessary  
ADD-ON [REDACTED] - [REDACTED] - [REDACTED]  
PART NUMBER: [REDACTED] (WATER-FUEL SEP ELEM) REPAIR DATE: [REDACTED] REPAIR  
DISTANCE: [REDACTED] COUNTRY: [REDACTED] IS COVERED UNDER -POWERTRAIN  
WARRANTY (BEGIN [REDACTED])

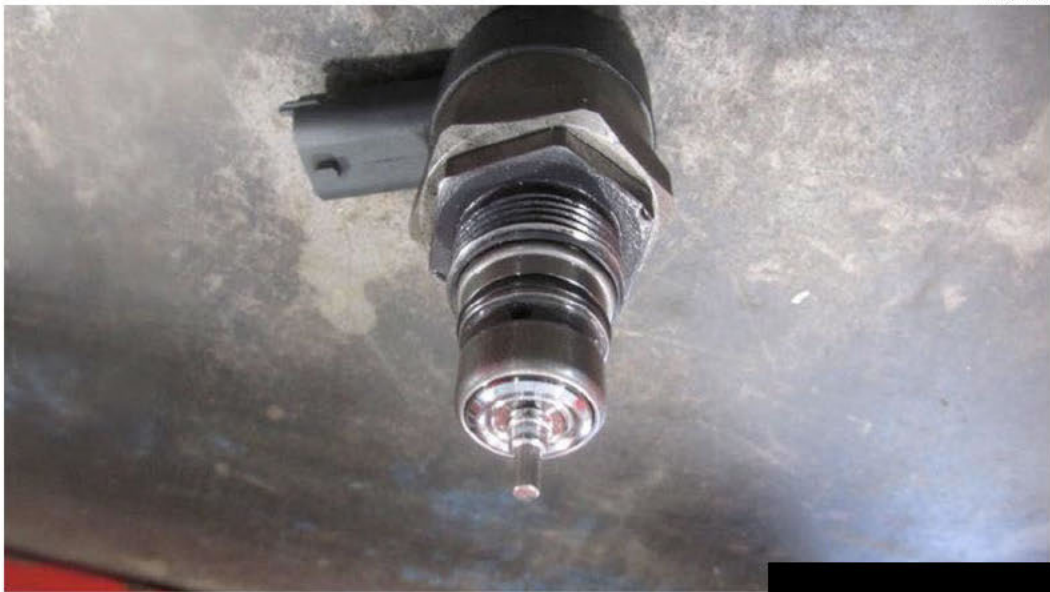
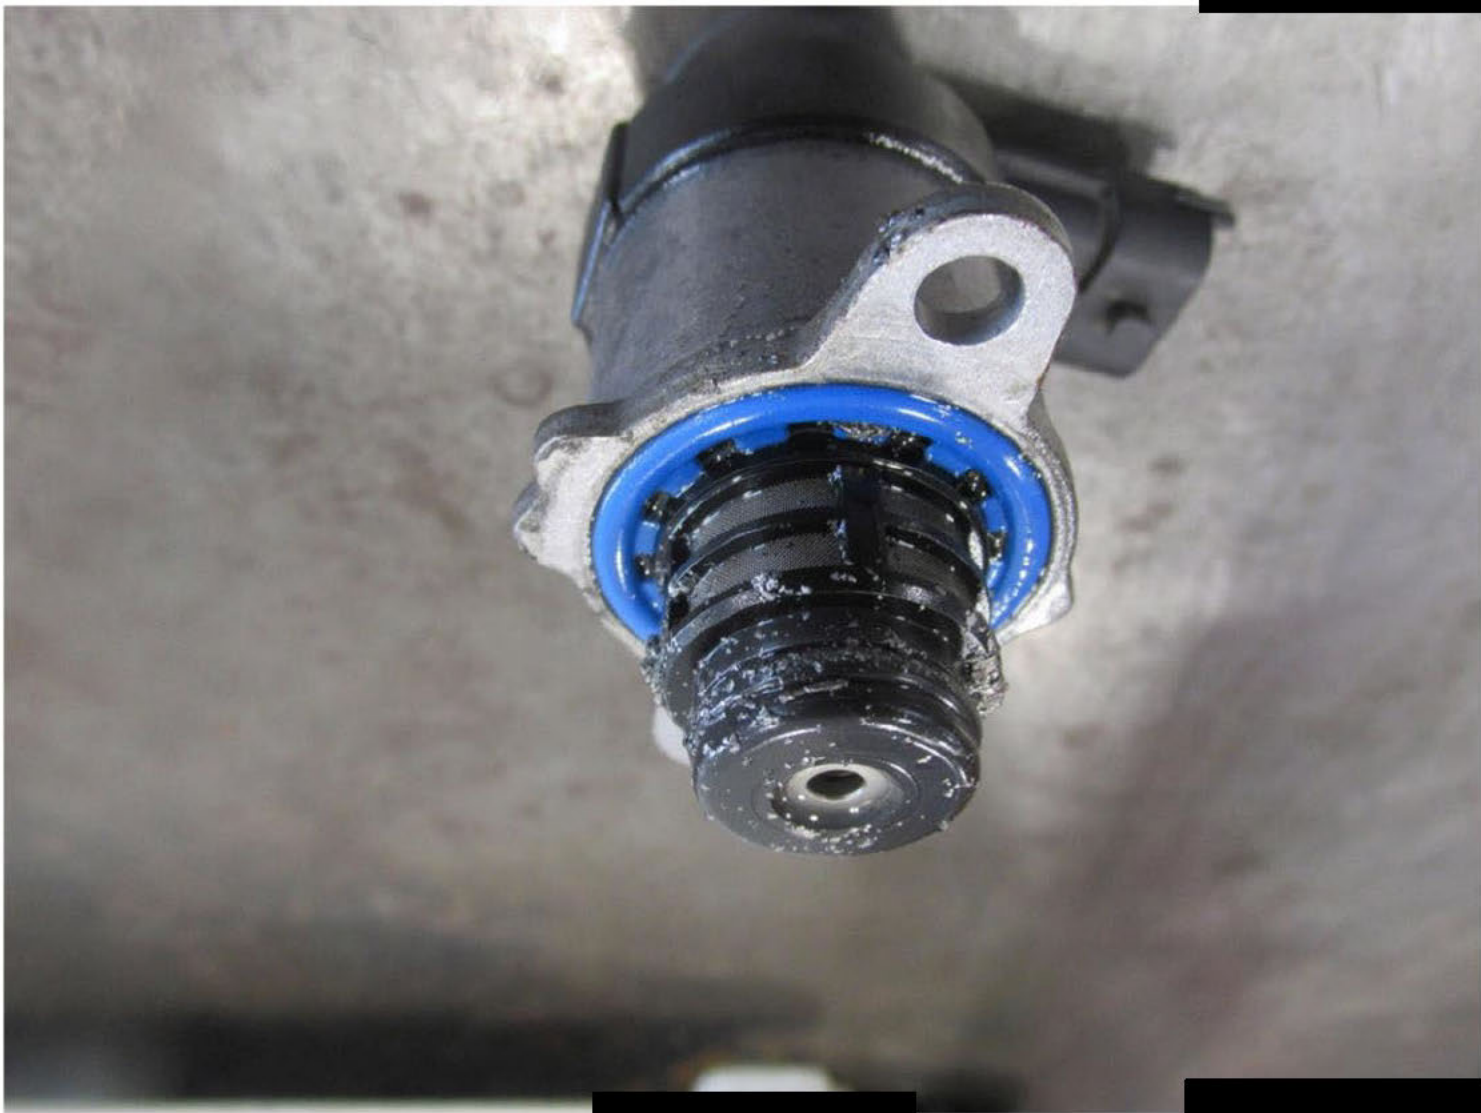
RO#: [REDACTED] RO Date: [REDACTED] Warranty Type: FWR SPW Install  
Mileage: SPW Install Date: [REDACTED] Please describe customers concern.  
Include as many details as possible. customer states fluid coming out  
of front end<br/>Why is the component being replaced? metal in fuel  
system<br/>Please list PID readings per data logger for DIST REGEN\_C  
and DPF REGEN AVGD <br/>Please enter the Engine Hours below, if  
available. <br/>Is black smoke observed in a [REDACTED] neutral run up?  
<br/>Is liquid contamination found at the tail pipe (fuel, oil,  
coolant)? <br/>Provide any additional details necessary. Please  
include any technical information that you feel will help the Hotline  
process your prior approval request. found to have fuel leak at  
secondary fuel filter, crack on top, replace fuel filters bleed air  
from system, no start, perform pin test MA1- yes [REDACTED], MA2- yes, MA3-

yes, MA4- yes, [REDACTED] yes, [REDACTED] yes, [REDACTED] yes, [REDACTED] perform clean fuel test,  
no gas, no water, no DEF or rust was found, found to have metal in the  
fuel rail and in the high pressure pump and on the VCV<br/>Please  
describe the brand, type (e.g. OE airbox vs. Aftermarket airbox, if OE  
airbox is the filter paper only or treated with oil), and condition of  
the air filter installed: OE air box<br/>If you have already completed  
the diesel particulate filter manual regeneration process using the  
scan tool, please indicate the results including DPF LOAD PCT(%), and  
whether regeneration completed or aborted. NOTE: It is required to  
attempt a manual regeneration prior to DPF replacement. If a manual  
regeneration has not yet been attempted or completed, please perform a  
manual regeneration using the IDS (Tool Box, Powertrain, Service  
Functions, Diesel Particulate Regeneration System, DPF Manual Regen).

[REDACTED], ... With the vehicle identified to not have any form of  
contamination outside of metal debris as identified, it is agreed that  
the High Pressure Fuel System should be replaced at this time to  
address this vehicles fuel system concern. The "Diesel Fuel System  
Contamination Repair/Flushing procedure in [REDACTED] >General  
Procedures of the work shop manual ([REDACTED]) should be followed for the  
fuel system flushing procedure and High Pressure Fuel System component  
replacement list.</P> ...<P>&nbsp;</P> ...<P><b><U>NOTE:</U></b> Please  
remember to obtain Prior Approval for any additional components that  
require Prior Approval, before proceeding with the repairs. Dealers  
can find their Prior Approval programs and component list on  
[REDACTED] under Parts & [REDACTED] Service<A

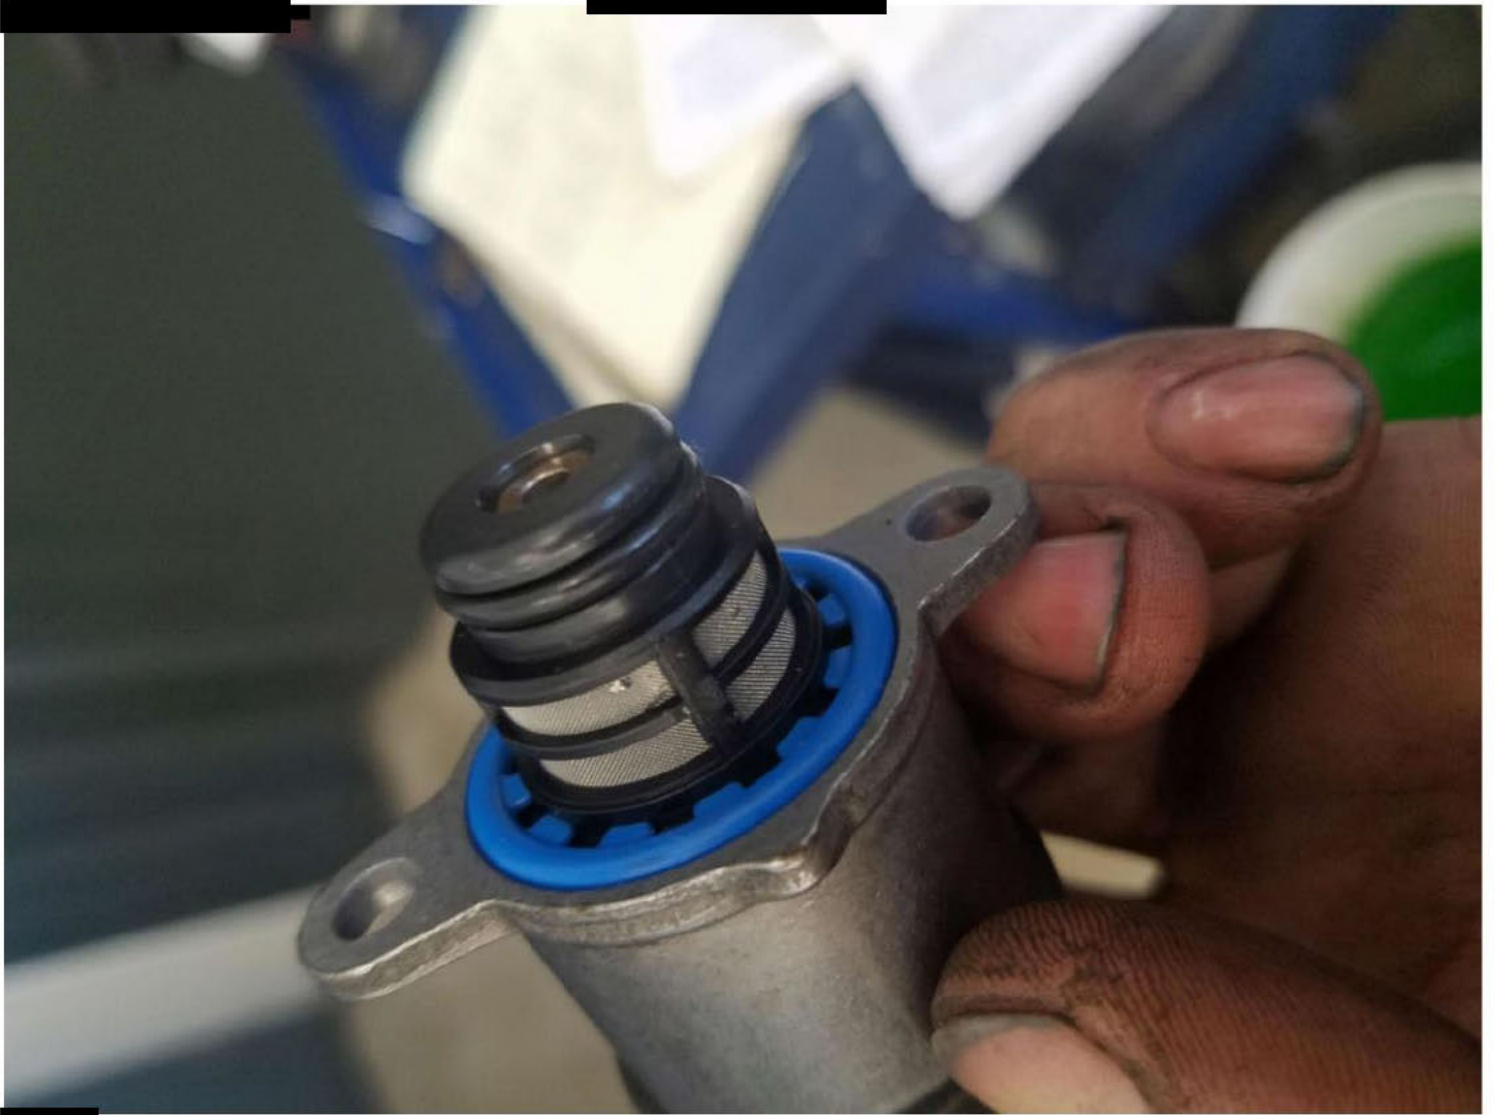
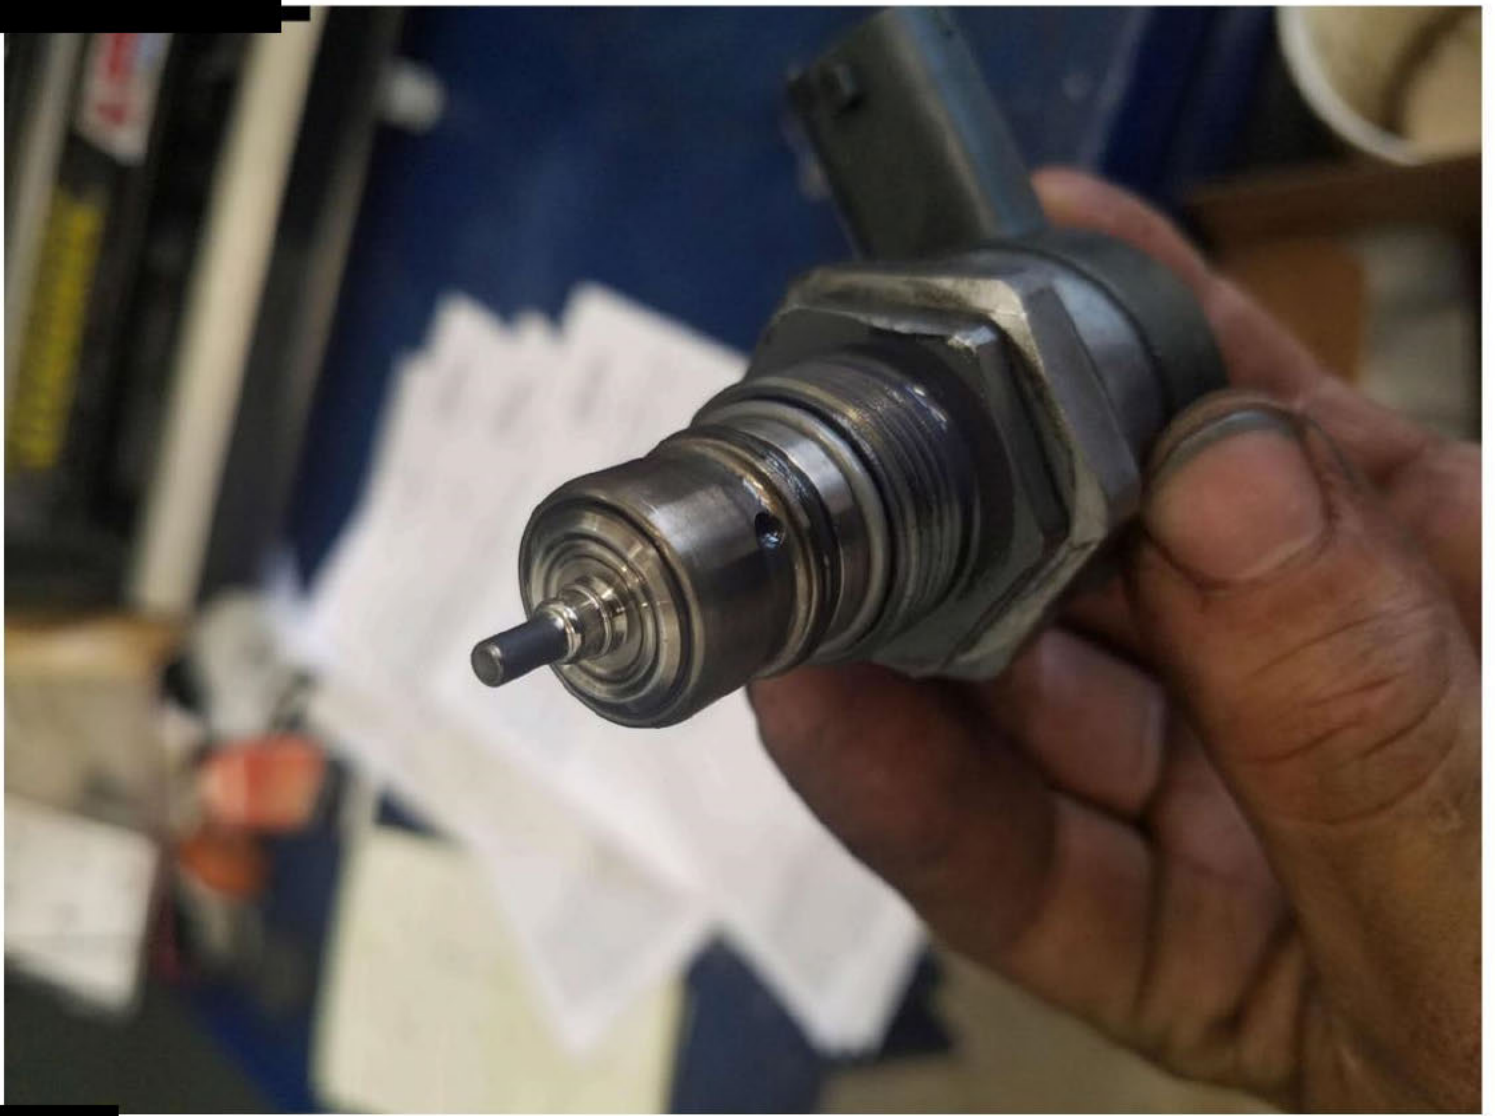
SYMPTOM: [REDACTED] START/RUN/MOVE FLUIDS  
FUEL VISIBLE LEAK

RO: [REDACTED] Date: [REDACTED] Warranty Type: FWR SPW Install Mileage:  
SPW Install Date: Please describe customers concern. Include as many  
details as possible. fuel leaking from secondary fuel filter Please  
enter the Engine Hours below, if available. What are the Total Hour  
and Idle Hour readings from the Instrument Cluster? engine hours reads  
[REDACTED] idle hours reads [REDACTED] Please list the qualifying base part number  
which was replaced previously that makes this repair eligible for SPW  
coverage: Please describe why the component(s) is being replaced.  
Include any other causal component(s) and/or system(s) that caused  
component damage/failure. Provide supporting PPT test results from  
[REDACTED] and/or the Workshop Manual. during diagnosis a fuel sample was  
obtained from primary fuel filter housing. did not find def, water, or  
fuel contamination but did find metal fragments in diesel fluid.

obtained a fuel sample from the return line indicating a failed  
injector fuel sample also has metal fragments. isolated fuel injector  
to right bank cylinder [REDACTED]. removed pcv and vcv for corrosion  
and contamination inspection, did not find rust or gumming but did  
find metal particles in the screen of the vcv. at this time high  
pressure fuel system replacement is recommended Are there indications  
of Vehicle or Component Abuse, Modifications, or Lack of Maintenance?  
If so please continue to the Warranty Cancellation/Reinstatement  
Request Form. To get to this form proceed to [REDACTED] and  
follow these steps: <ol> <li>Select Parts and Service tab</li>  
<li>Select Warranty Administration & Warranty Parts Return from the  
left navigation menu</li> <li>Select Warranty  
Cancellation/Reinstatement Request Form (right side of the screen,  
near the bottom)</li> <li>Complete the form, including photo uploads

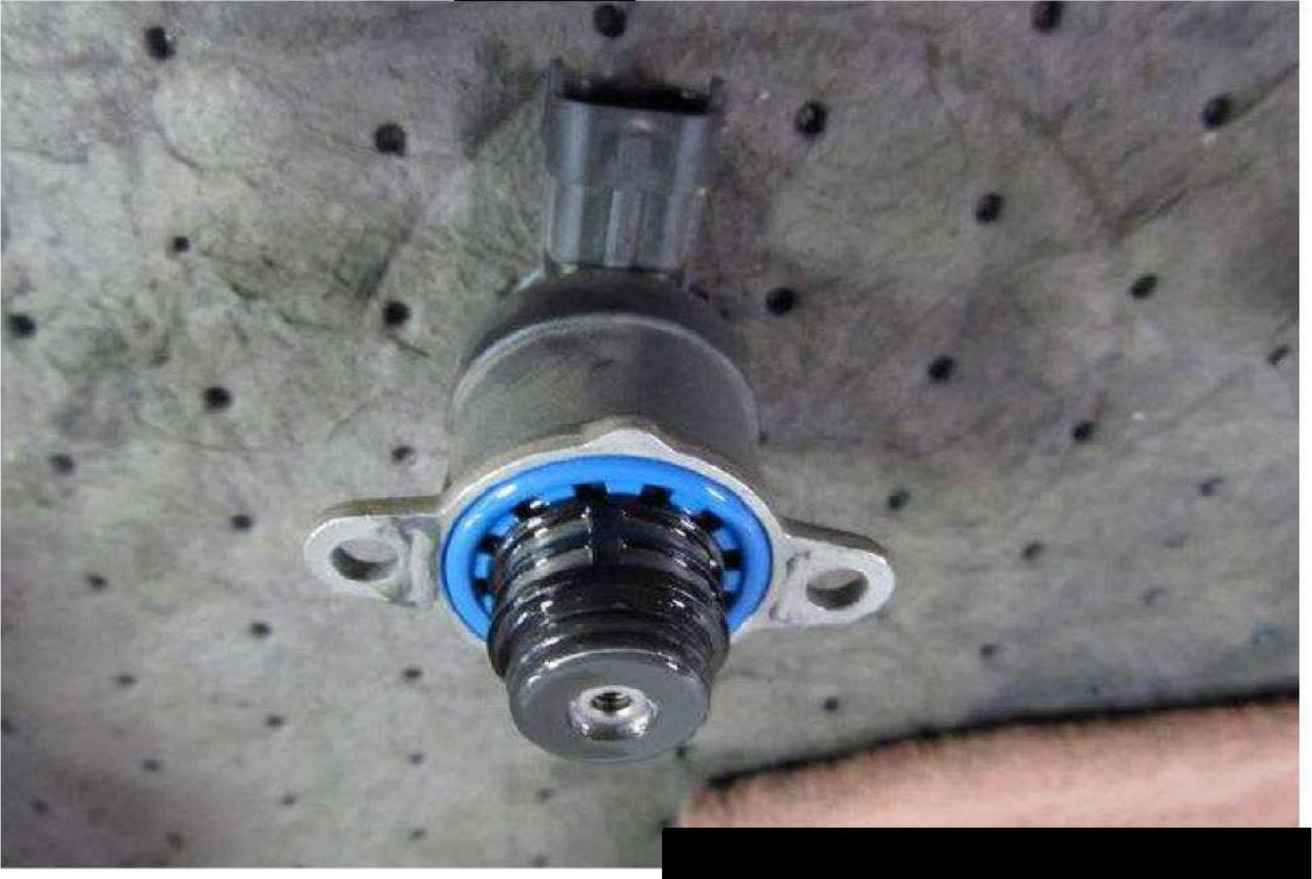
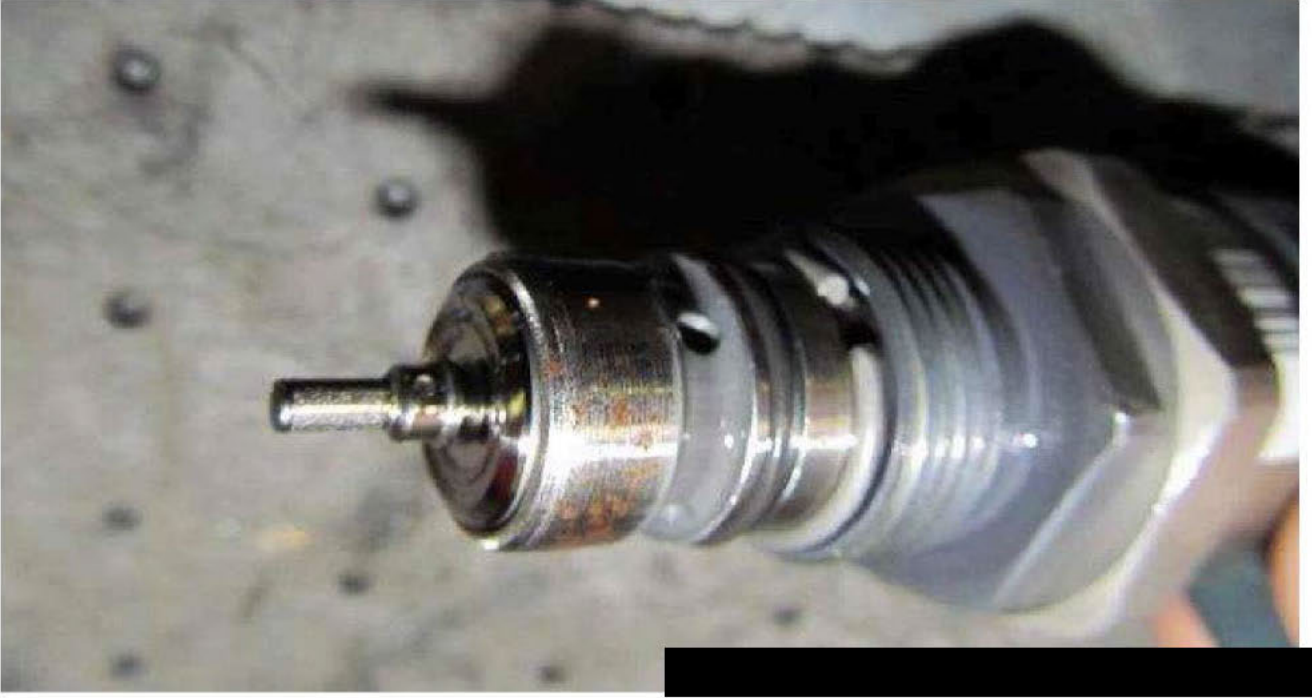
○ Attachment Id : [REDACTED] [Top](#)

any additional details necessary. Please include any technical  
information that you feel will help the Hotline process your prior  
approval request. ...PERFORMED FUEL DEBRIS TEST AND FOUND METAL DEBRIS  
IN HIGH PRESSURE FUEL SYSTEM AT FUEL RAILS AND AT HIGH PRESSURE FUEL  
PUMP. ...5. What are the Total Hour and Idle Hour readings from the  
Instrument Cluster? [REDACTED] HOURS ARE [REDACTED] IDLE HOURS ARE  
271 HRS

RECOMM [REDACTED]  
Hello [REDACTED] sets when the Fuel [REDACTED] (FRP) is too low  
for the PCM to control. [REDACTED] sets when there is a large leak, [REDACTED]  
sets when there is an air to fuel mixture fault and [REDACTED] sets when  
the FRP does not increase enough while cranking. All of these faults  
indicate a concern with the fuel system and lead to [REDACTED] MA  
being performed. While this testing is indicated, and metal debris  
found in the fuel sample from the high pressure fuel line, this does  
not isolate the fault to a high pressure pump. This fault is only  
indicated when there is visible metal on the VCV or in the VCV port of  
the high pressure fuel pump. While the metal debris may not indicate a  
fault, the image you have supplied of the PCV indicates the fuel  
system has been contaminated. This is noted by the rust marks on the

--TYPE-- ----- COMMENT TEXT -----  
valve and can be verified by referencing [REDACTED] of [REDACTED]  
valve and can be verified by referencing [REDACTED] of [REDACTED]  
Diesel Fuel System Service Tips. With this fault, it is agreed that  
the high pressure fuel system will need to be repaired, but it cannot  
be performed under warranty. To repair this vehicle ensure the Diesel  
Fuel System Contamination Repair/Flushing-Key turned to RUN or engine  
started procedure in [REDACTED] ( [REDACTED] ) [REDACTED] is  
performed. After this procedure continue with replacement of the high  
pressure fuel system. DCPA Not Approved  
ADD-ON [REDACTED] - [REDACTED] - [REDACTED] CENTER  
Article [REDACTED] DIESEL EQUIPPED VEHICLES - METAL  
DEBRIS TESTING UPDATE  
CONCER [REDACTED] TECHHOT  
SORRY FOR NOT ELABORATING OUR COMPLETE DIAG. WE FOUND [REDACTED] IN  
REGARDS TO [REDACTED]. WE DID MONITOR FRP DURING CONCERN AND FOUND FRP

CUSTOMER HAS ALSO ASKED IF WATER COULD HAVE ENTERED FUEL SYSTEM DURING  
FUEL LEAK OCCURANCE WHEN FUEL PRESSURE DROPPED WITH IGNITION OFF?  
RECOMM [REDACTED]  
[REDACTED] Your photo of the PCV provided still appears to have rust  
contamination. As noted in the job aid, fuel system failures due to  
fuel contamination are not covered by warranty. Even though the  
vehicle had a past failure of the fuel filter housing, this is not  
likely to allow water to enter the fuel system on this vehicle. If you  
feel the photos are not showing the PCV correctly, it would be  
recommended to wipe the PCV with a clean rag and clean diesel as  
sometimes fuel staining can appear at rust in the system. If you feel  
the repair should be covered, update this form with more information  
on the condition of the PCV after cleaning and include updated photos  
for review. DCPA Not Approved
