March 4, 2024

Version 3

Safety Recall: 2023–24 Accord Front Seat Belt Pretensioner Inspection

Supersedes 23-098, dated November 29, 2023, to revise the information highlighted in yellow.

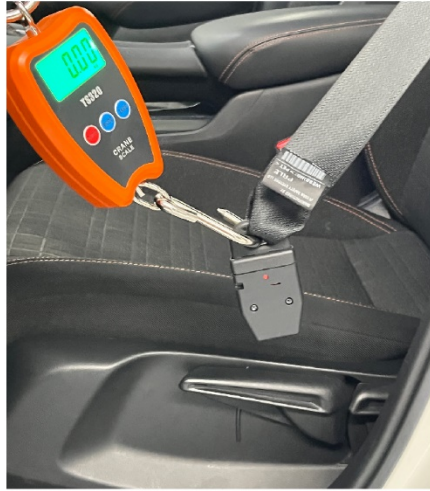
NO GOOD

During manufacturing, some front seat belt pretensioners may have been assembled without a rivet securing the quick connector and wire plate, resulting in front seat belts not functioning as designed, increasing the risk of injury.

2. While wearing eye protection, carefully pull up and apply a load of **30kgf (70 lbs)**
 - If the pretensioner quick connector remains intact and **DOES NOT** separate from the pretensioner assembly, no further action is required.
 - If the pretensioner quick connector separates from the pretensioner assembly, go to the REPAIR PROCEDURE.

Inspect the seat belt pretensioner and, if necessary, replace it.

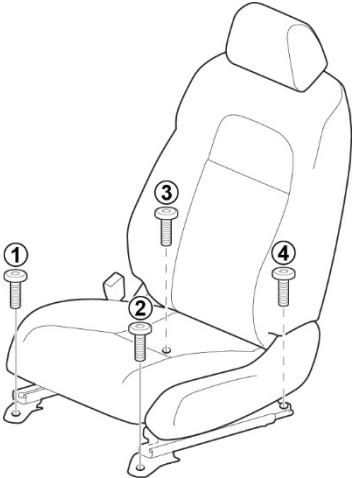
1. Move the driver's front seat to the rear position and remove the front seat bolts.

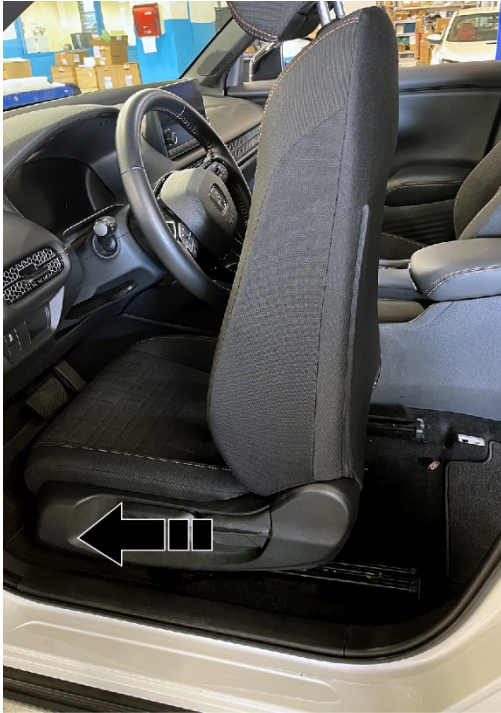
2. Move the driver's front seat to the forwardmost position and remove the rearmost seat bolts.

3. Slide the seat forward.

NOTE: Do not remove the seat.

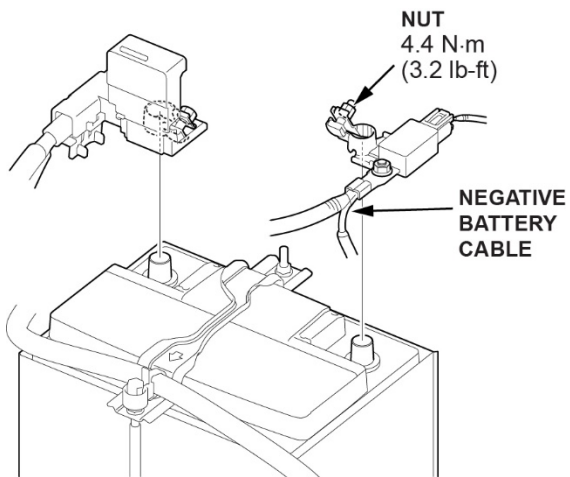
4. Disconnect the negative cable of the 12-volt battery **4.4 N·m (3.2 lb-ft)**.

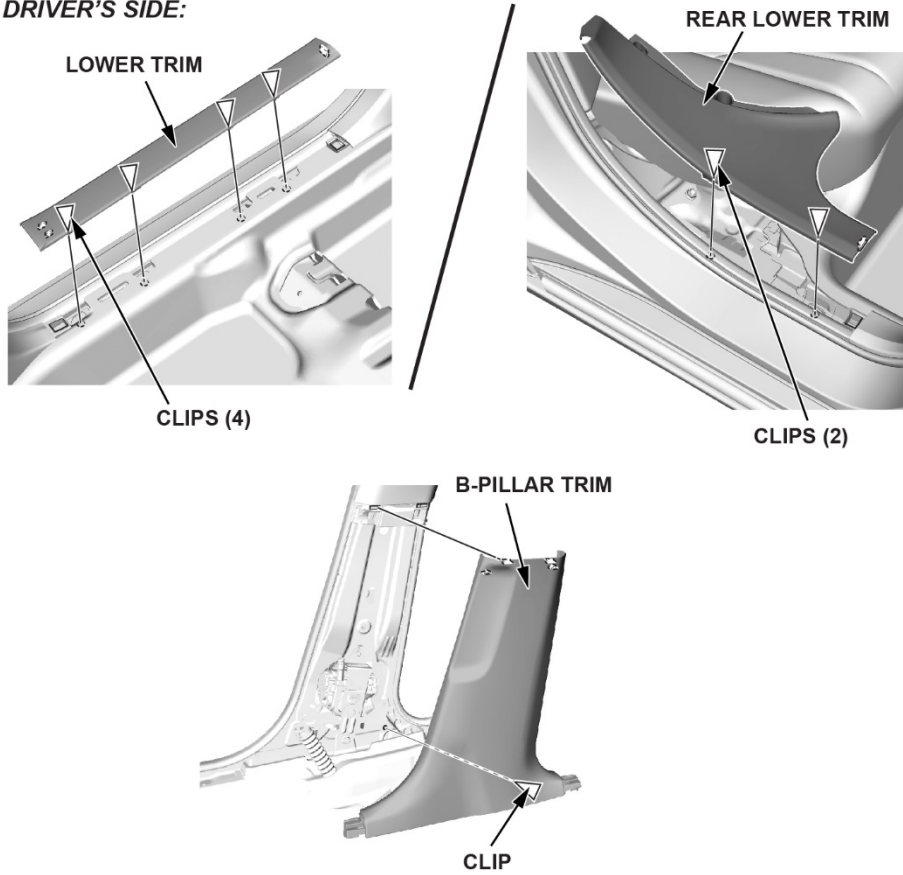
DRIVER'S SIDE:

5. Remove the driver's side lower trim, the rear lower trim, and the center B-pillar trim.

Note: Passenger's side images shown for reference only.

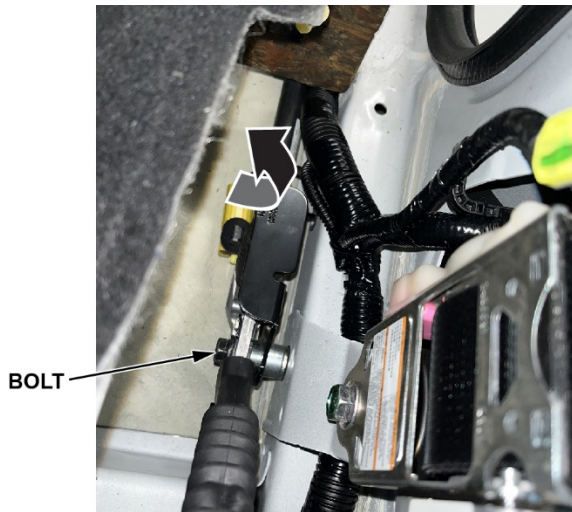
6. Pull back on the carpet as needed to gain access to the seat belt pretensioner bolt.

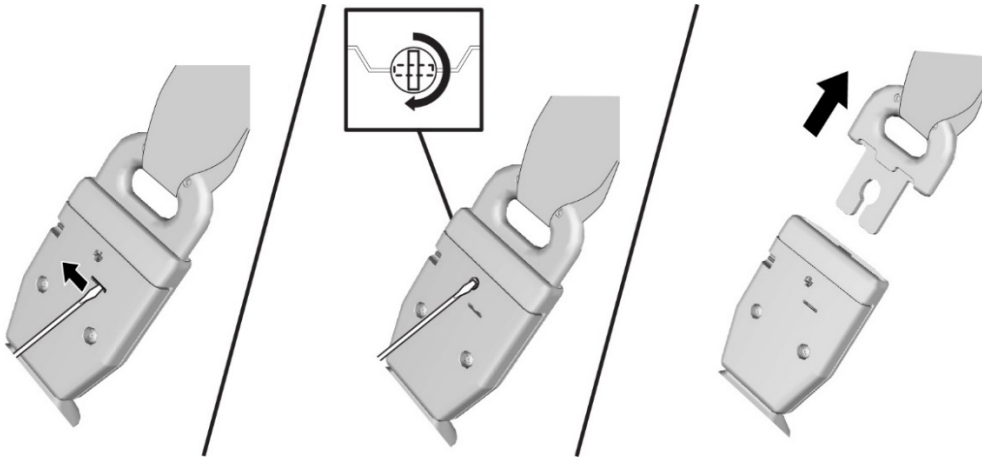
7. Use a small screwdriver to release the seat belt from the quick connector.

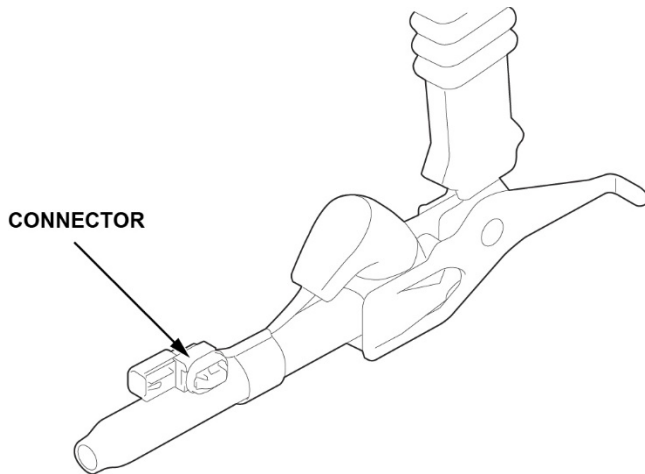
8. Disconnect the driver's seat belt outer lap tensioner connector from the floor wire harness.

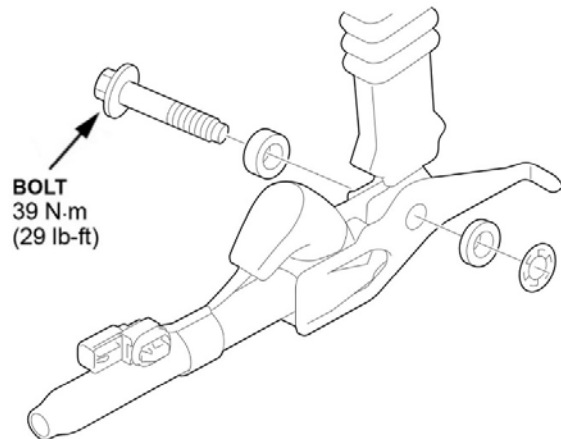
9. Remove the bolt, then remove the pretensioner.

NOTE: Do not use power tools.

10. Install the new pretensioner and torque the bolt to **39 N·m (29 lb-ft)**.

- **DO NOT** use power tools on installation.
- **DO NOT** reconnect any connectors to the pretensioner unit until fully installed, including torquing the bolts.

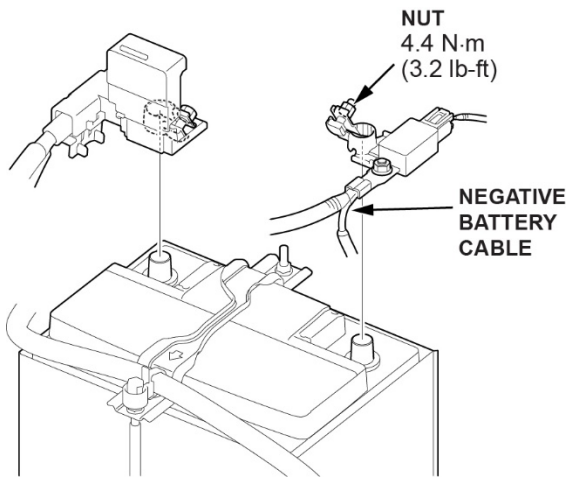
12. Connect the negative cable of the 12-volt battery **4.4 N·m (3.2 lb-ft)**.

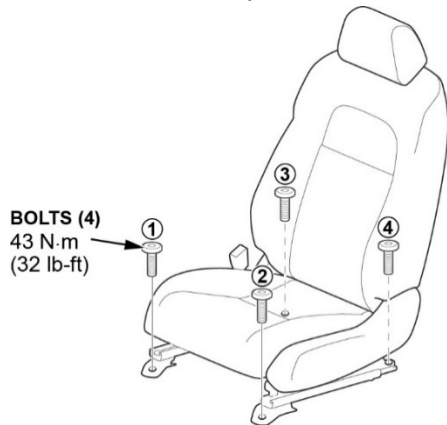
15. Tighten the driver's seat bolts by hand, then torque the front seat to **43 N·m (32 lb-ft)** in the sequence shown.

NOTE: **DO NOT** use power tools.
