**November 29, 2023**

Version 2

## Safety Recall: 2023–24 Accord Front Seat Belt Pretensioner Inspection

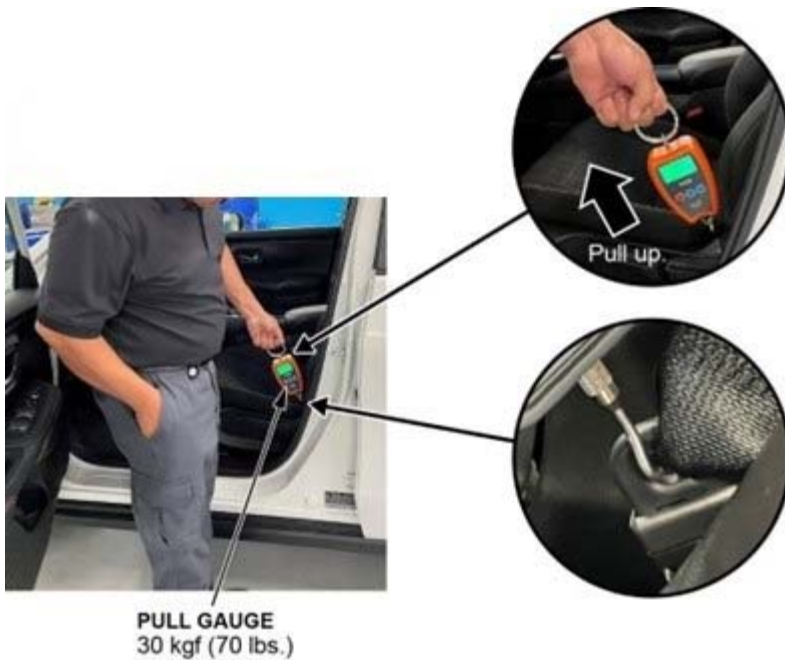
1. Insert the S-hook of the pull force gauge into the seat belt pretensioner loop to inspect the driver's side.

2. While wearing eye protection, carefully pull up and apply a load of **30kgf (70 lbs)**
  - If the pretensioner quick connector remains intact and **DOES NOT** separate from the pretensioner assembly, no further action is required.
  - If the pretensioner quick connector separates from the pretensioner assembly, go to the REPAIR PROCEDURE.

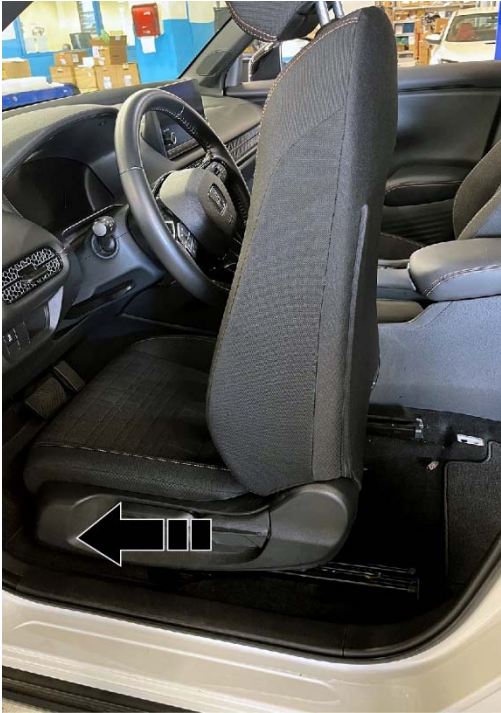
2. Move the driver's front seat to the forwardmost position and remove the rearmost seat bolts.

3. Slide the seat forward.

NOTE: Do not remove the seat.

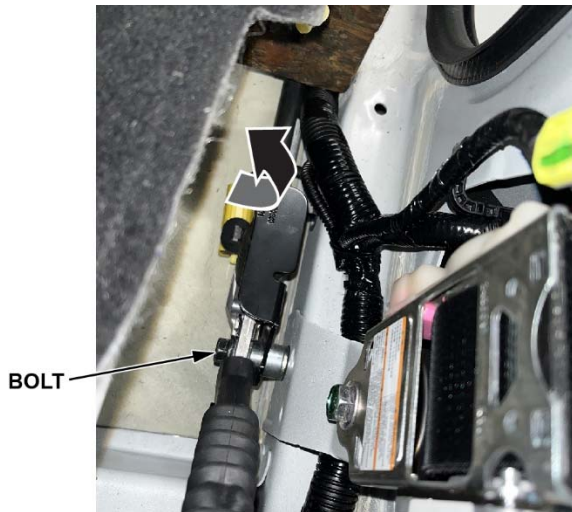
6. Pull back on the carpet as needed to gain access to the seat belt pretensioner bolt.
