**November 29, 2023**

Version 2

**Safety Recall: 2023–24 Accord Front Seat Belt Pretensioner Inspection****AFFECTED VEHICLES**

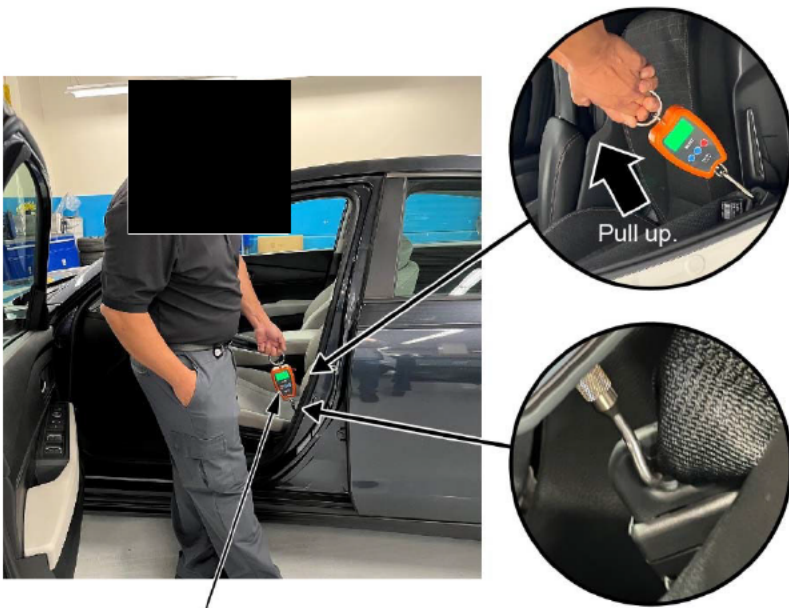
**PULL GAUGE**  
30 kgf (70 lbs.)

1. Insert the S-hook of the pull force gauge into the seatbelt pretensioner loop to inspect the driver's side.

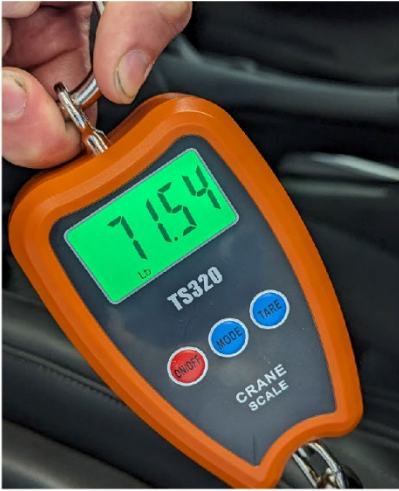
**GOOD**

2. While wearing eye protection, carefully pull up and apply a load of **30kgf (70 lbs)**
  - If the pretensioner quick connector remains intact and **DOES NOT** separate from the pretensioner assembly, no further action is required.
  - If the pretensioner quick connector separates from the pretensioner assembly, go to the REPAIR PROCEDURE.

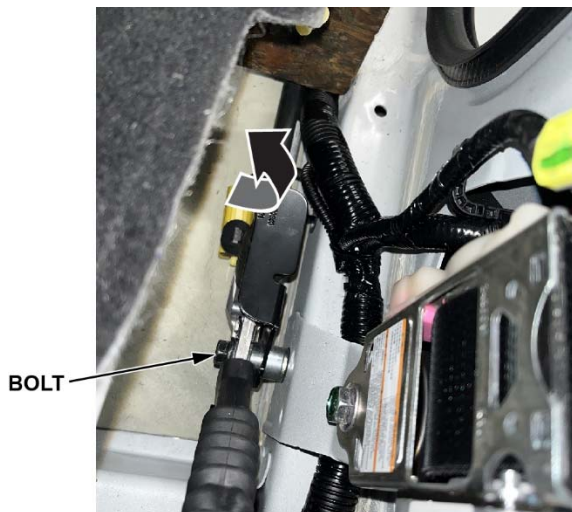
6. Pull back on the carpet as needed to gain access to the seat belt pretensioner bolt.
