## CERTAIN 2018-2020 MODEL YEAR EXPEDITION AND NAVIGATOR VEHICLES — FRONT SEATBELT RETRACTOR DATE CODE INSPECTION

### SERVICE PROCEDURE

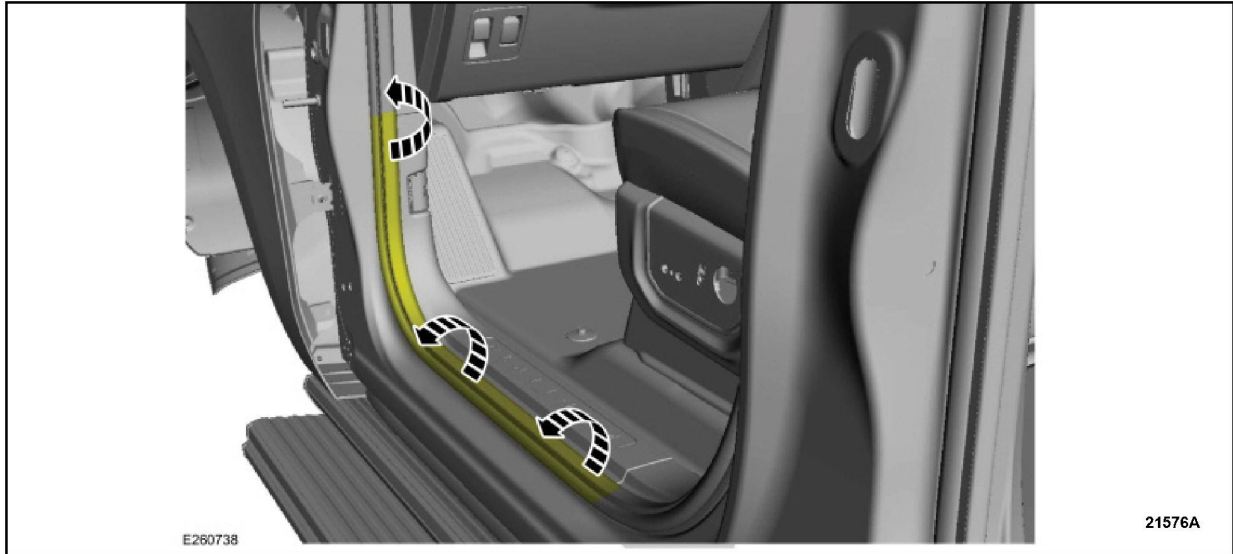
FIGURE 1

1. Position the front door weatherstrip aside. See Figure 1.

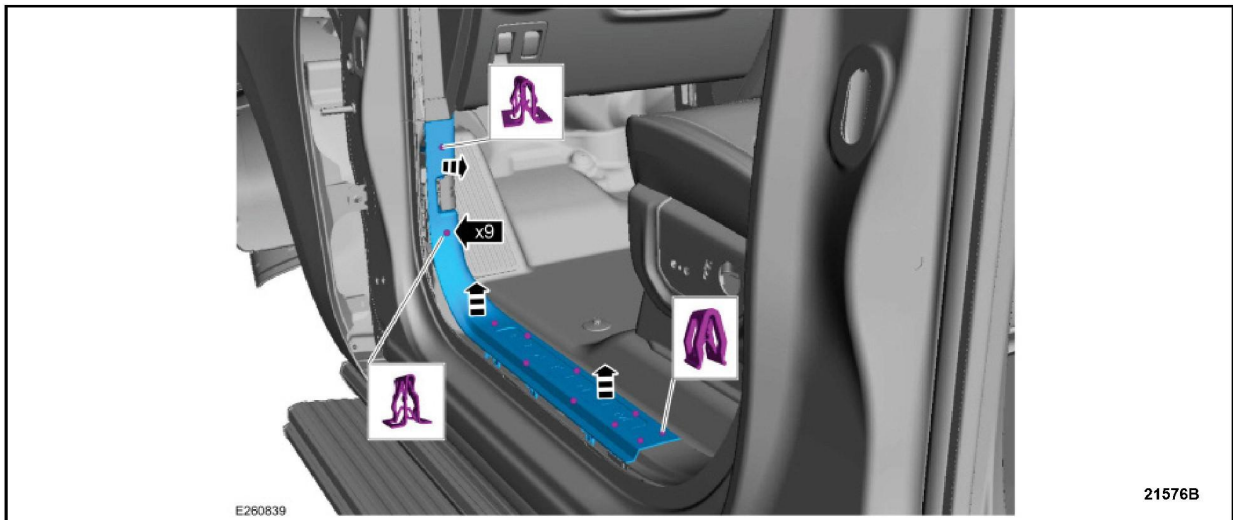
FIGURE 2

2. Release the clips and remove the front door scuff plate trim panel. See Figure 2.

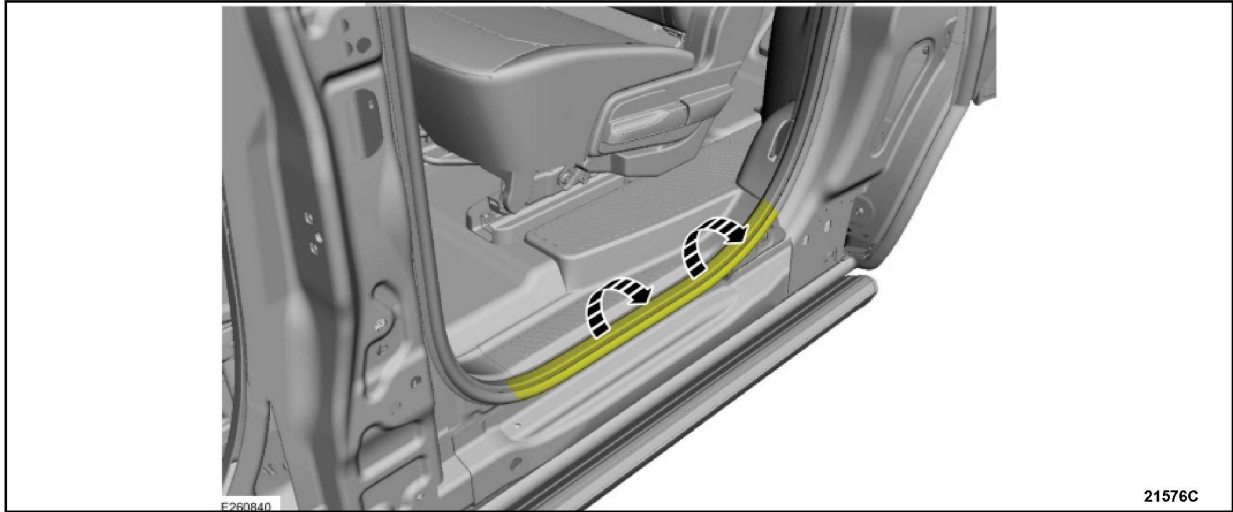
**FIGURE 3**

3. Position the rear door weatherstrip aside. See Figure 3.

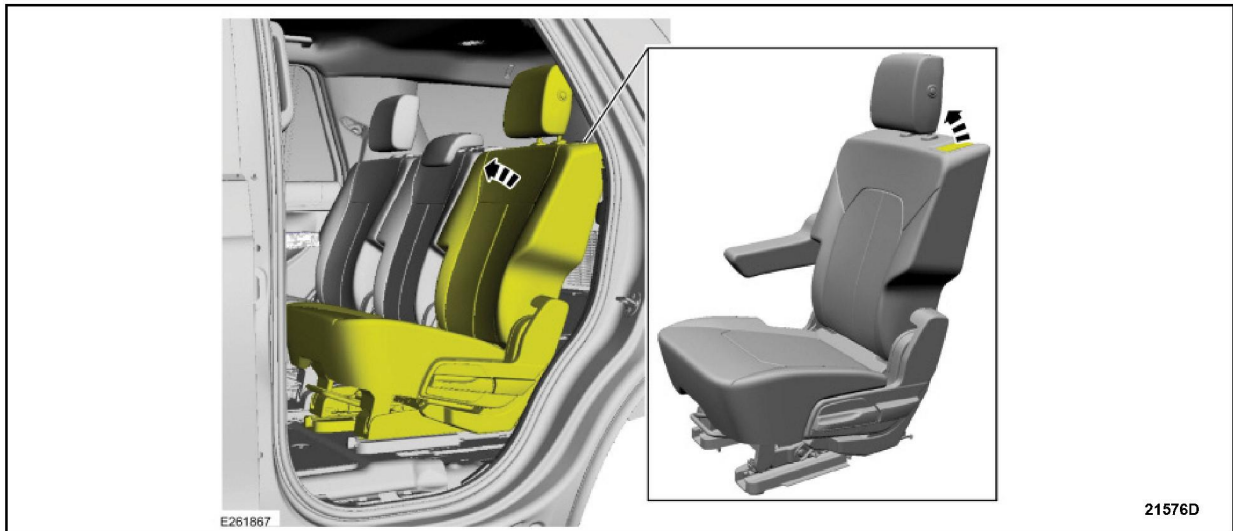
**FIGURE 4**

4. Position the second row seat forward. See Figure 4.

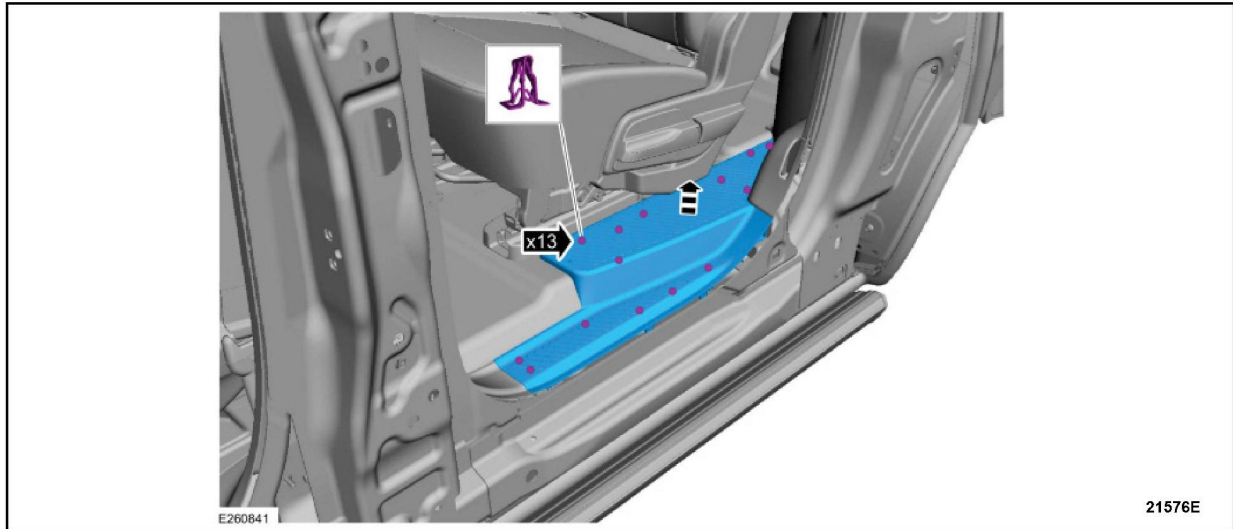
**FIGURE 5**

5. Release the clips and remove the rear door scuff plate trim panel. See Figure 5.

**NOTE:** Long wheelbase shown, short wheelbase similar.

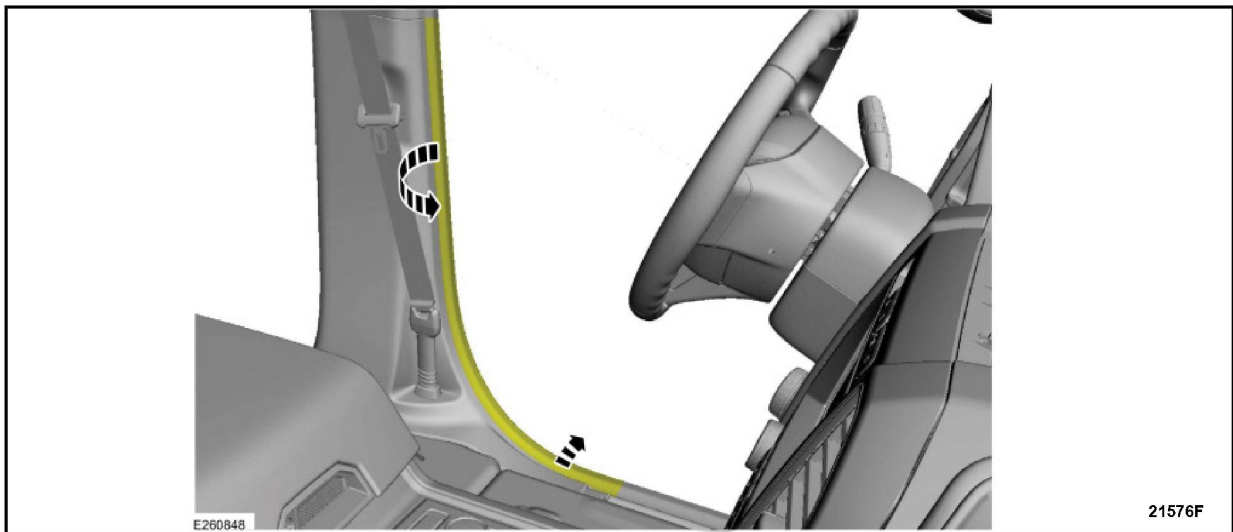
**FIGURE 6**

6. Position the front door weatherstrip aside. See Figure 6.

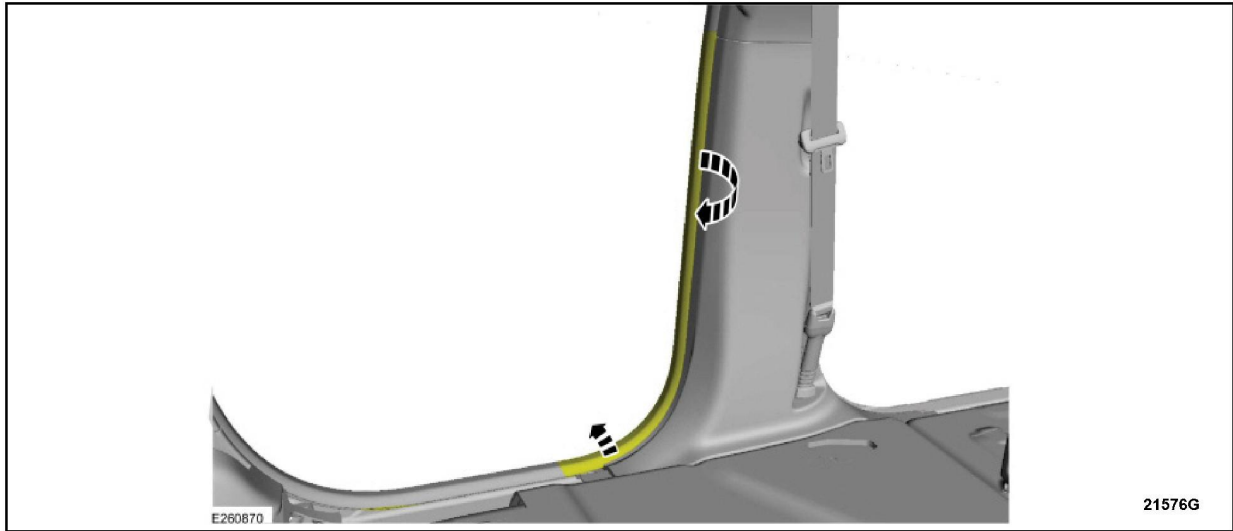
**FIGURE 7**

7. Position the rear door weatherstrip aside. See Figure 7.

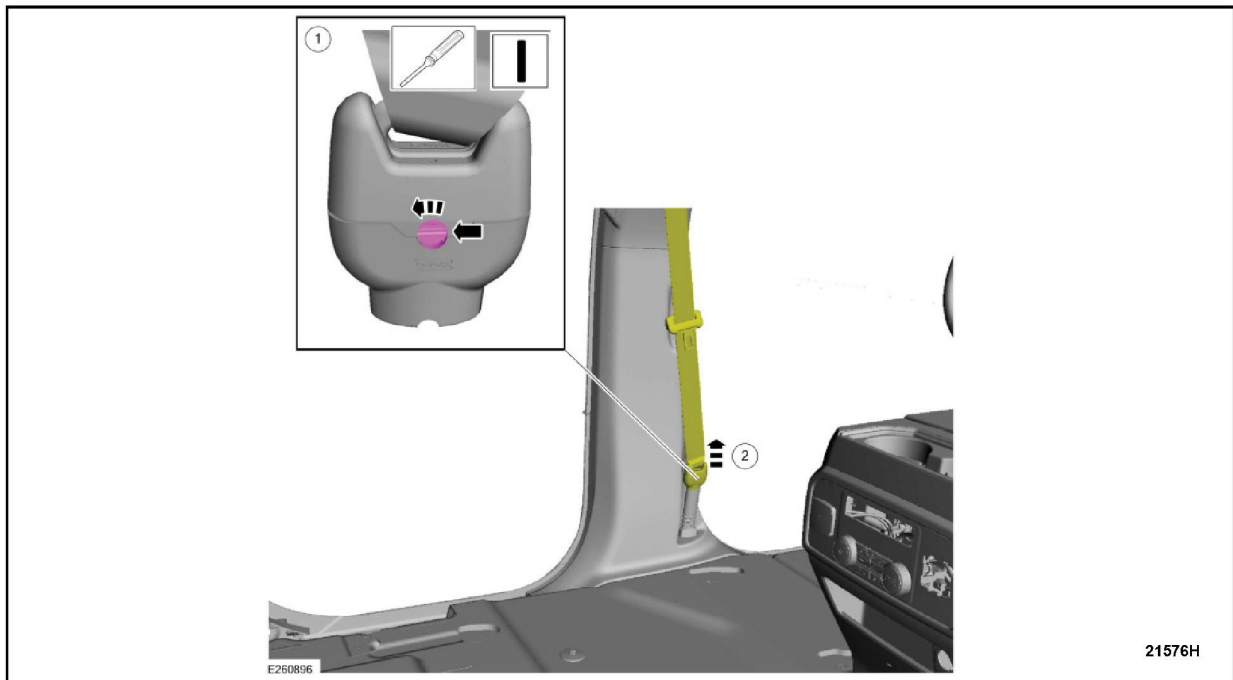
**FIGURE 8**

8. Press in on the release button and disconnect the front seatbelt retractor from the front seatbelt anchor pretensioner. See Figure 8.

Use the General Equipment: Flat-Bladed Screwdriver

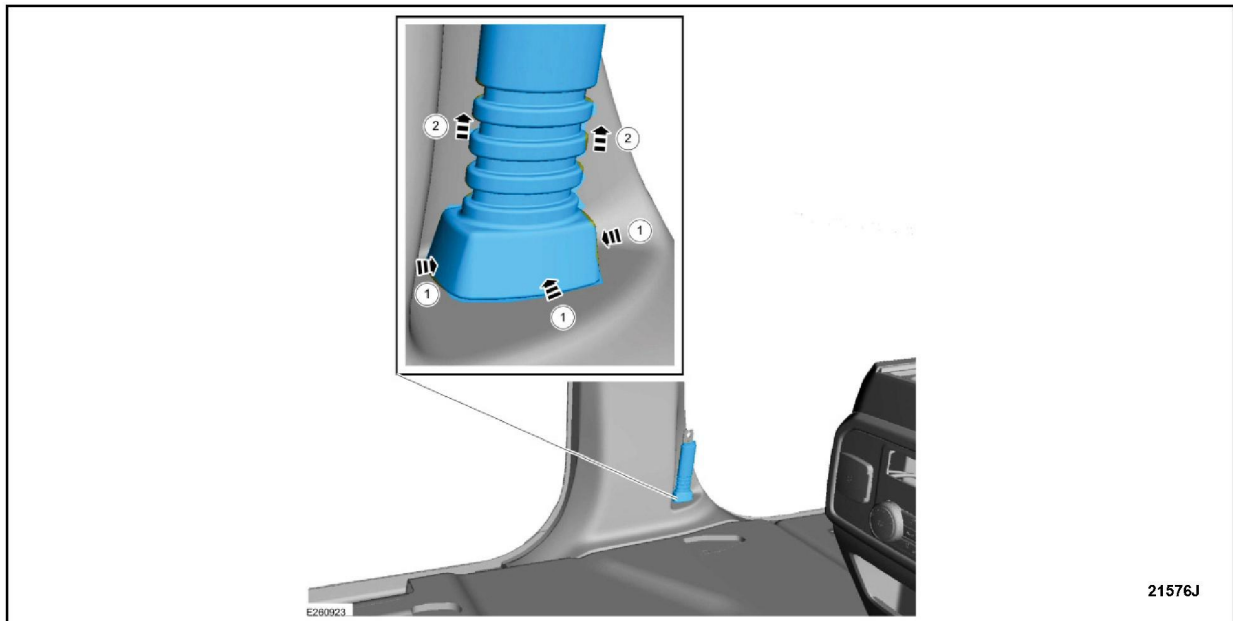
**FIGURE 9**

9. Press in on the sides of the front seatbelt anchor pretensioner boot, then lift up and remove the front seatbelt anchor pretensioner boot. See Figure 9.

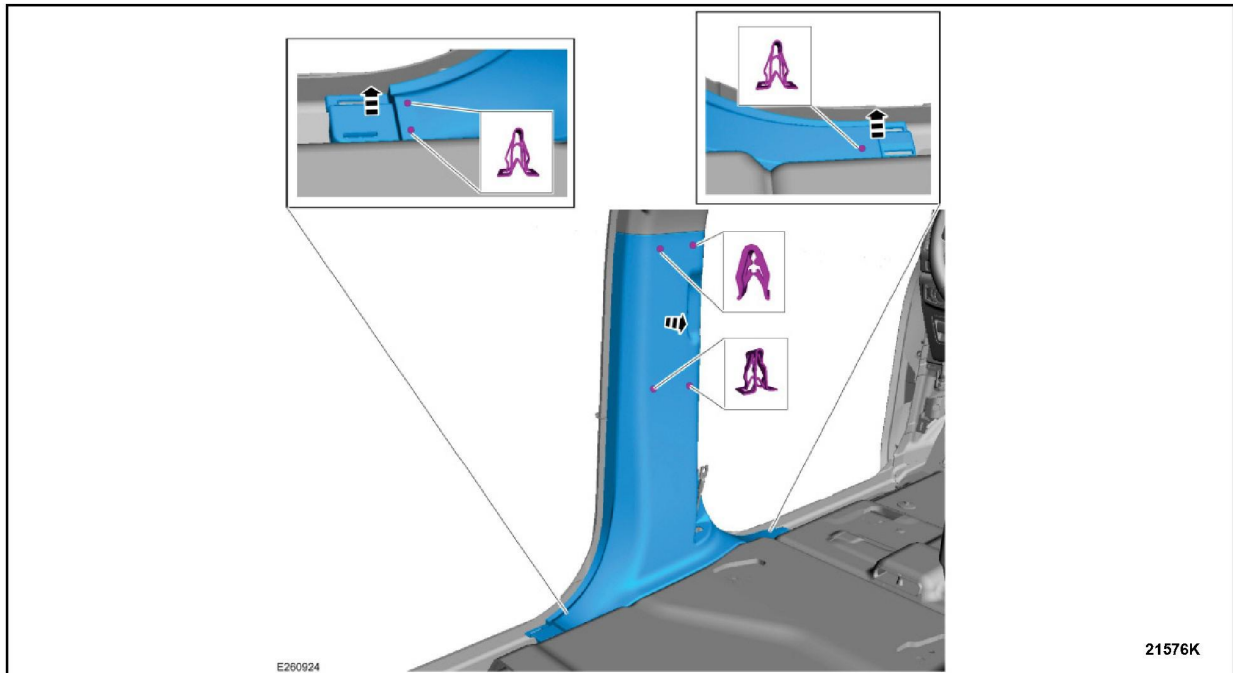
**FIGURE 10**

10. Release the clips and remove the lower B-pillar trim panel. See Figure 10.

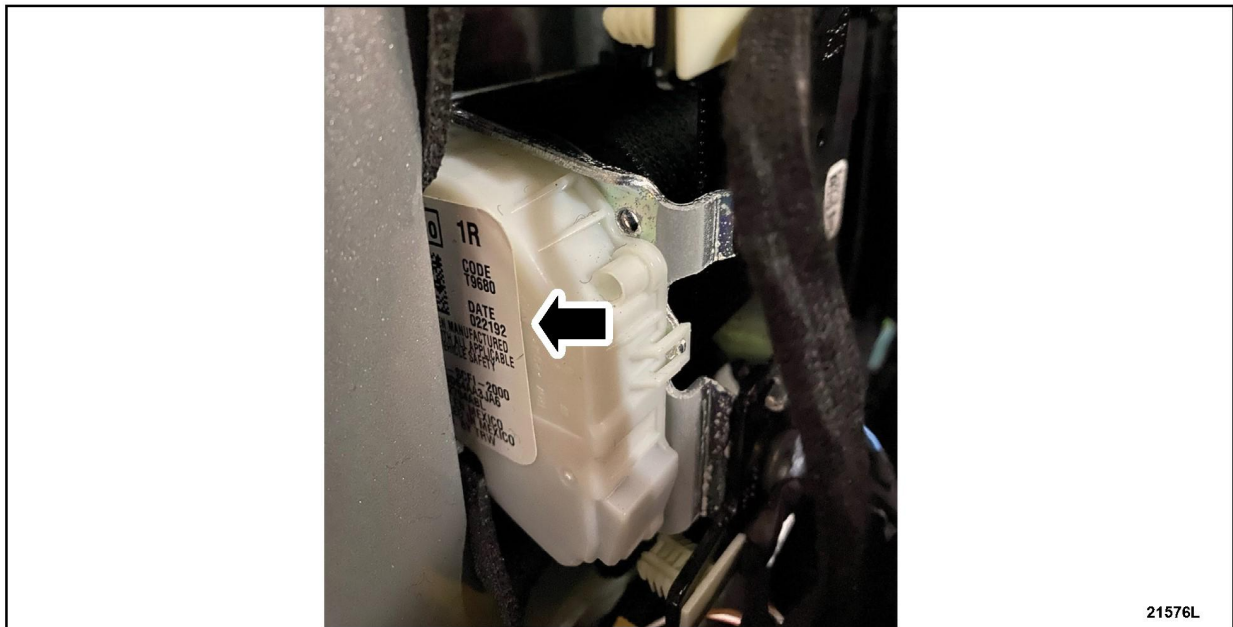
FIGURE 11

12. Locate the part label sticker on the back of the Left-Hand (LH) and Right-Hand (RH) front seatbelt retractors. See Figure 11.

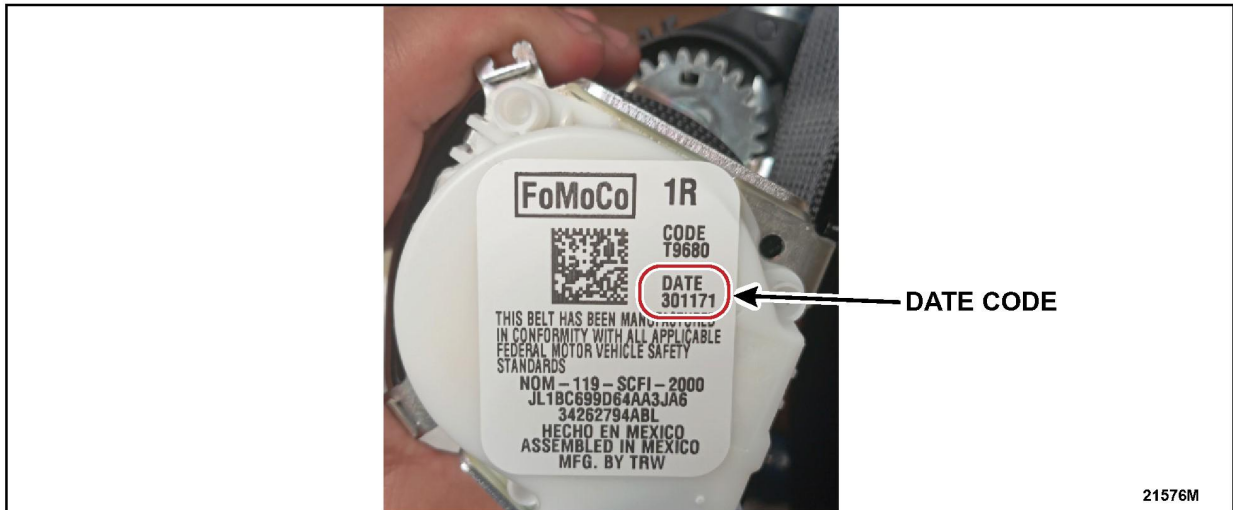
FIGURE 12

13. Locate the date code on both the LH and RH front seatbelt retractors. See Figure 12.

14. Do either the LH or RH front seatbelt retractor date codes match any of the following date codes listed in the chart below?

**NOTE: The 3rd digit and the 6th digit of the date codes do NOT need to match.**

Yes - Replace the front seatbelt retractor(s) that have the suspect date codes. Follow the Workshop Manual (WSM) procedures in Section 501-20A.

No - Replacement is not needed. Reinstall the lower B-pillar trim panels by reversing steps 1 through 10, then continue to step 15.
