CERTAIN 2018-2020 MODEL YEAR EXPEDITION AND NAVIGATOR VEHICLES — FRONT SEATBELT RETRACTOR DATE CODE INSPECTION

SERVICE PROCEDURE

Evaporator Drain Tube Inspection

Front Seatbelt Retractor Inspection

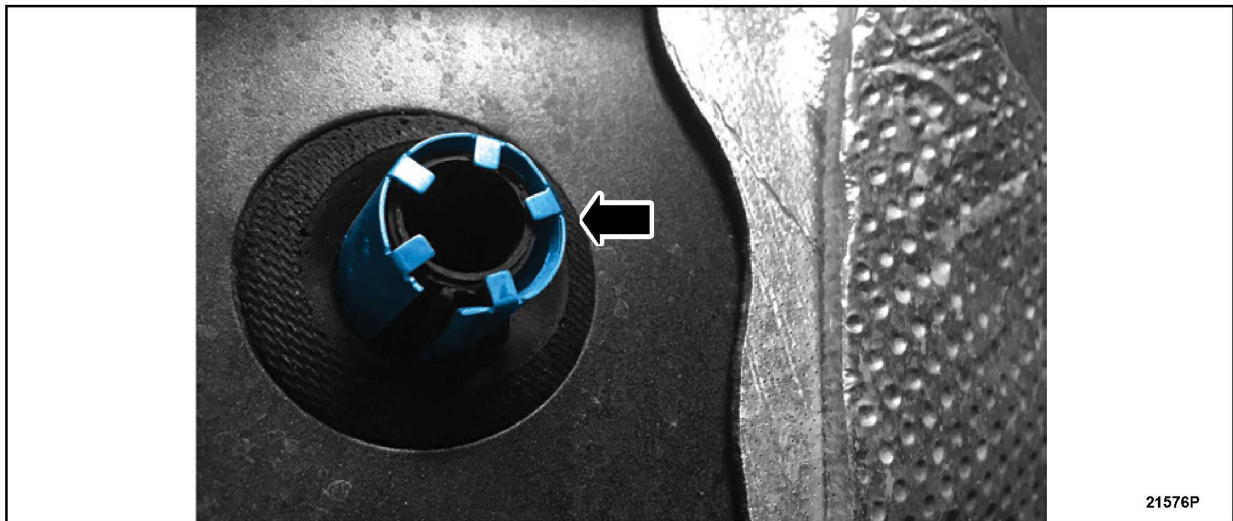
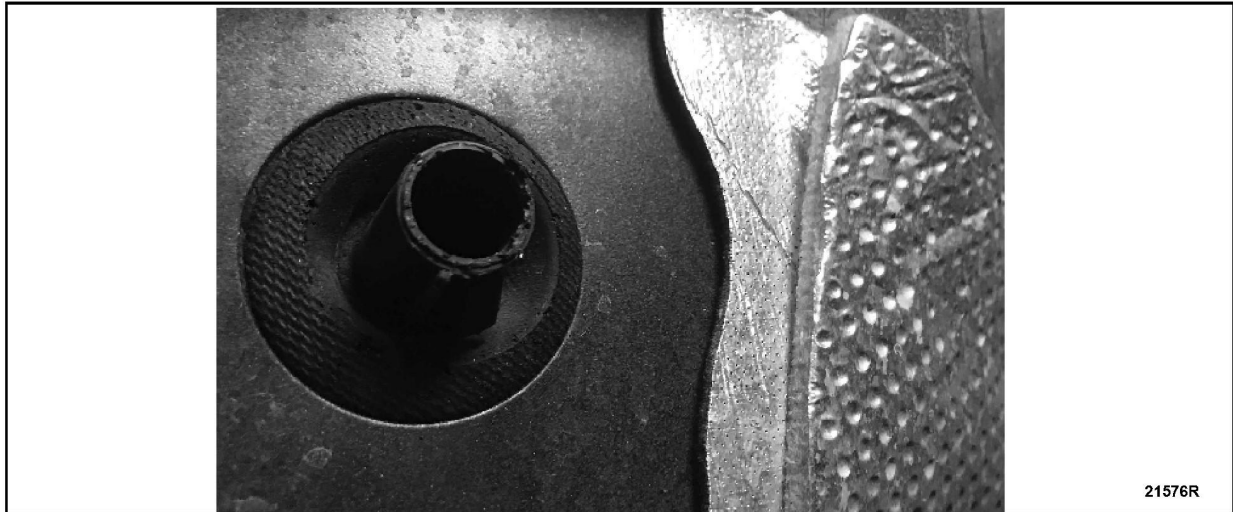
2. Raise the vehicle and remove the RH front tire.
3. Remove the RH front fender splash shield. Follow the Workshop Manual (WSM) procedures in Section 501-02.
4. Using needle nose pliers or equivalent, remove and discard the metal shield from the evaporator drain tube by bending the tabs away from the tube. See Figures 3 through 5.

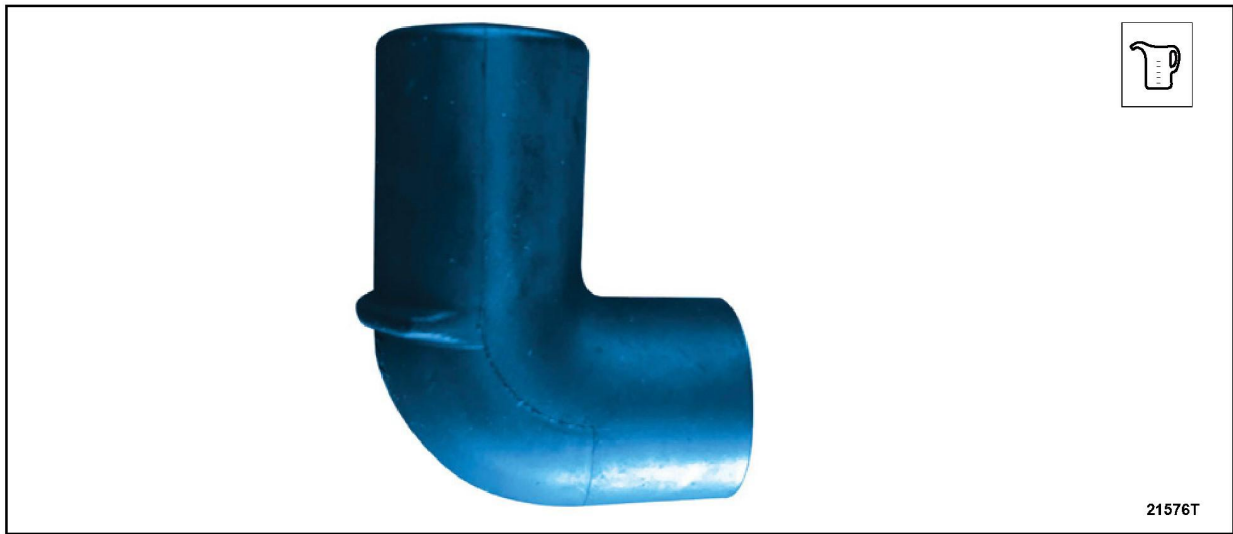
5. Lubricate the inside of the elbow with water. Install the short end of the elbow onto the drain tube. See Figures 6 and 7.

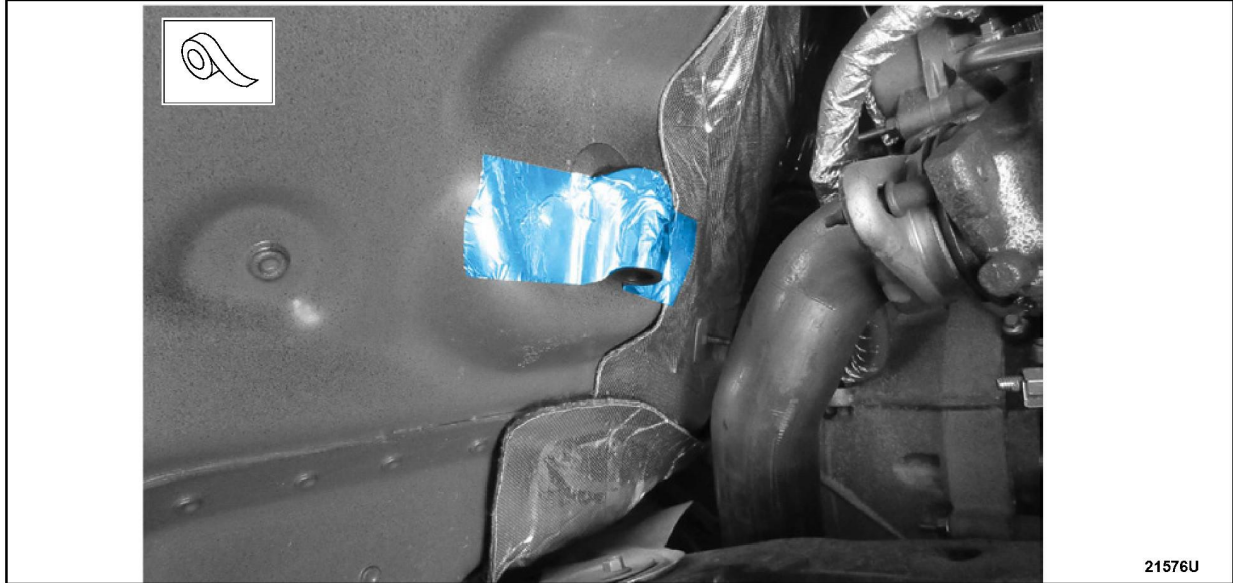
FIGURE 8

6. Clean the surface of the elbow, drain seal, and surrounding sheet metal with isopropyl alcohol or equivalent.
7. Apply heat shield tape over the elbow. See Figure 8.

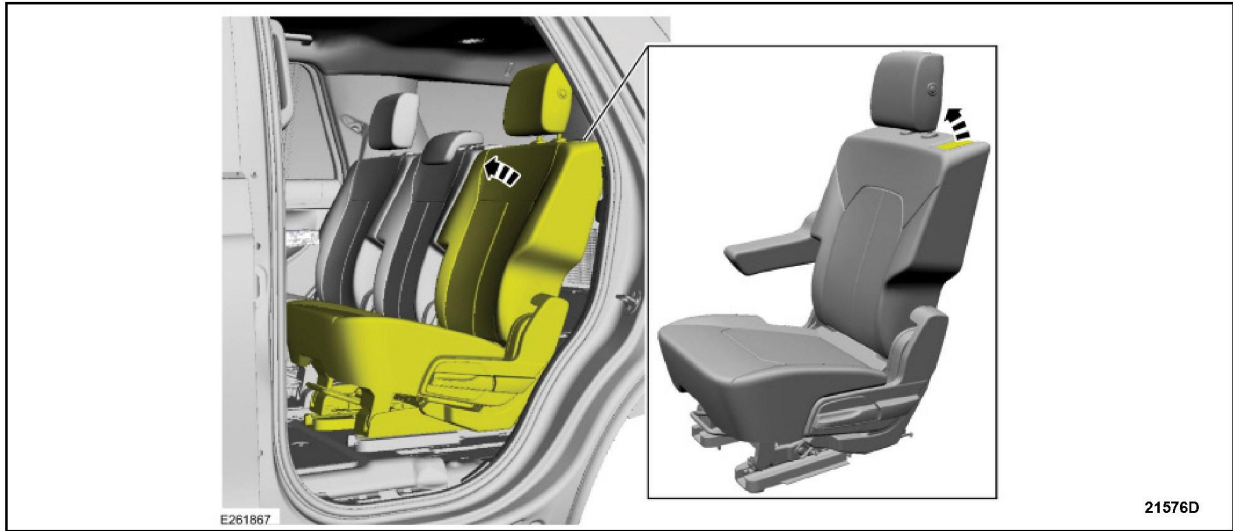
FIGURE 12

4. Position the second row seat forward. See Figure 12.

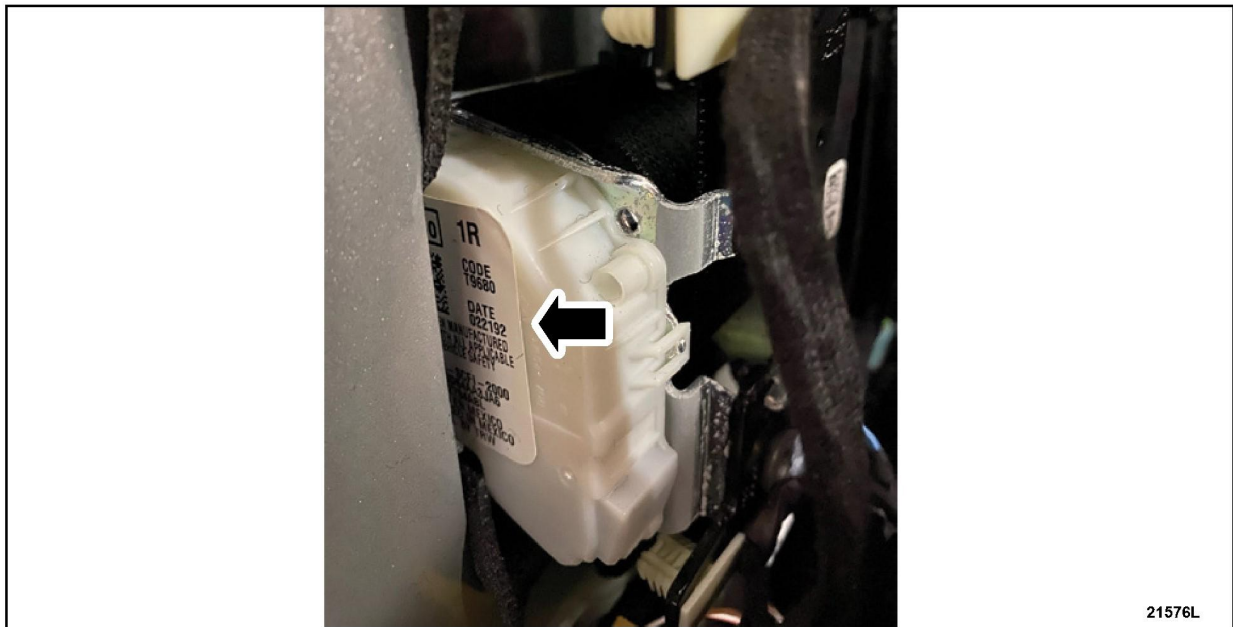
FIGURE 19

12. Locate the part label sticker on the back of the Left-Hand (LH) and Right-Hand (RH) front seatbelt retractors. See Figure 19.

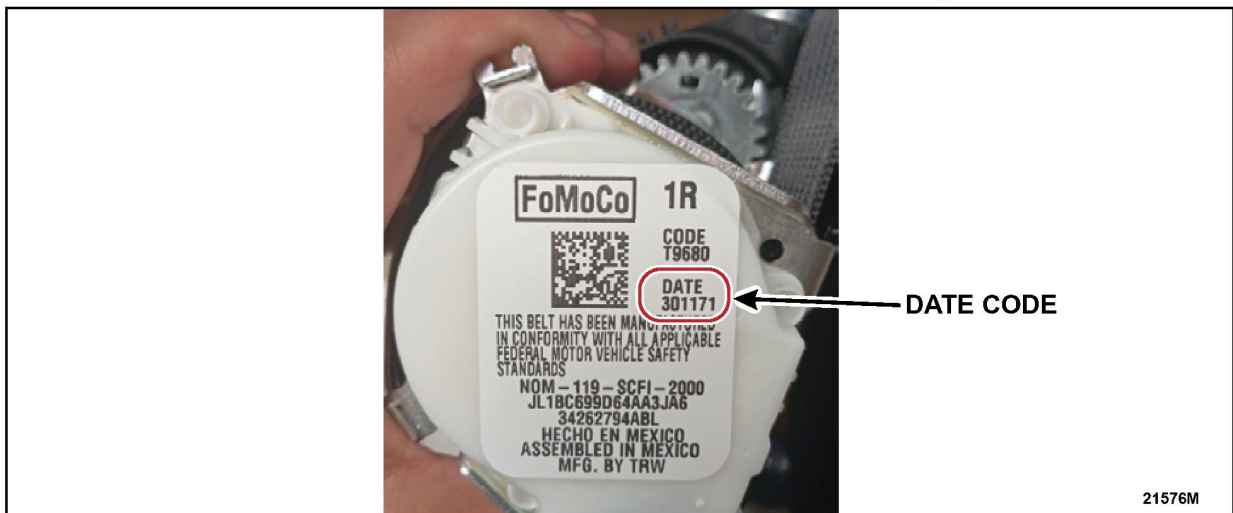
FIGURE 20

13. Locate the date code on both the LH and RH front seatbelt retractors. See Figure 20.

14. Do either the LH or RH front seatbelt retractor date codes match any of the following date codes listed in the chart below?

NOTE: The 3rd digit and the 6th digit of the date codes do NOT need to match.

Yes - Replace the front seatbelt retractor(s) that have the suspect date codes. Follow the WSM procedures in Section 501-20A.
