## CERTAIN 2018-2020 MODEL YEAR EXPEDITION AND NAVIGATOR VEHICLES — FRONT SEATBELT RETRACTOR DATE CODE INSPECTION

### SERVICE PROCEDURE

### Evaporator Drain Tube Inspection

## Front Seatbelt Retractor Inspection

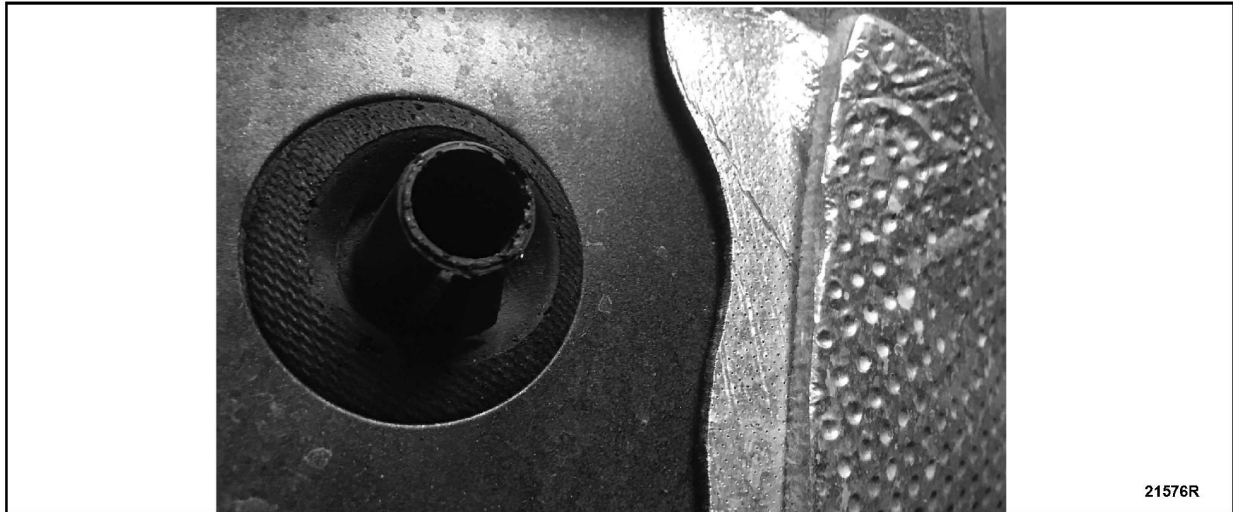
2. Raise the vehicle and remove the RH front tire.
3. Remove the RH front fender splash shield. Follow the Workshop Manual (WSM) procedures in Section 501-02.
4. Using needle nose pliers or equivalent, remove and discard the metal shield from the evaporator drain tube by bending the tabs away from the tube. See Figures 3 through 5.

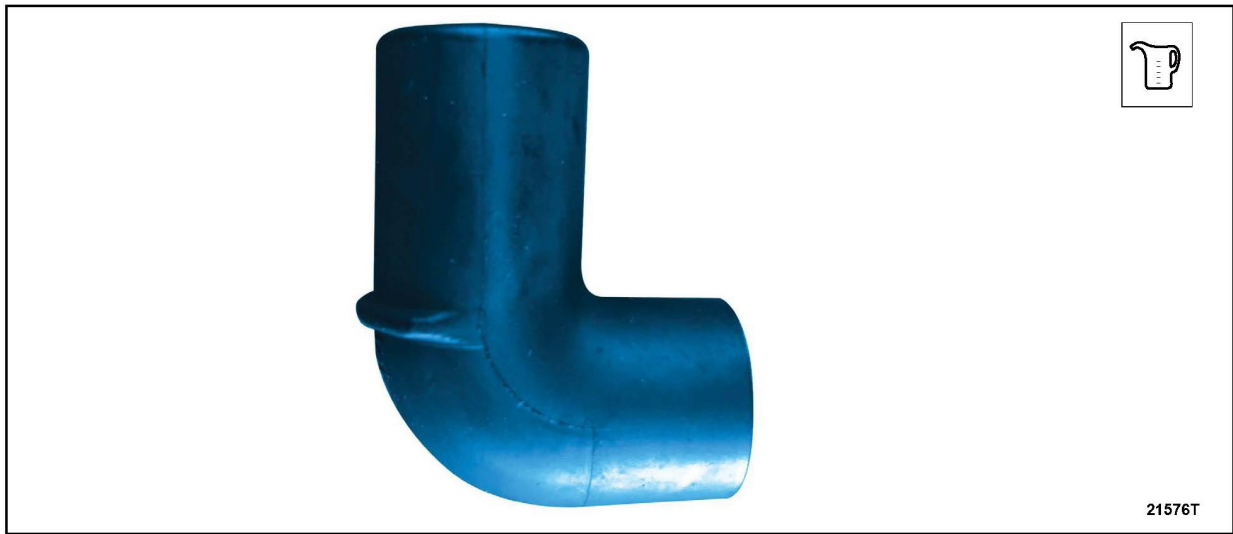
5. Lubricate the inside of the elbow with water. Install the short end of the elbow onto the drain tube. See Figures 6 and 7.

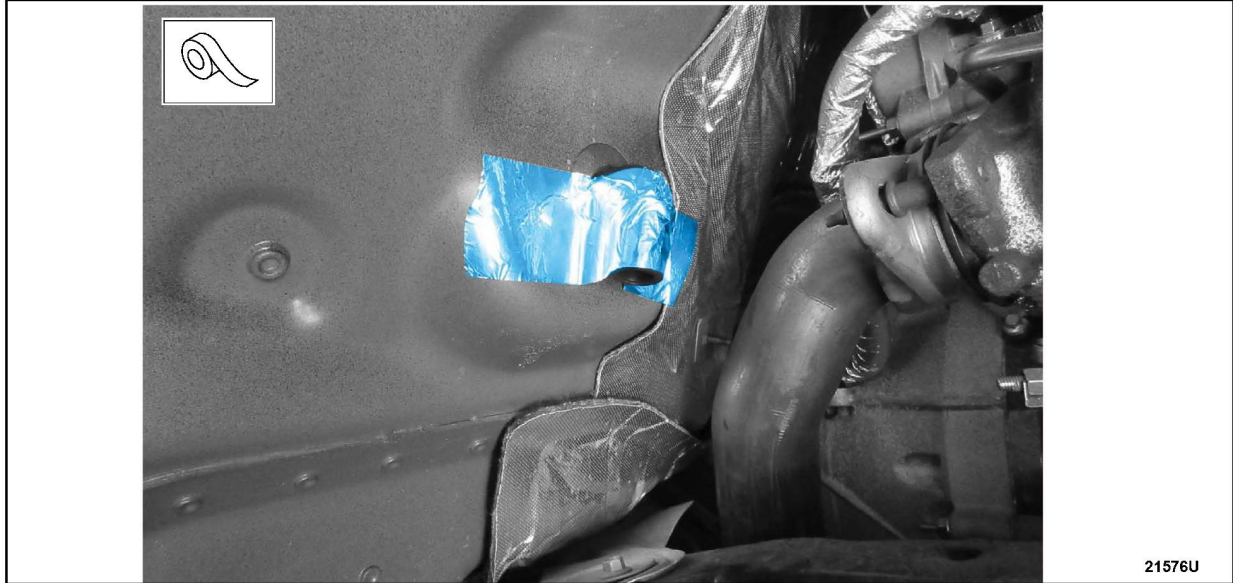
**FIGURE 8**

6. Clean the surface of the elbow, drain seal, and surrounding sheet metal with isopropyl alcohol or equivalent.
7. Apply heat shield tape over the elbow. See Figure 8.

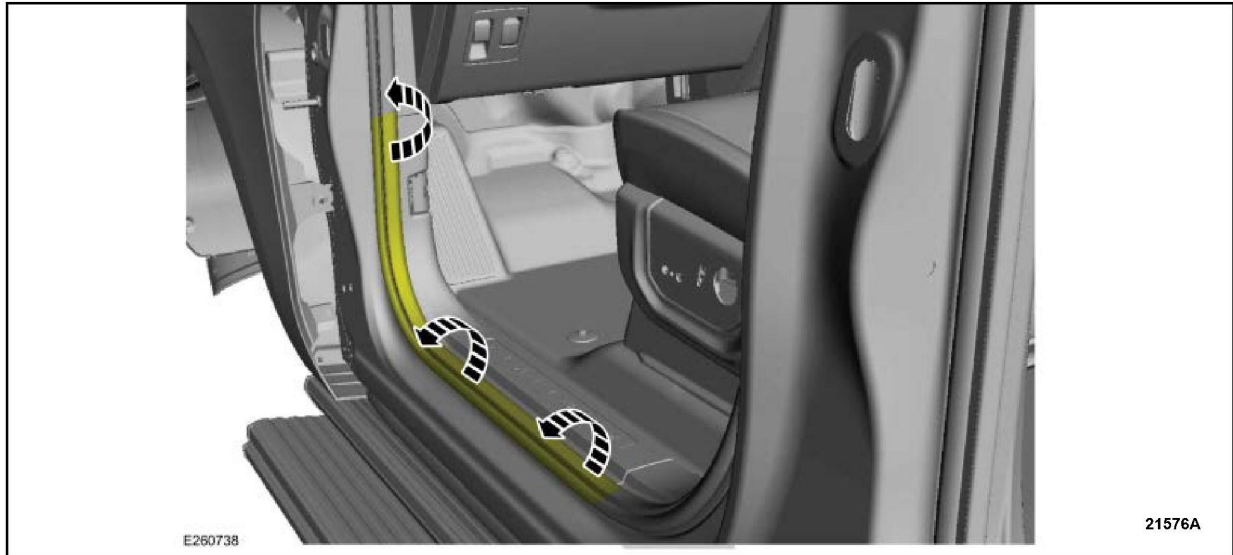
FIGURE 9

1. Position the front door weatherstrip aside. See Figure 9.

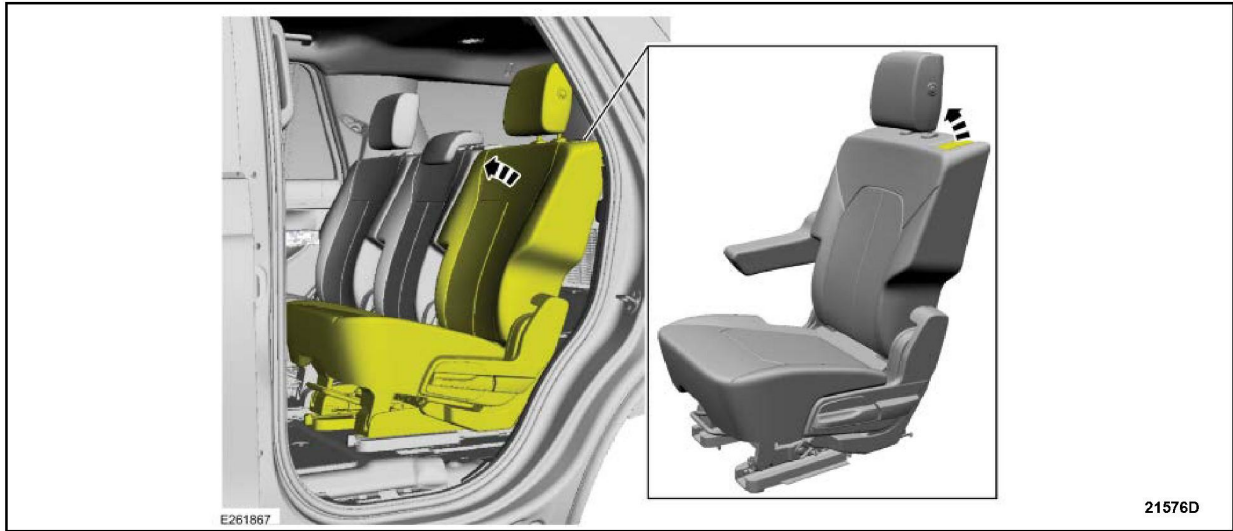
**FIGURE 12**

4. Position the second row seat forward. See Figure 12.

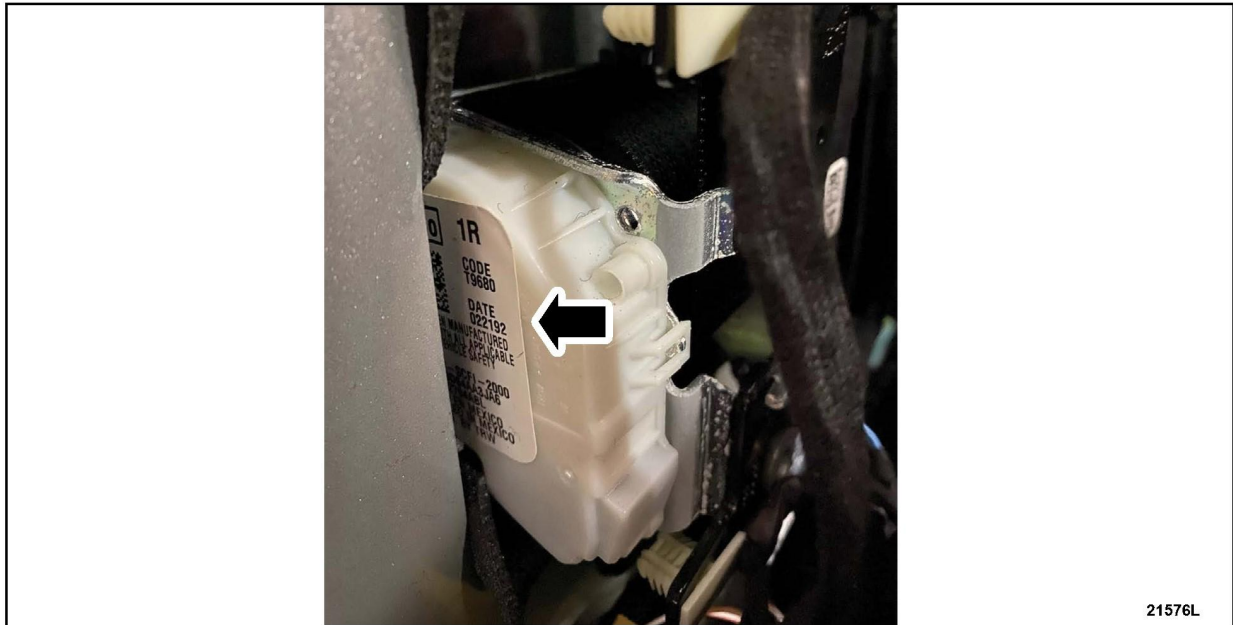
**FIGURE 19**

12. Locate the part label sticker on the back of the Left-Hand (LH) and Right-Hand (RH) front seatbelt retractors. See Figure 19.

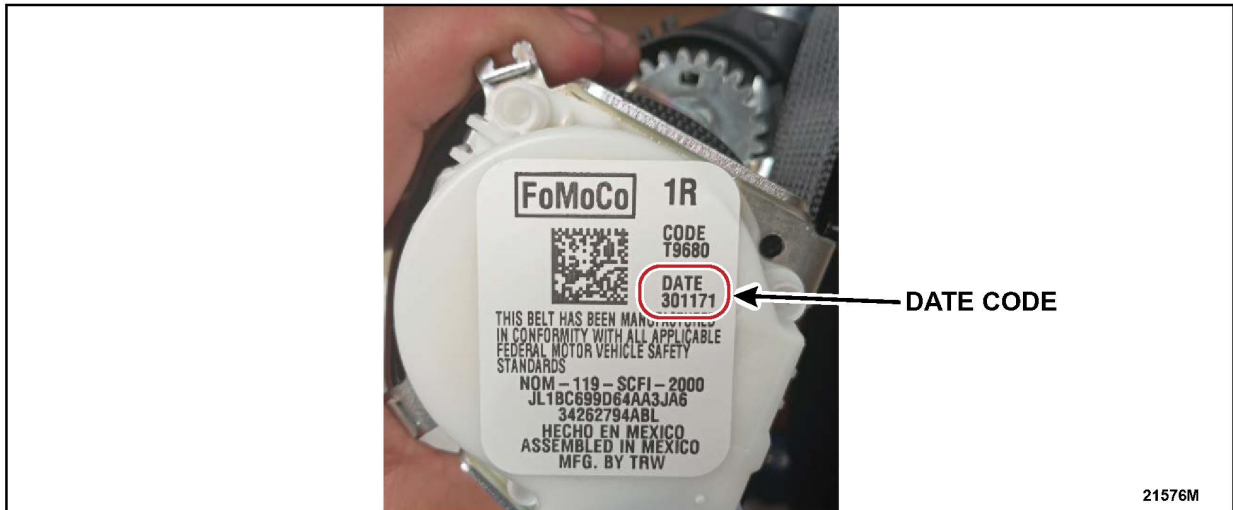
**FIGURE 20**

13. Locate the date code on both the LH and RH front seatbelt retractors. See Figure 20.

14. Do either the LH or RH front seatbelt retractor date codes match any of the following date codes listed in the chart below?

**NOTE: The 3rd digit and the 6th digit of the date codes do NOT need to match.**

Yes - Replace the front seatbelt retractor(s) that have the suspect date codes. Follow the WSM procedures in Section 501-20A.
