**HYUNDAI**

## Technical Service Bulletin

GROUP	NUMBER
<b>RECALL</b>	<b>15-01-048</b>
DATE	MODEL(S)
<b>DECEMBER, 2015</b>	<b>2011-2012MY SONATA (YF)</b>

**SUBJECT:** SONATA GDI ENGINE INSPECTION / REPLACEMENT  
(RECALL CAMPAIGN 132)

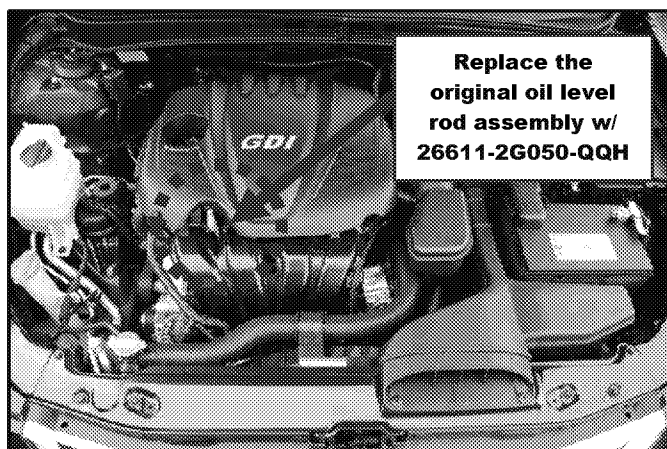
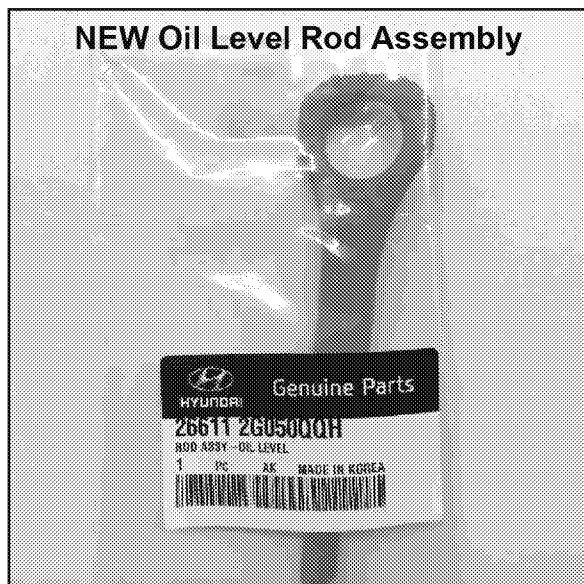
- Replace the oil level rod assembly (engine oil dipstick) with the new campaign part.
- Adjust the engine oil level to near FULL mark.

2. Replace the current Oil Level Rod Assembly with the new campaign part.
- Remove and discard the existing Oil Level Rod Assembly.
  - Install new **ORANGE** handle Oil Level Rod Assembly (P/N 26611-2G050-QQH)
