CQIS DETAIL REPORT

VEHICLE: 2015 FOCUS,SE,4 DOOR ,SEDAN VIN: [REDACTED]  
Engine : 1.0L 12V DI TC I3 GS 120PS FOX Odometer: 68,227 MILES  
Operating Environ: WCC :  
Vehicle Use : Rsp. Act:

VEHICLE: 2015 FOCUS,SE,4 DOOR ,SEDAN VIN [REDACTED]  
Engine : 1.0L 12V DI TC I3 GS 120PS FOX Odometer: 57,246 MILES  
Operating Environ: WCC :  
Vehicle Use : Rsp. Act:

VEHICLE: 2018 FOCUS,SE,4 DOOR ,SEDAN VIN: [REDACTED]  
Engine : 1.0L 12V DI TC I3 GS 120PS FOX Odometer: 59,249 MILES  
Operating Environ: WCC :  
Vehicle Use : Rsp. Act:

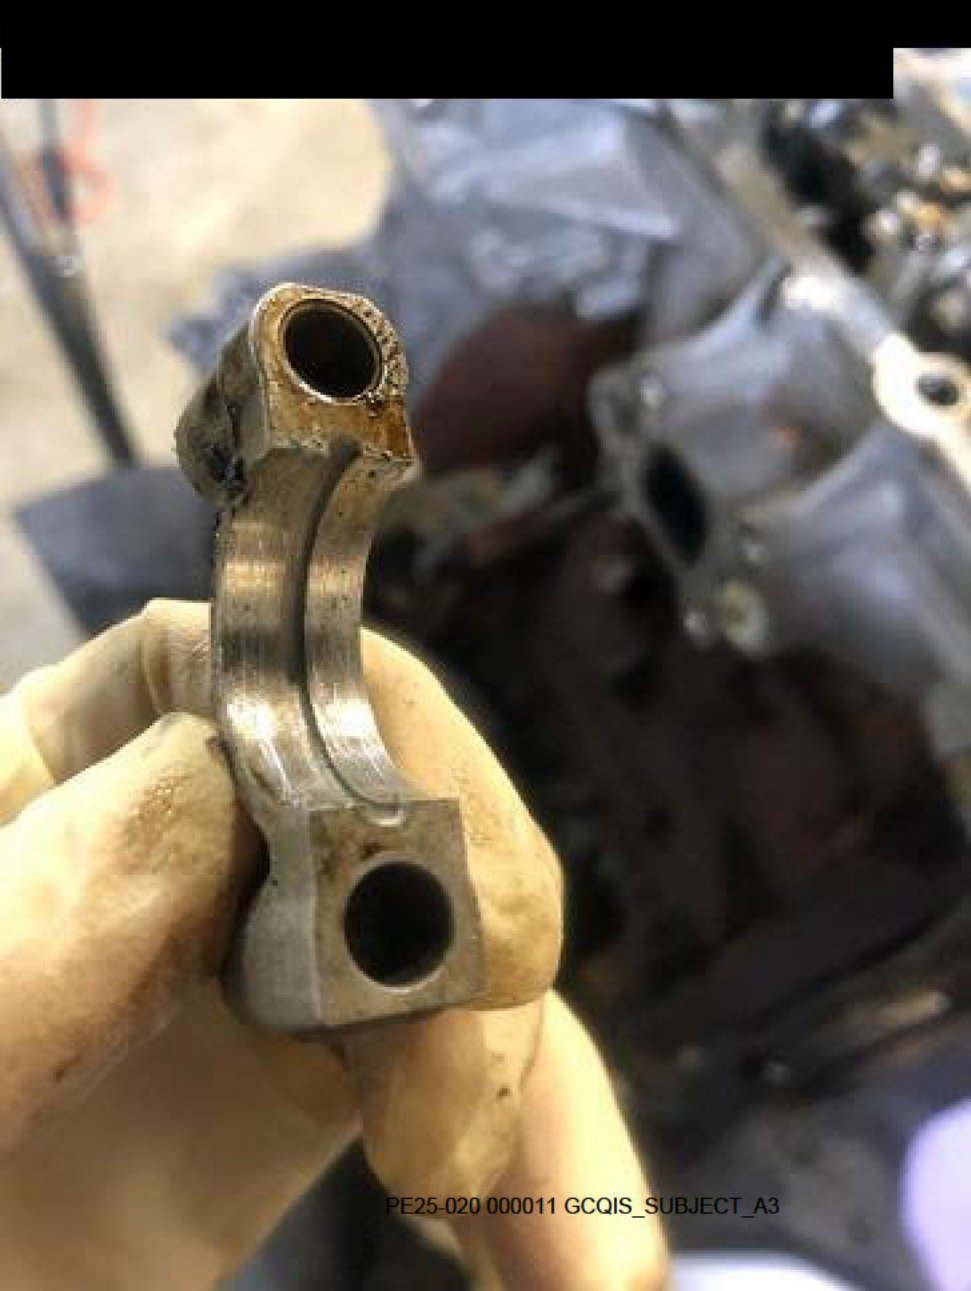
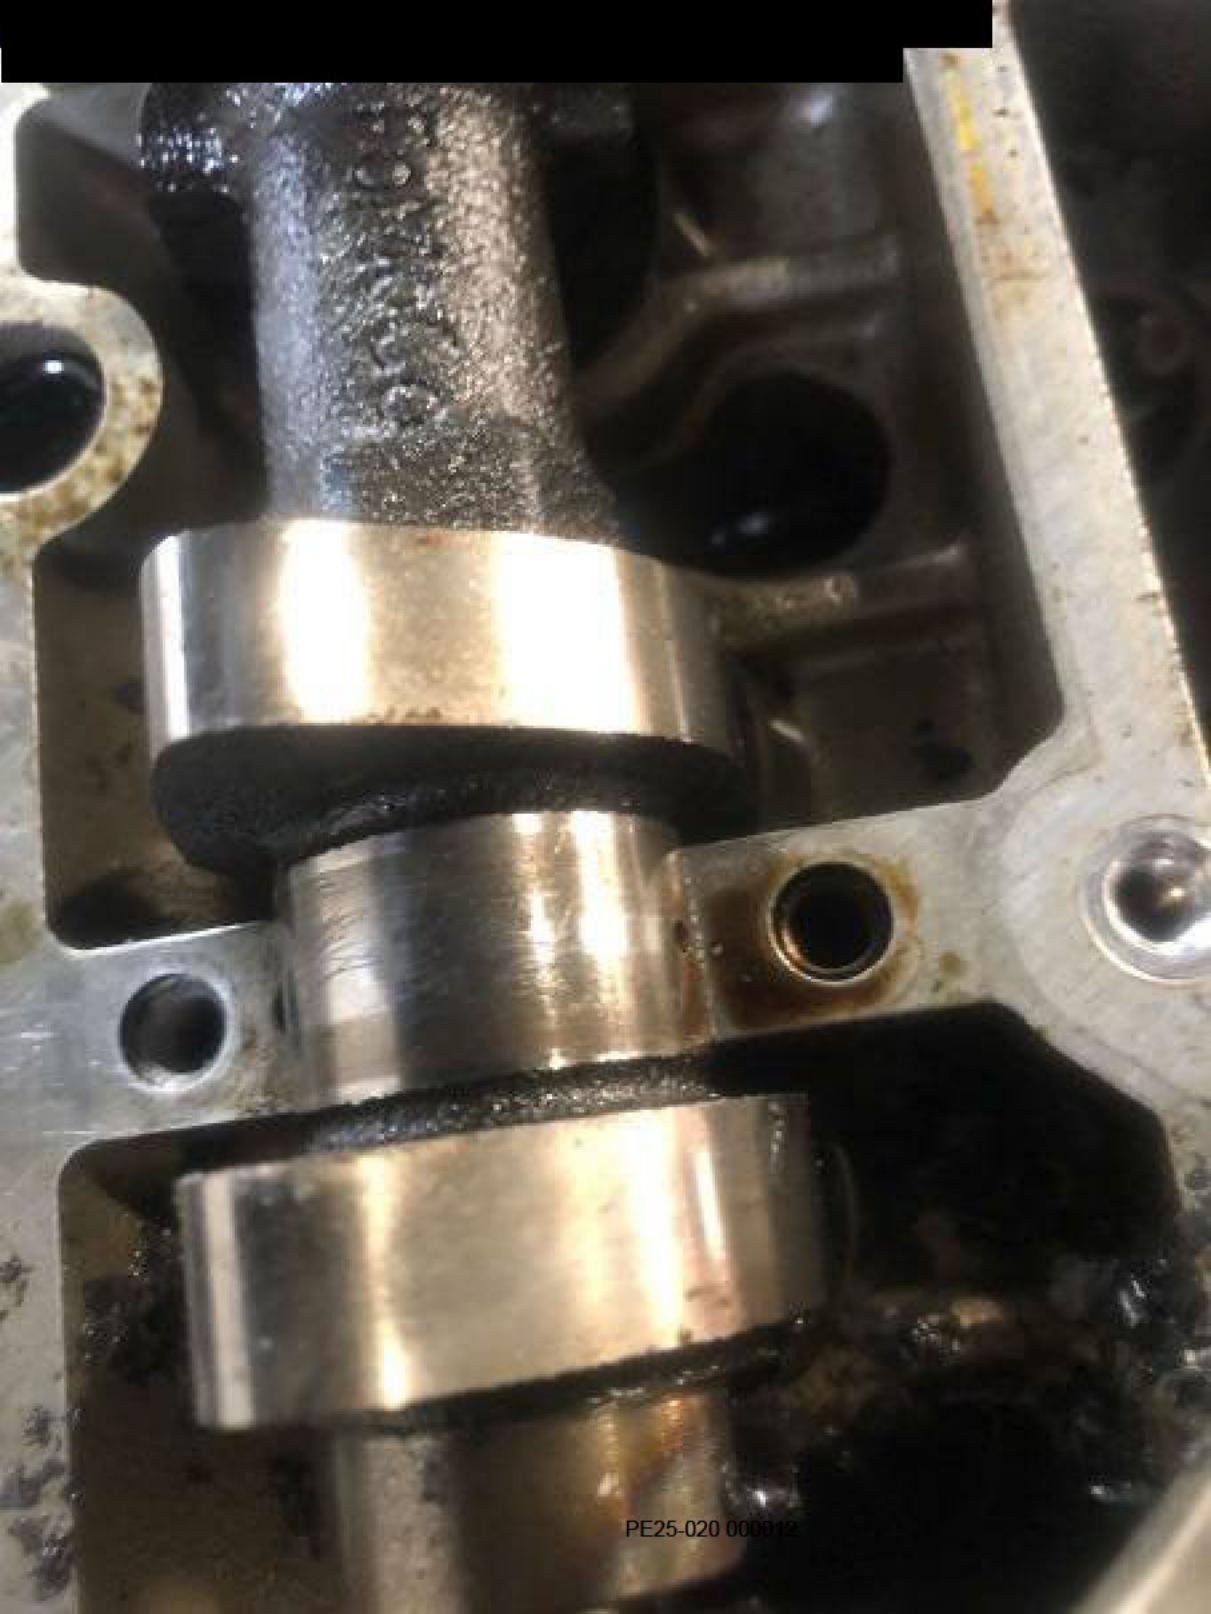
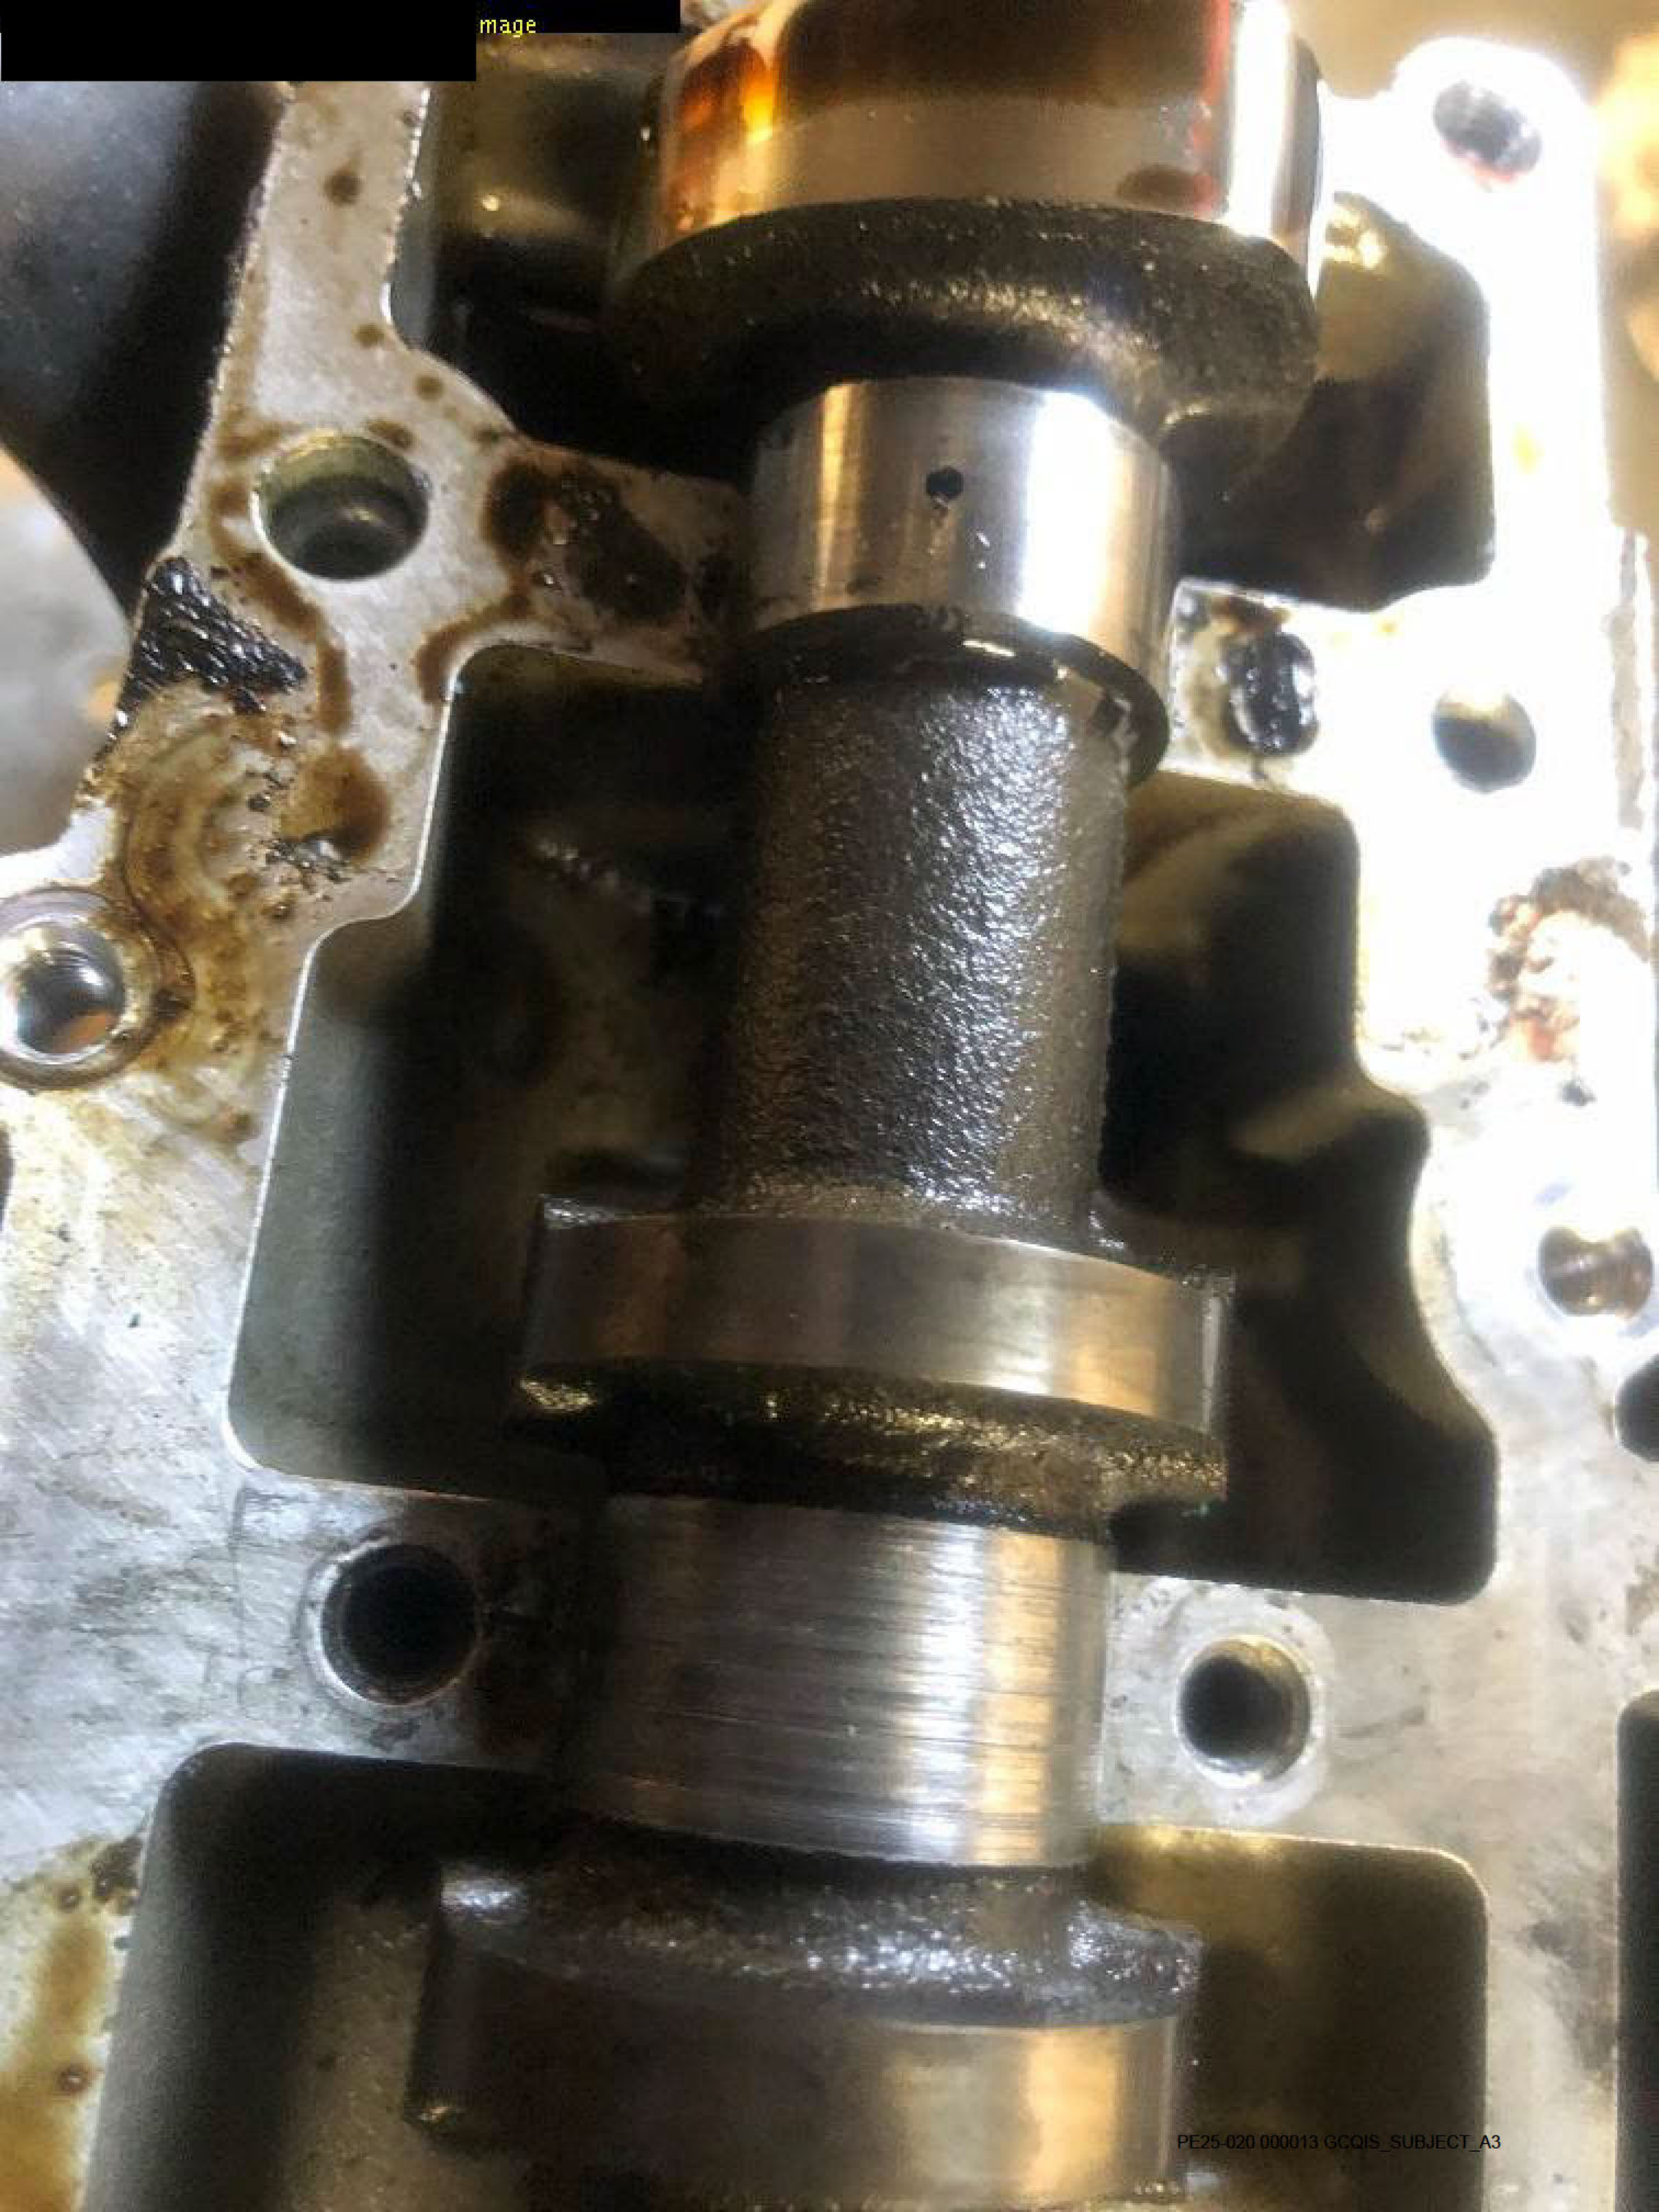
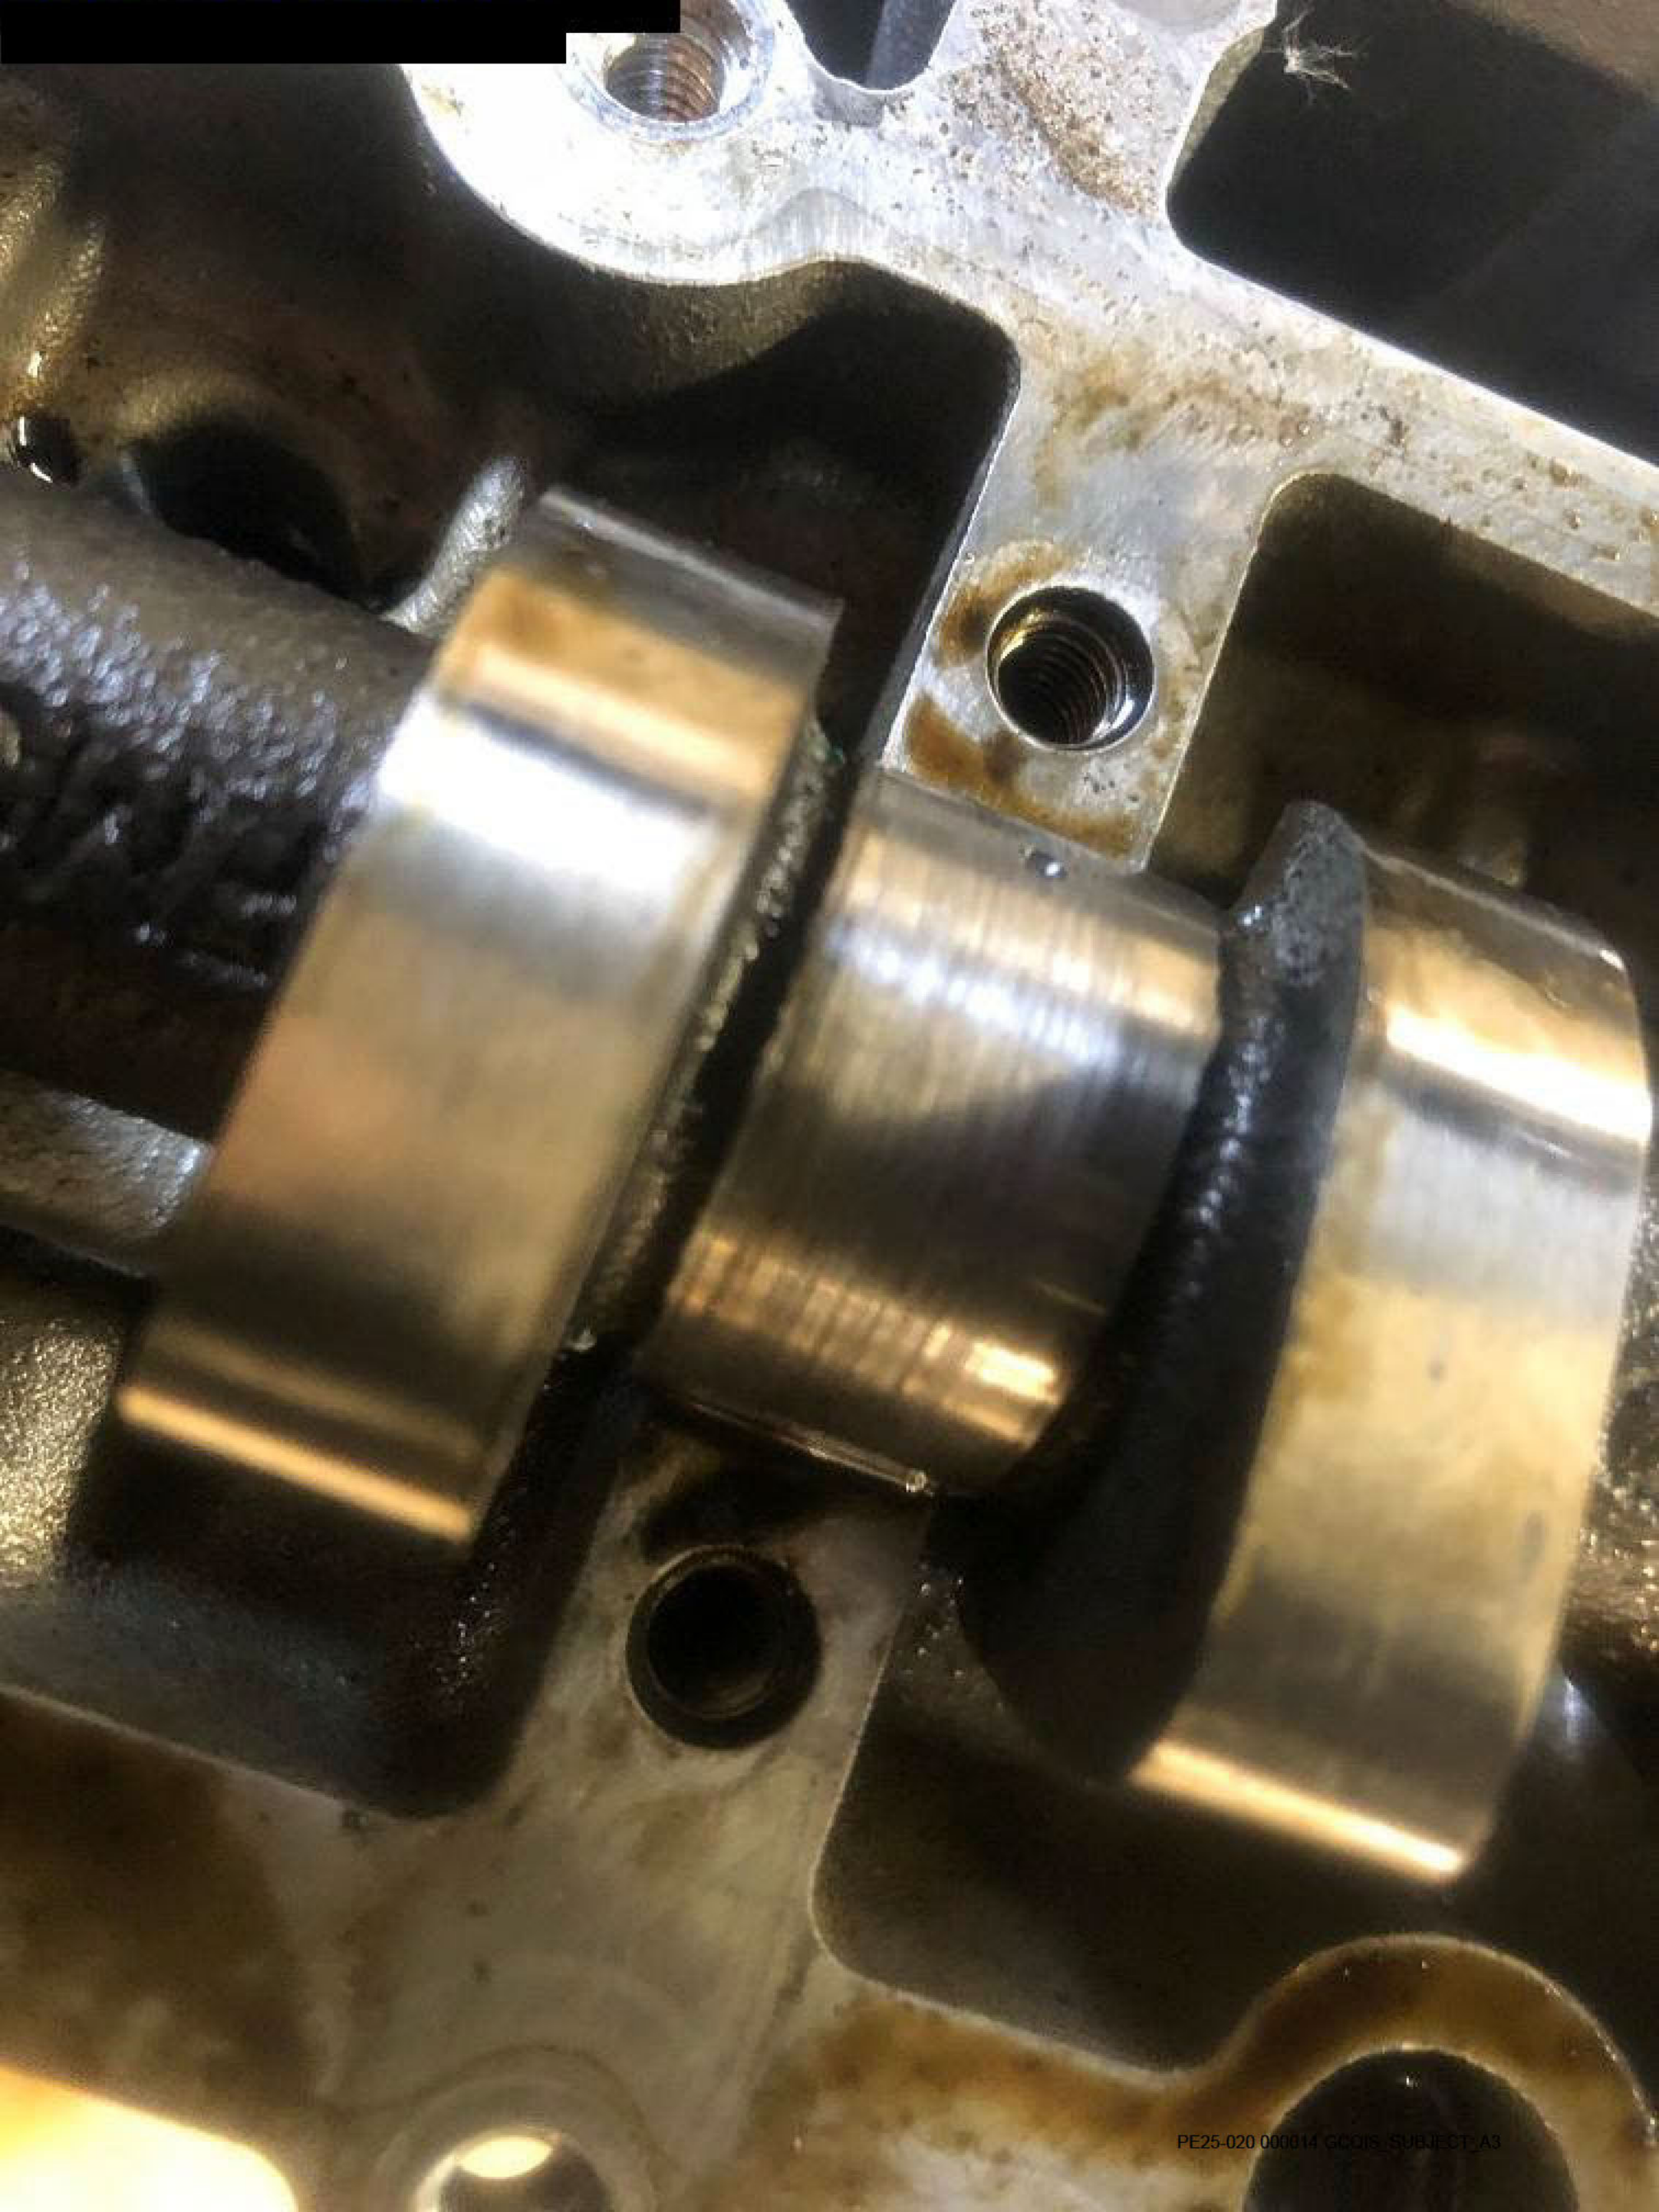
F1FT-14A280  
D.A.

knock and oil light on. varified engine oil level good and oil  
condition, ...removed valve cover and found metal shavings in bank 2 cam  
at vaccum pump for brake booster. check engine timing and found to be  
off 2-3 teeth. ...rmvd engine oil found shavings in oil. rmvd catalist  
requiring arc torch to heat 2 bolts (1.0 m-time) ...rmvd and inspectd  
ening oil pan and oil pump/pick-up. metal shavings found inoil pick-up  
causing upper end of head to be oil starved causing failure to vaccum  
pump bearing on bank 2 cam shaft. reinstalled oil pan ...rmvd pwertrain  
(engine and trans) assembly for teardown. removed intake manifold  
inpected good, visually checked engine valves on exhaust side possable  
concern at cly 1, trans/clutch assembly removed inspected good. ...rmvd  
compressor and inlet pipe from head, found no damage. removed harmonic  
balancer and engine cover, found damage to timing belt assembly where

engine timing had jumped. removed timing belt and tensioner, ...rmvd  
camshafts as directed by wsm inspected found majory concern at the  
vaccum pump failur<br/>List major components (by name, not part#)  
needed for repair: short block and head.. found both camshhafts on  
back order so requesting a long block. perfromed PAC with no ETA or  
release date. PACO #'s [REDACTED] and 6 [REDACTED]>Please list part (by  
name, not part#) that was root cause of failure: vacuum pump and oil

CONCER 03/06/2019 01:48PM GTCGCQSP  
cam caps and shaft are scorn from metal dabris and lack of oil since  
the engine was startved of oil once the oil pickup became clogged

RECOMM 03/06/2019 02:15PM ADAM HOPPER MSS - FCSD - TECH ASSIT CENTER  
Evan, <P> ...The images that were uploaded show damage to the camshaft  
cap and camshaft that is not congruent with normal engine wear or  
damage. This type of damage can only occur due to outside objects  
contacting the cap and camshaft and will not occur with normal engine  
operation. Normal wear will be shown as symmetrical lines across the  
entire cap that do not stray off to one side or the  
other. ...<P><P> ...The damage that is present does warrant replacement of  
the cylinder head and camshaft, but due to the nature of the damage,  
this repair would not be warrantable. ... GASPA Not Approved

which was found. uploaded pictures of the cam bearing surface that the  
which was found. uploaded pictures of the cam bearing surface that the  
shop forman had removed.

Evan, ...Thank you for the additional images. Due to the scoring of the  
camshaft journals and the back ordered camshaft, it has been  
determined that the engine has a warrantable concern that requires  
replacement. Order a new Long Block (base part # 6006, or 6007 if a  
6006 is not available). ...<P>Be sure to review the service manual and  
the literature provided with the replacement engine regarding intake  
manifold cleaning/replacement, priming oil system, filling cooling  
system, etc. <B>Note:</B> If the intake manifold is not  
attached/supplied with the new assembly, it must be thoroughly  
inspected to ensure it is free of any and all metal debris. If  
contamination cannot be determined or it cannot be properly cleaned,  
replace the intake manifold. Metal debris in the intake manifold or  
oil cooler can cause subsequent failure and would not be  
warrantable.&nbsp;...<P>Once the repairs are completed, please refer

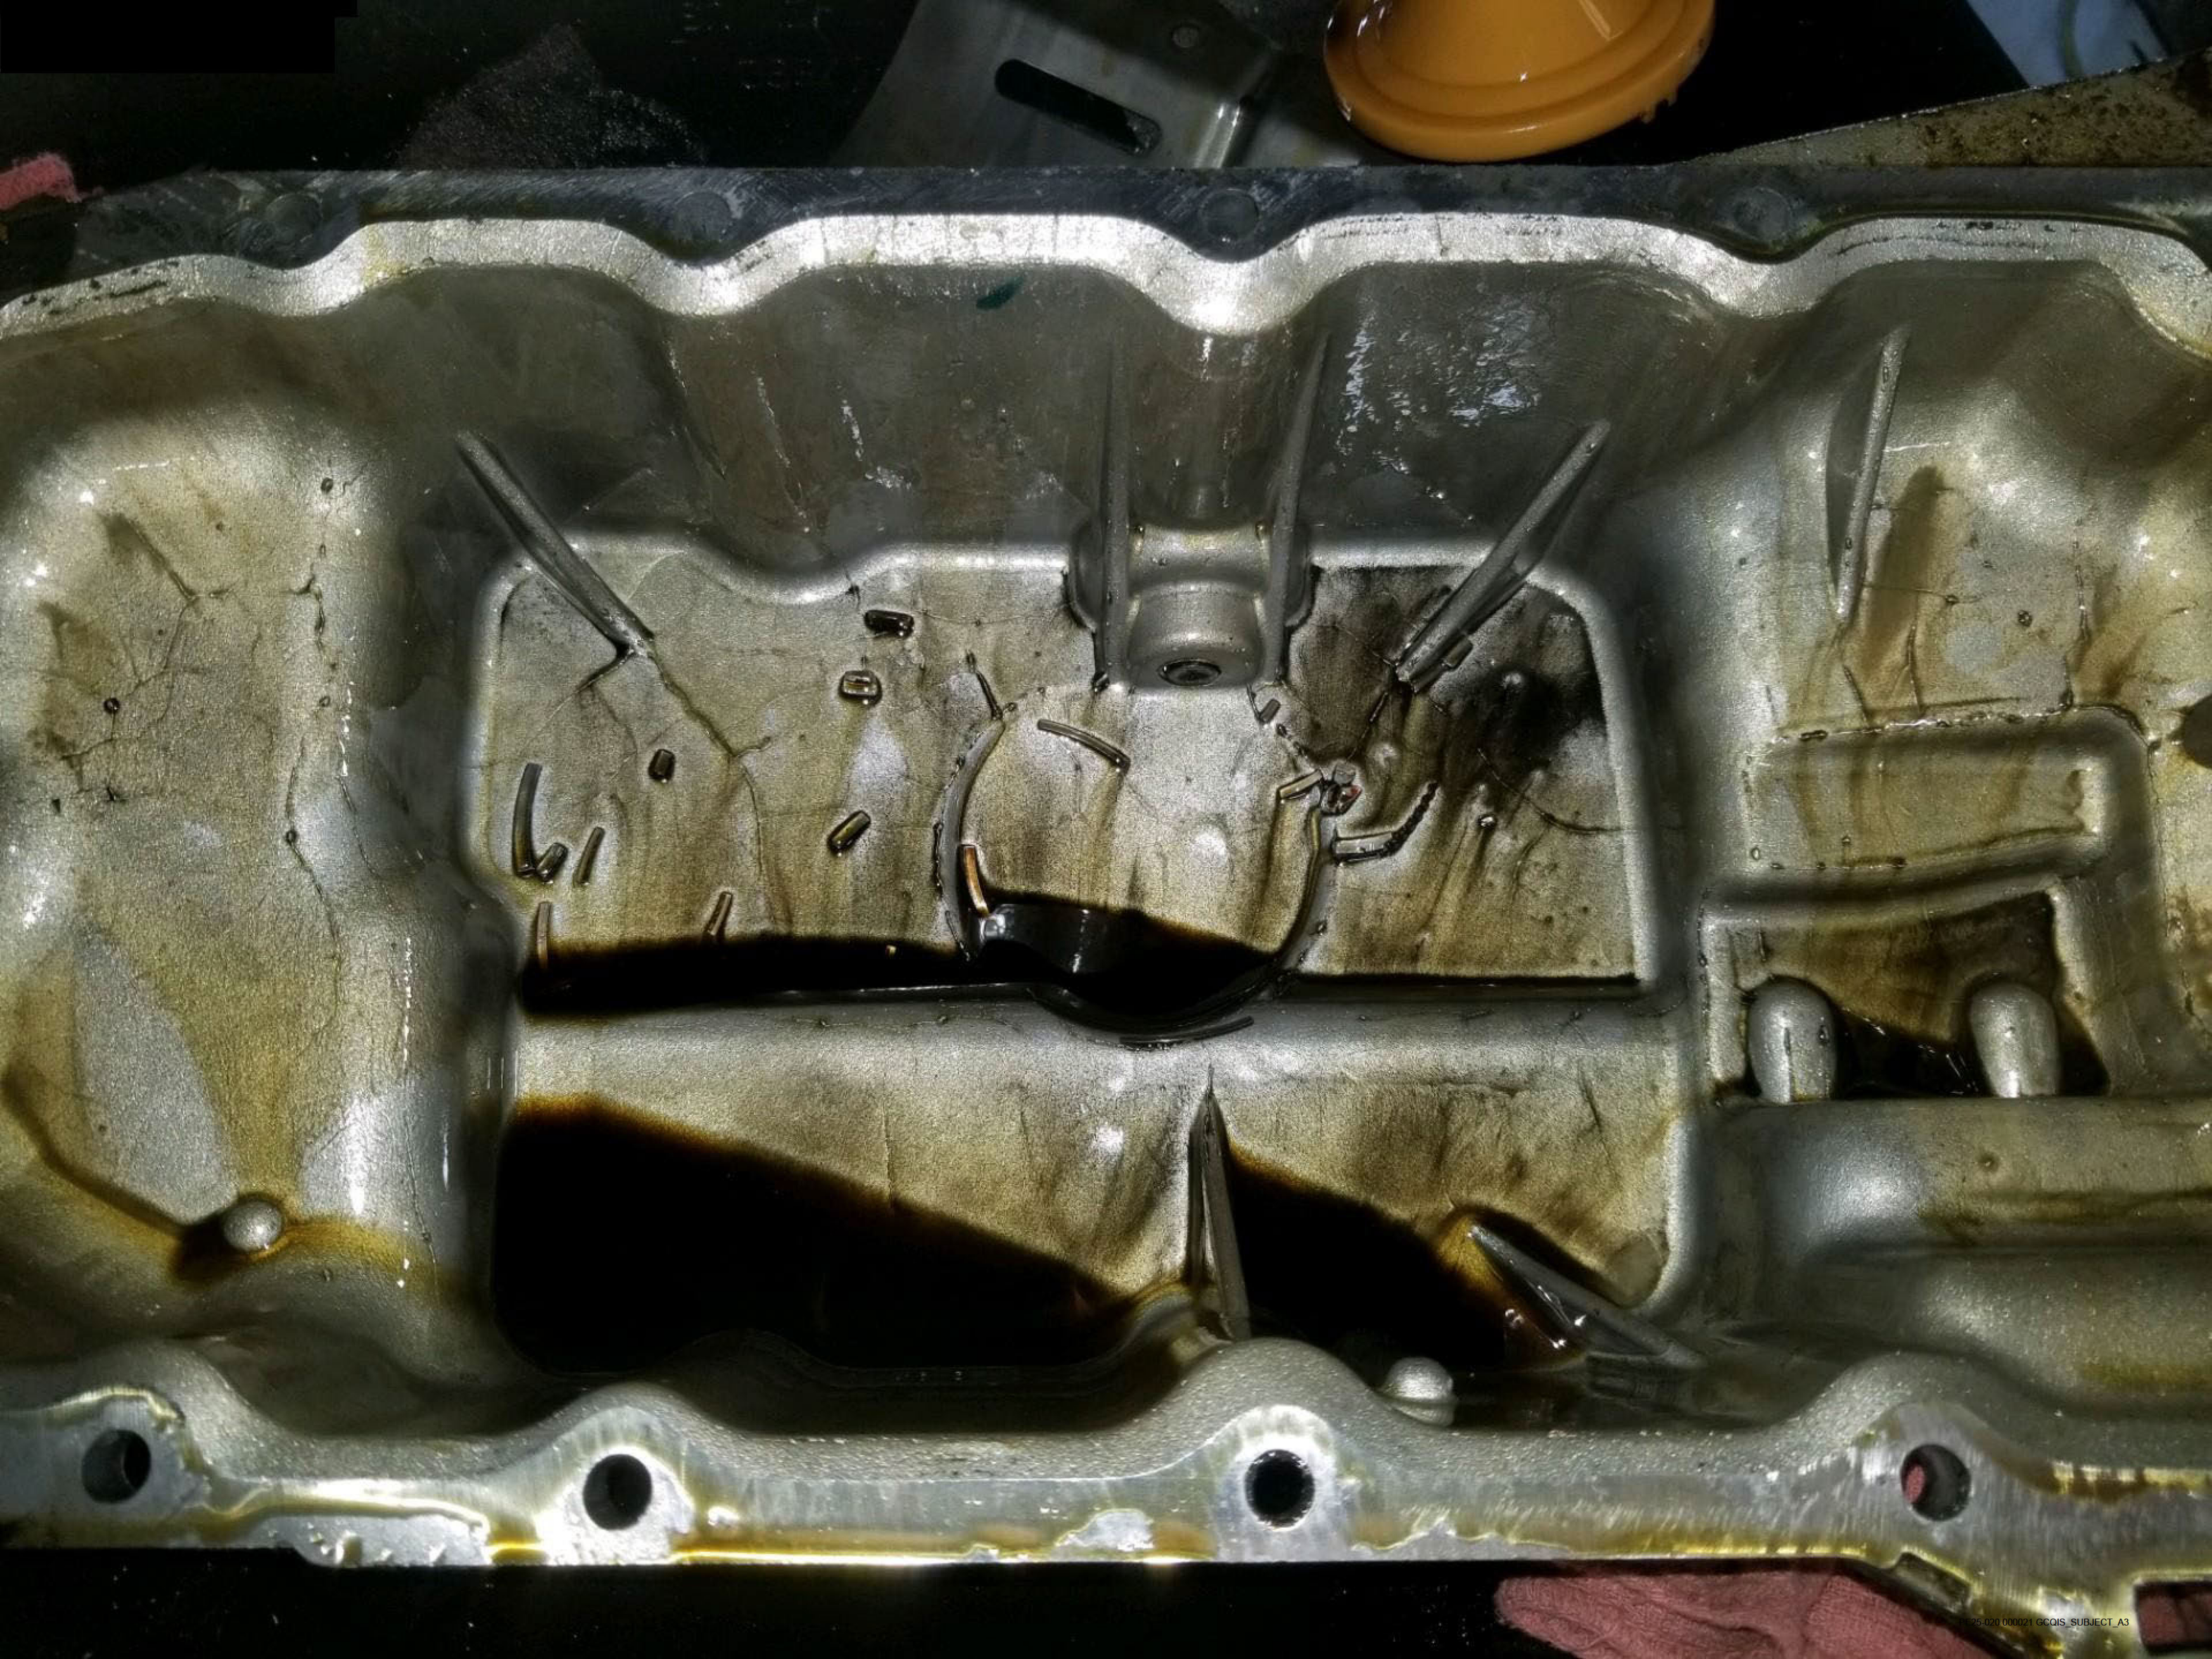
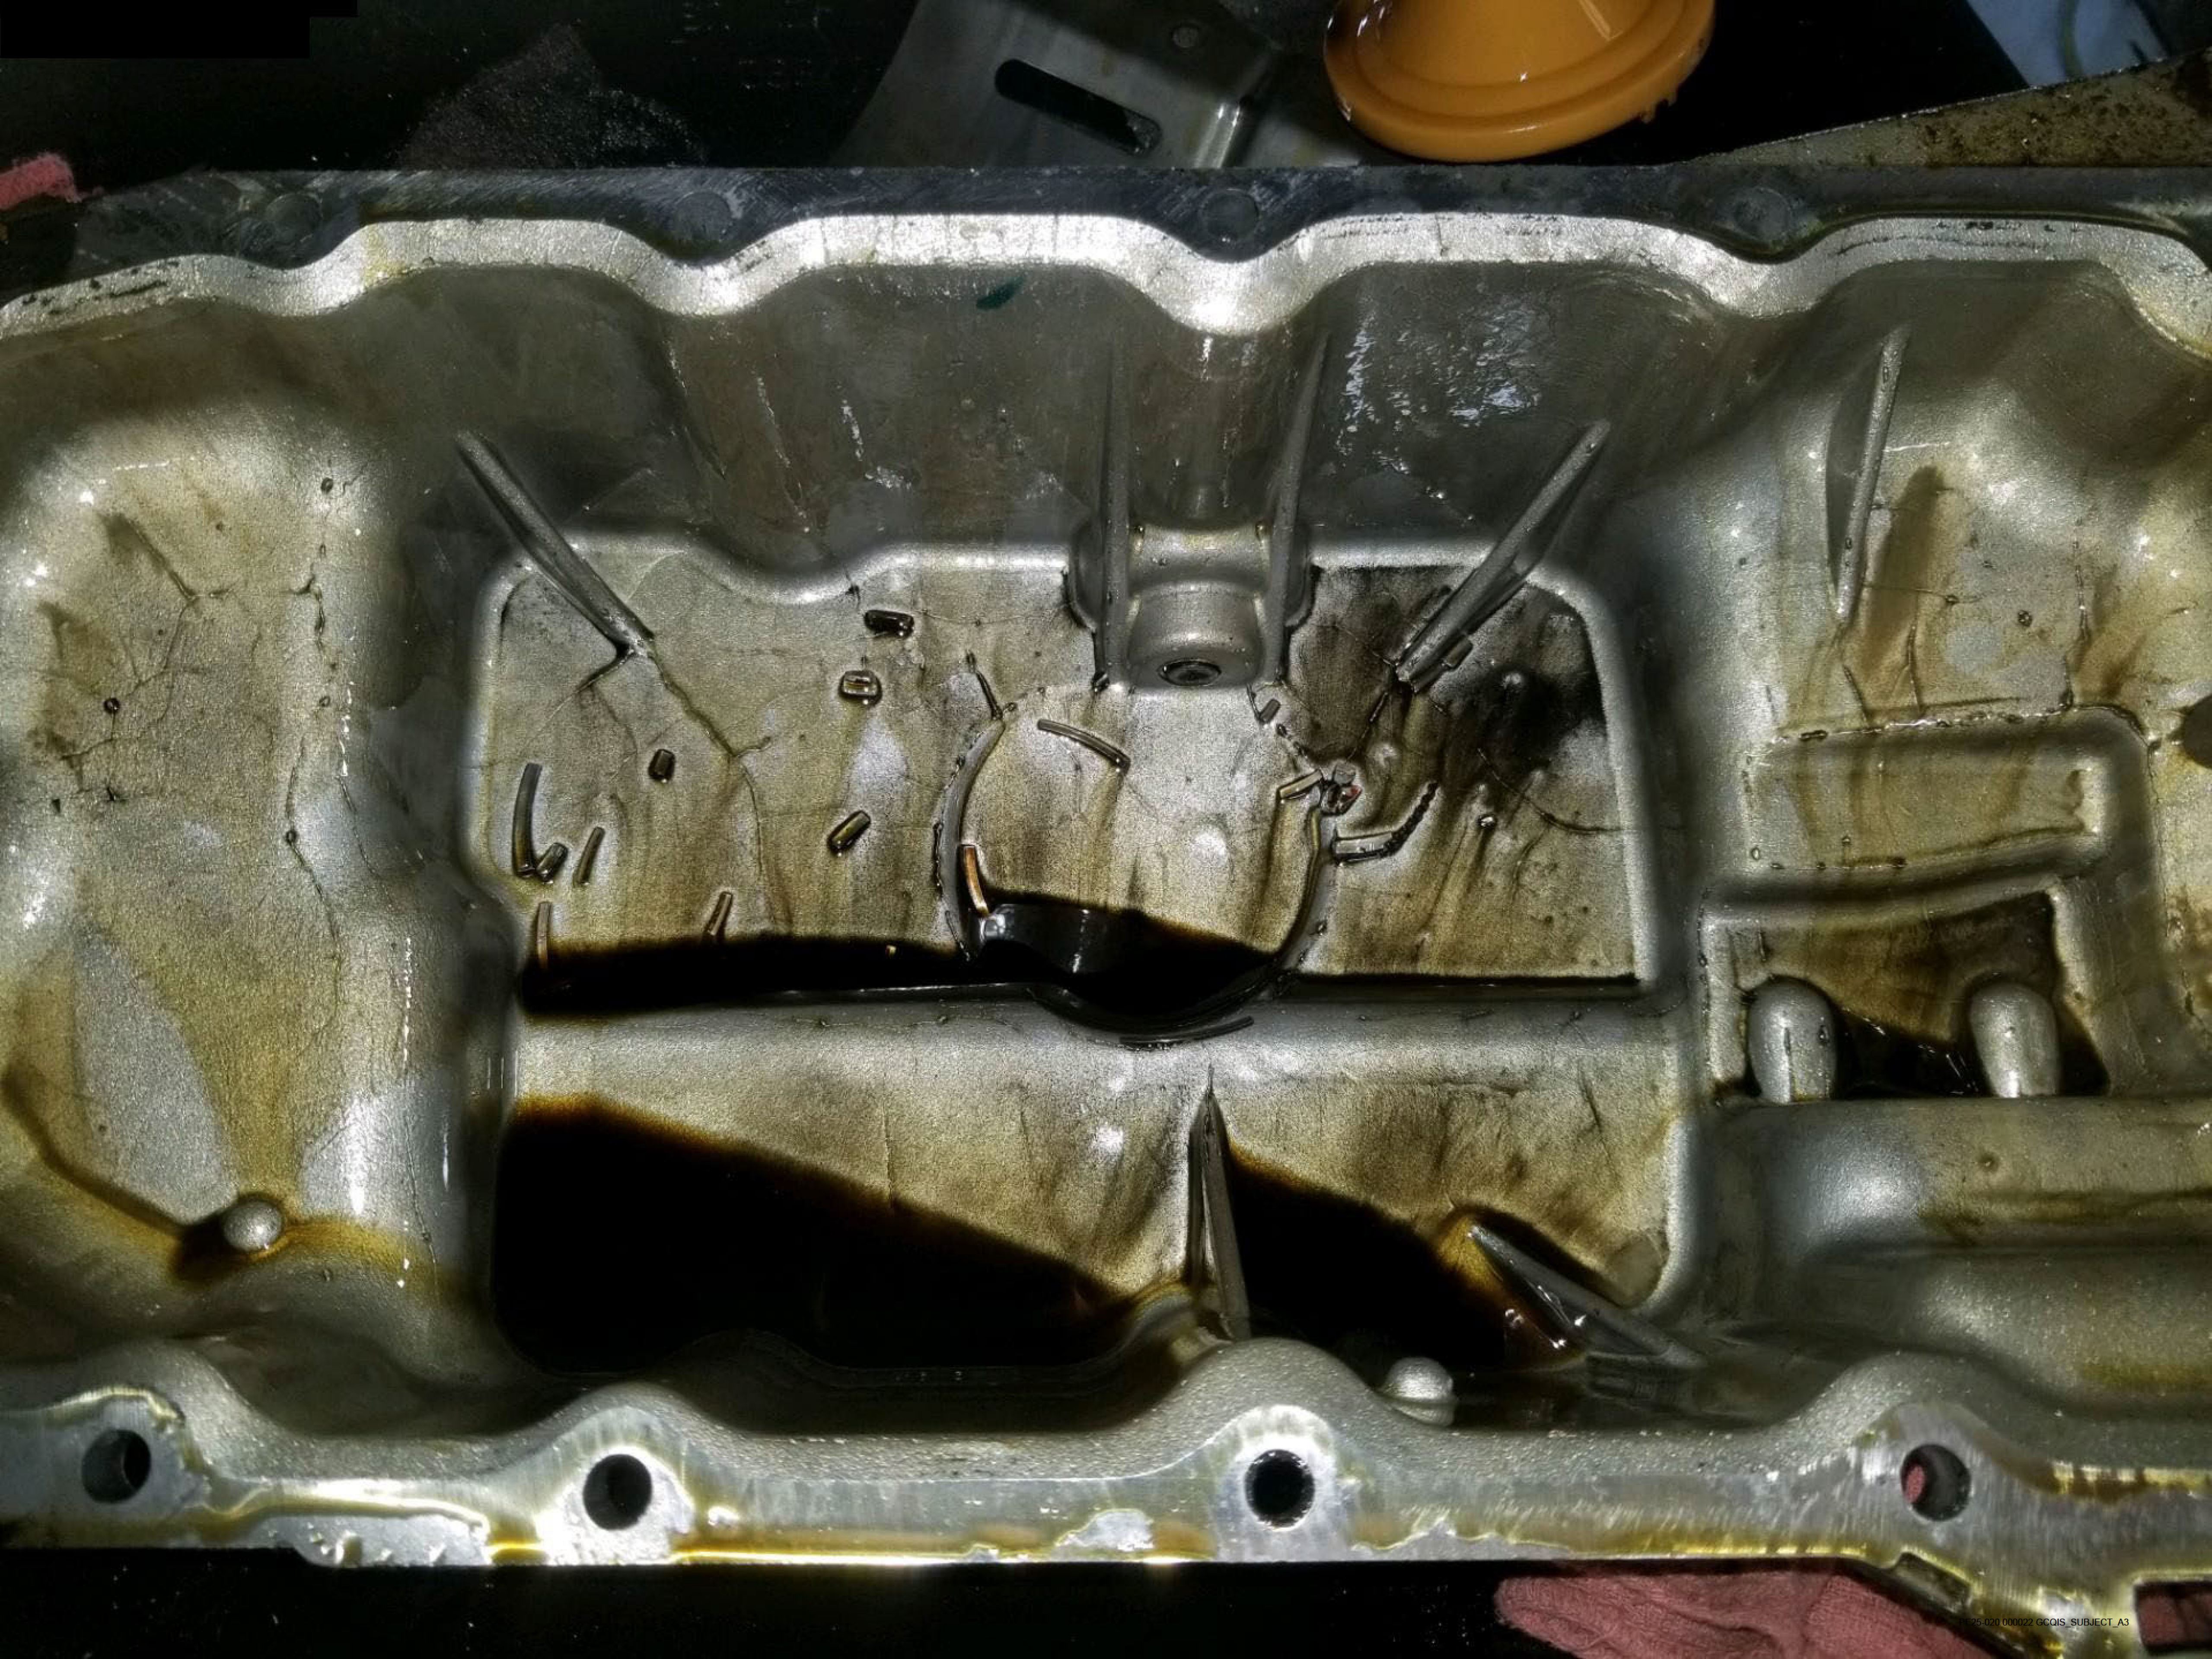
CONCER 01/17/2020 05:59PM SPILLWAY  
RO: 274481 RO Date: 2020/01/06 Warranty Type: FWR SPW Install Mileage:  
SPW Install Date: Please describe customers concern. Include as many  
details as possible. NO START - SPINS FREELY - NO COMPRESSION If  
applicable, please list any prior repair attempts (driveability or  
transmission related) which may have contributed to the customer  
symptom. NONE Please provide the diagnostic steps that were performed  
to determine that the assembly needed to be replaced. Please list the  
pinpoint tests completed and include test results (pressure readings,  
electrical measurements, etc.). 0 COMPRESSION, TIMING BELT BUSTED --  
INTERFERANCE ENGINE List major components (by name, not part) needed  
for repair: REQUESTING LONNG BLOCK Please list part (by name, not  
part) that was root cause of failure: THANK YOU Are there indications  
of Vehicle or Component Abuse, Modifications, or Lack of

RECOMM 01/18/2020 11:38AM CHOPPER9  
Carol, Continue with replacing the 6006 long block assembly. Order a Remanufactured Long Block (base part 6006) through your parts department. If a remanufactured assembly is not available, order a new assembly. <P>Before installation, please review the service manual and literature provided with the replacement engine regarding intake manifold cleaning/replacement, priming the oil system, filling the cooling system, etc. <B>Note:</B> If the intake manifold is not attached/supplied with the assembly, it must be thoroughly inspected to ensure that it is free of any and all metal debris. If contamination cannot be determined or it will not clean out, replace the intake manifold. Metal debris left in the intake manifold or oil cooler can cause subsequent failure and would not be warrantable. <P><B>\*If applicable:</B> Once the repairs are completed, please refer to <A target= blank href [REDACTED] WSM section 303-01 for information on performing the misfire monitor neutral profile correction procedure. This will aid in preventing false misfire DTCs, and a subsequent check engine light. <P>Please be sure to follow the FCS-700 tag core retrieval process and verify that all fluids are drained from the assembly prior to shipping. Verify ALL cylinder head cam caps and cylinder block main caps are returned with the engine. Make sure to properly secure the core to the crate/container to avoid any damage during shipping. Please refer to the Reman Powertrain Core Returns <A target= blank href [REDACTED] for additional details. </P> GASPA Approved THNR415534
