CQIS DETAIL REPORT

VEHICLE: 2015 FOCUS,SE,4 DOOR ,SEDAN VIN: [REDACTED]  
Engine : 1.0L 12V DI TC I3 GS 120PS FOX Odometer: 68,227 MILES  
Operating Environ: WCC :  
Vehicle Use : Rsp. Act:

VEHICLE: 2015 FOCUS,SE,4 DOOR ,SEDAN VIN [REDACTED]  
Engine : 1.0L 12V DI TC I3 GS 120PS FOX Odometer: 57,246 MILES  
Operating Environ: WCC :  
Vehicle Use : Rsp. Act:

VEHICLE: 2018 FOCUS,SE,4 DOOR ,SEDAN VIN: [REDACTED]  
Engine : 1.0L 12V DI TC I3 GS 120PS FOX Odometer: 59,249 MILES  
Operating Environ: WCC :  
Vehicle Use : Rsp. Act:

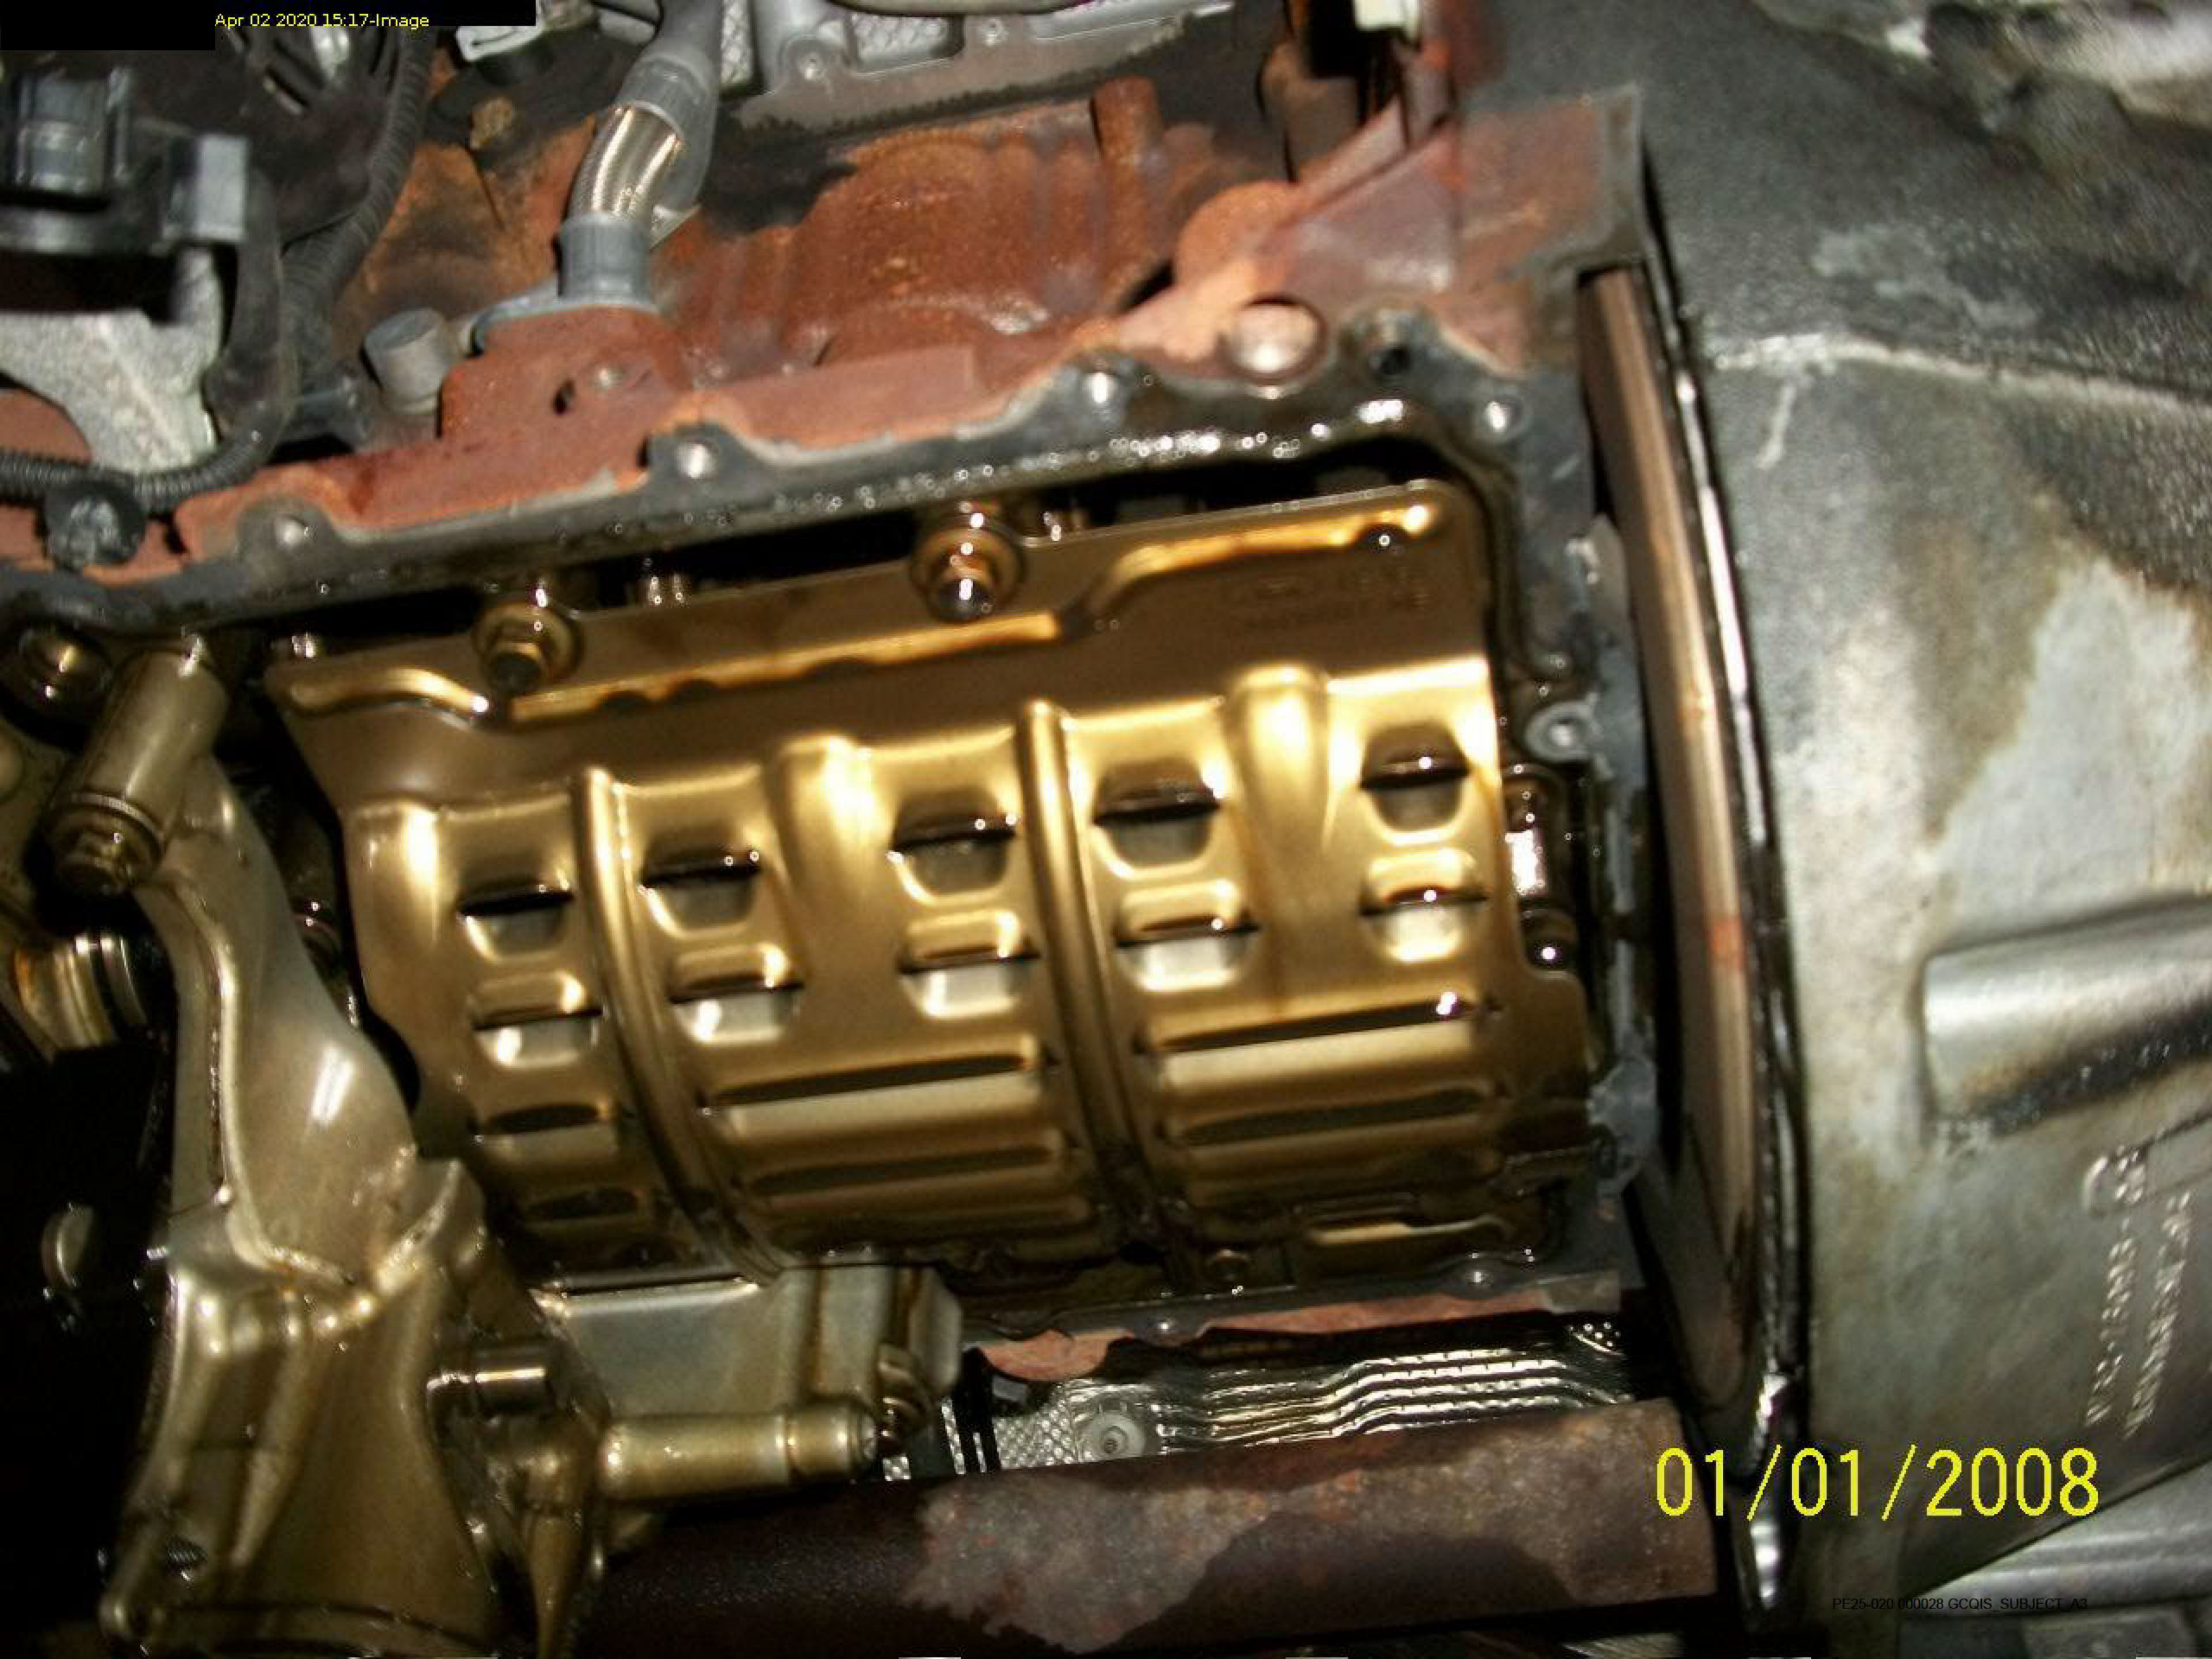
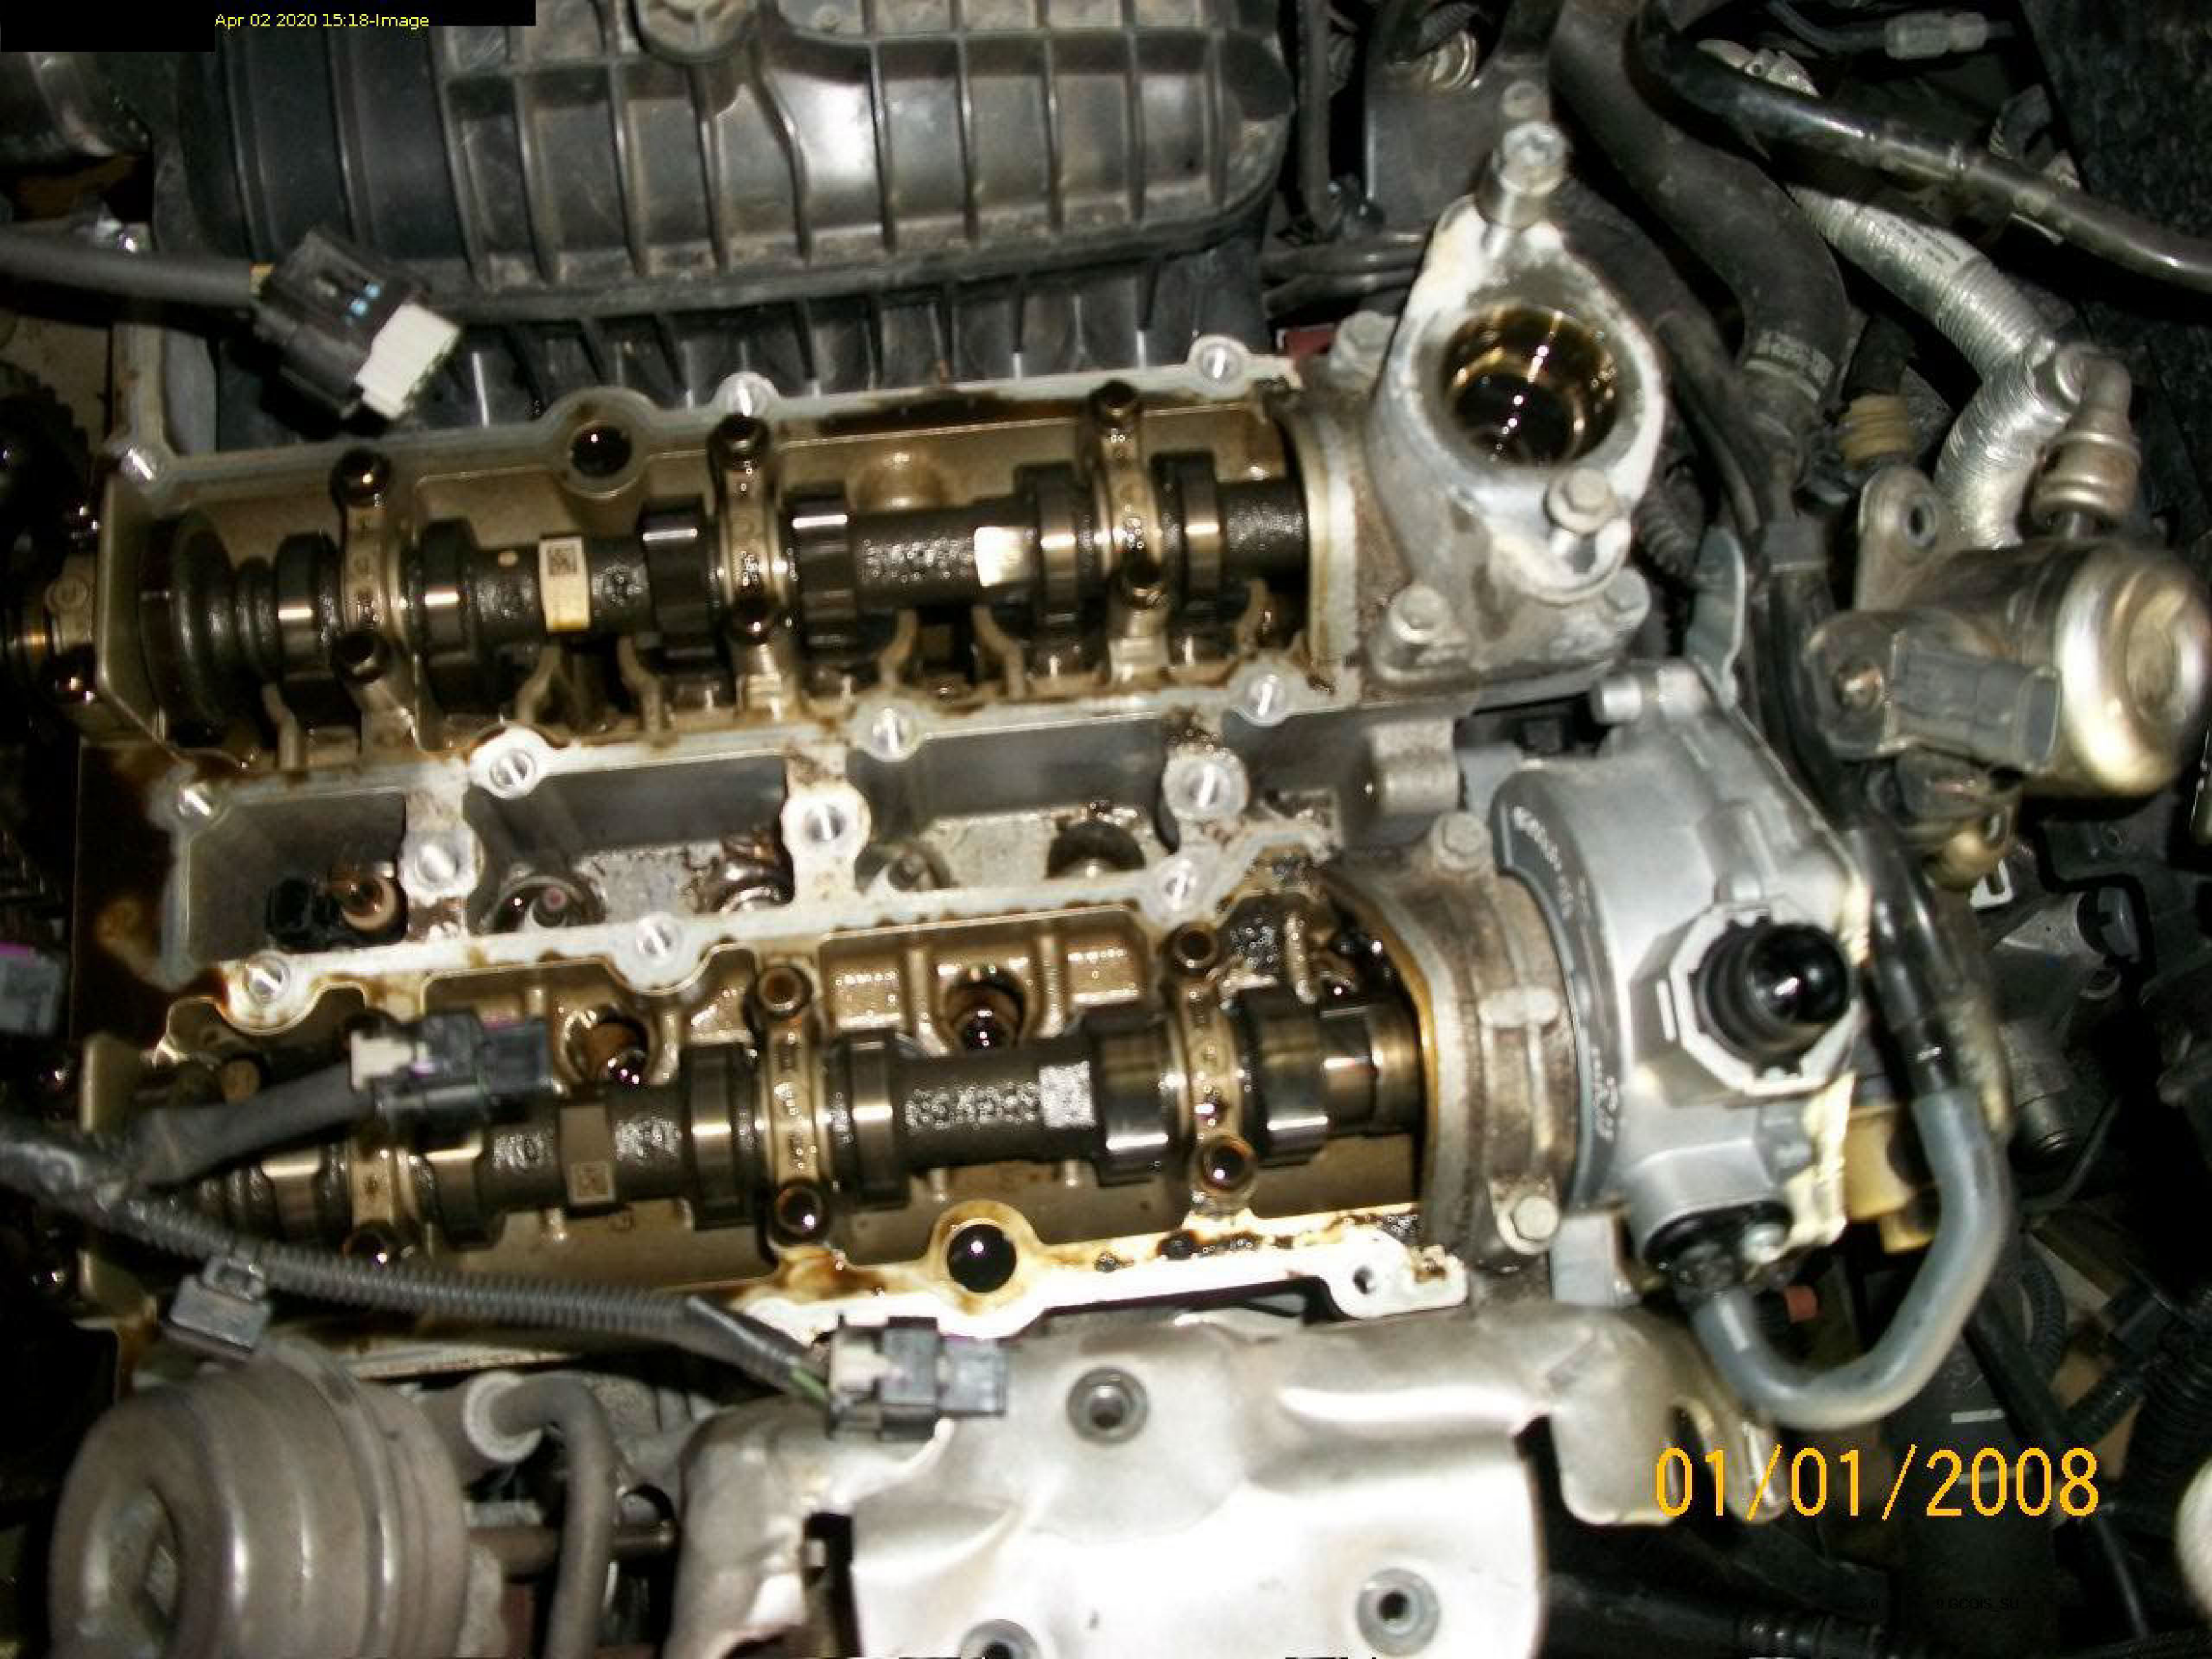
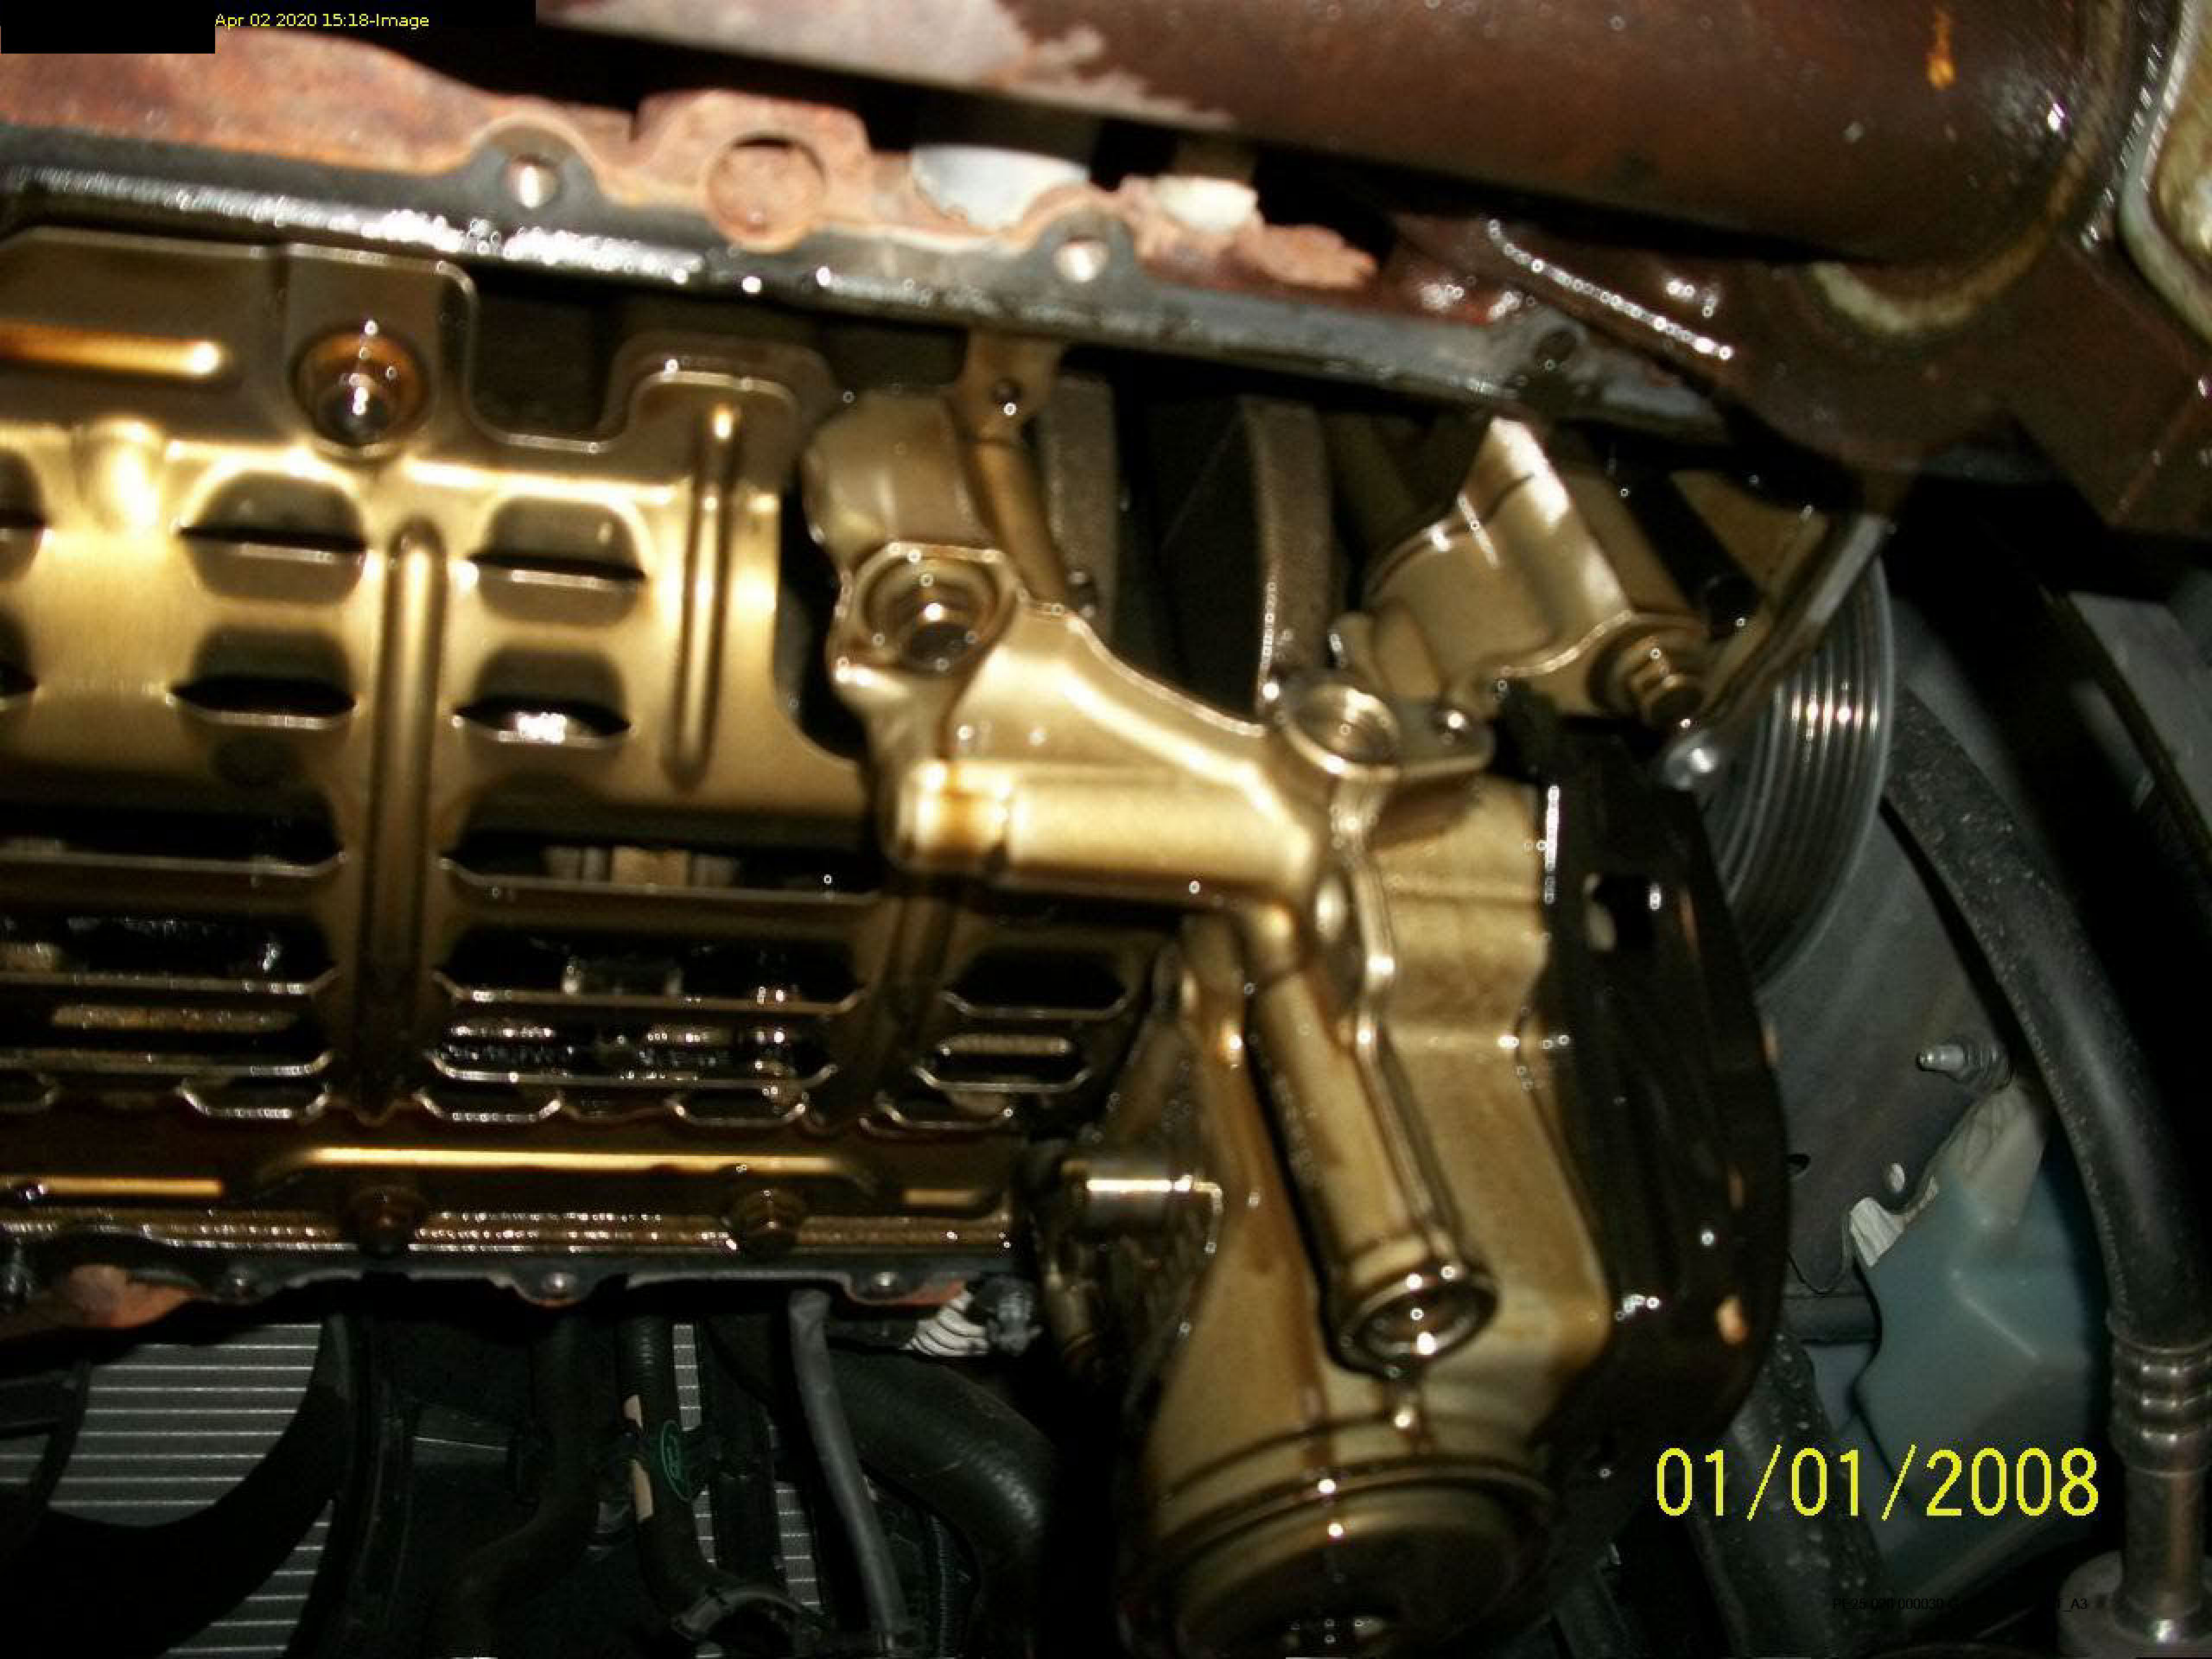
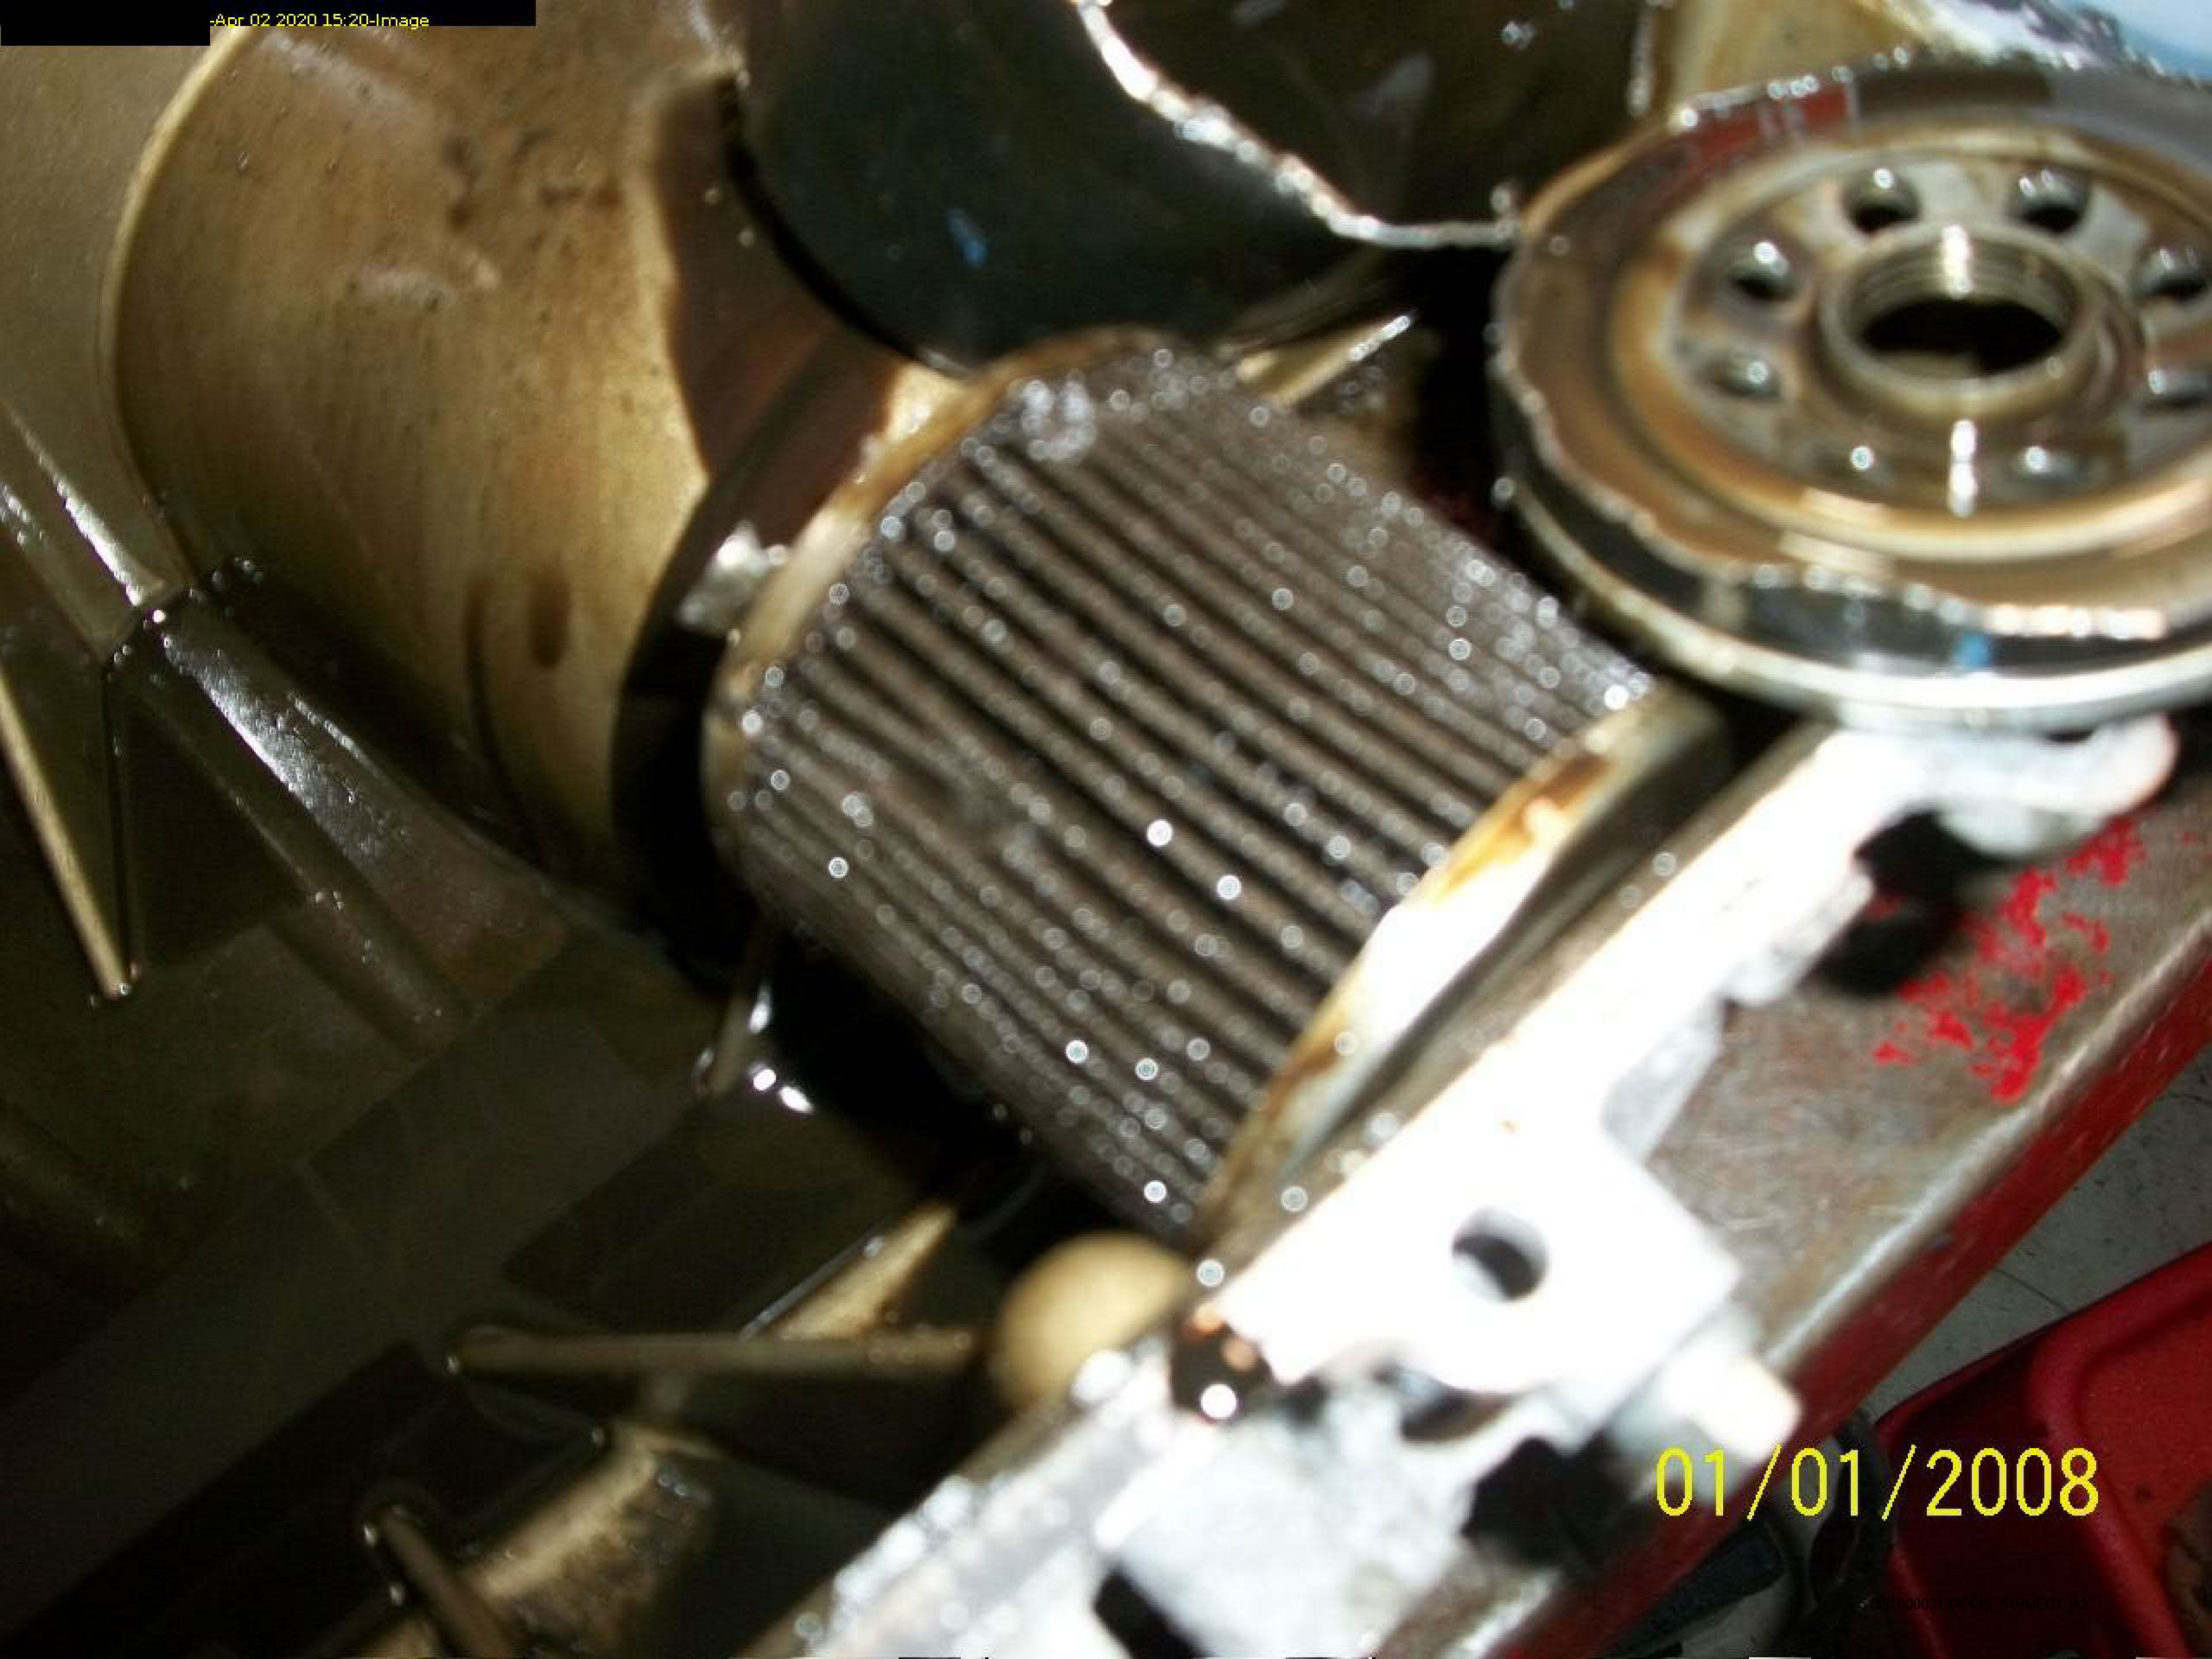
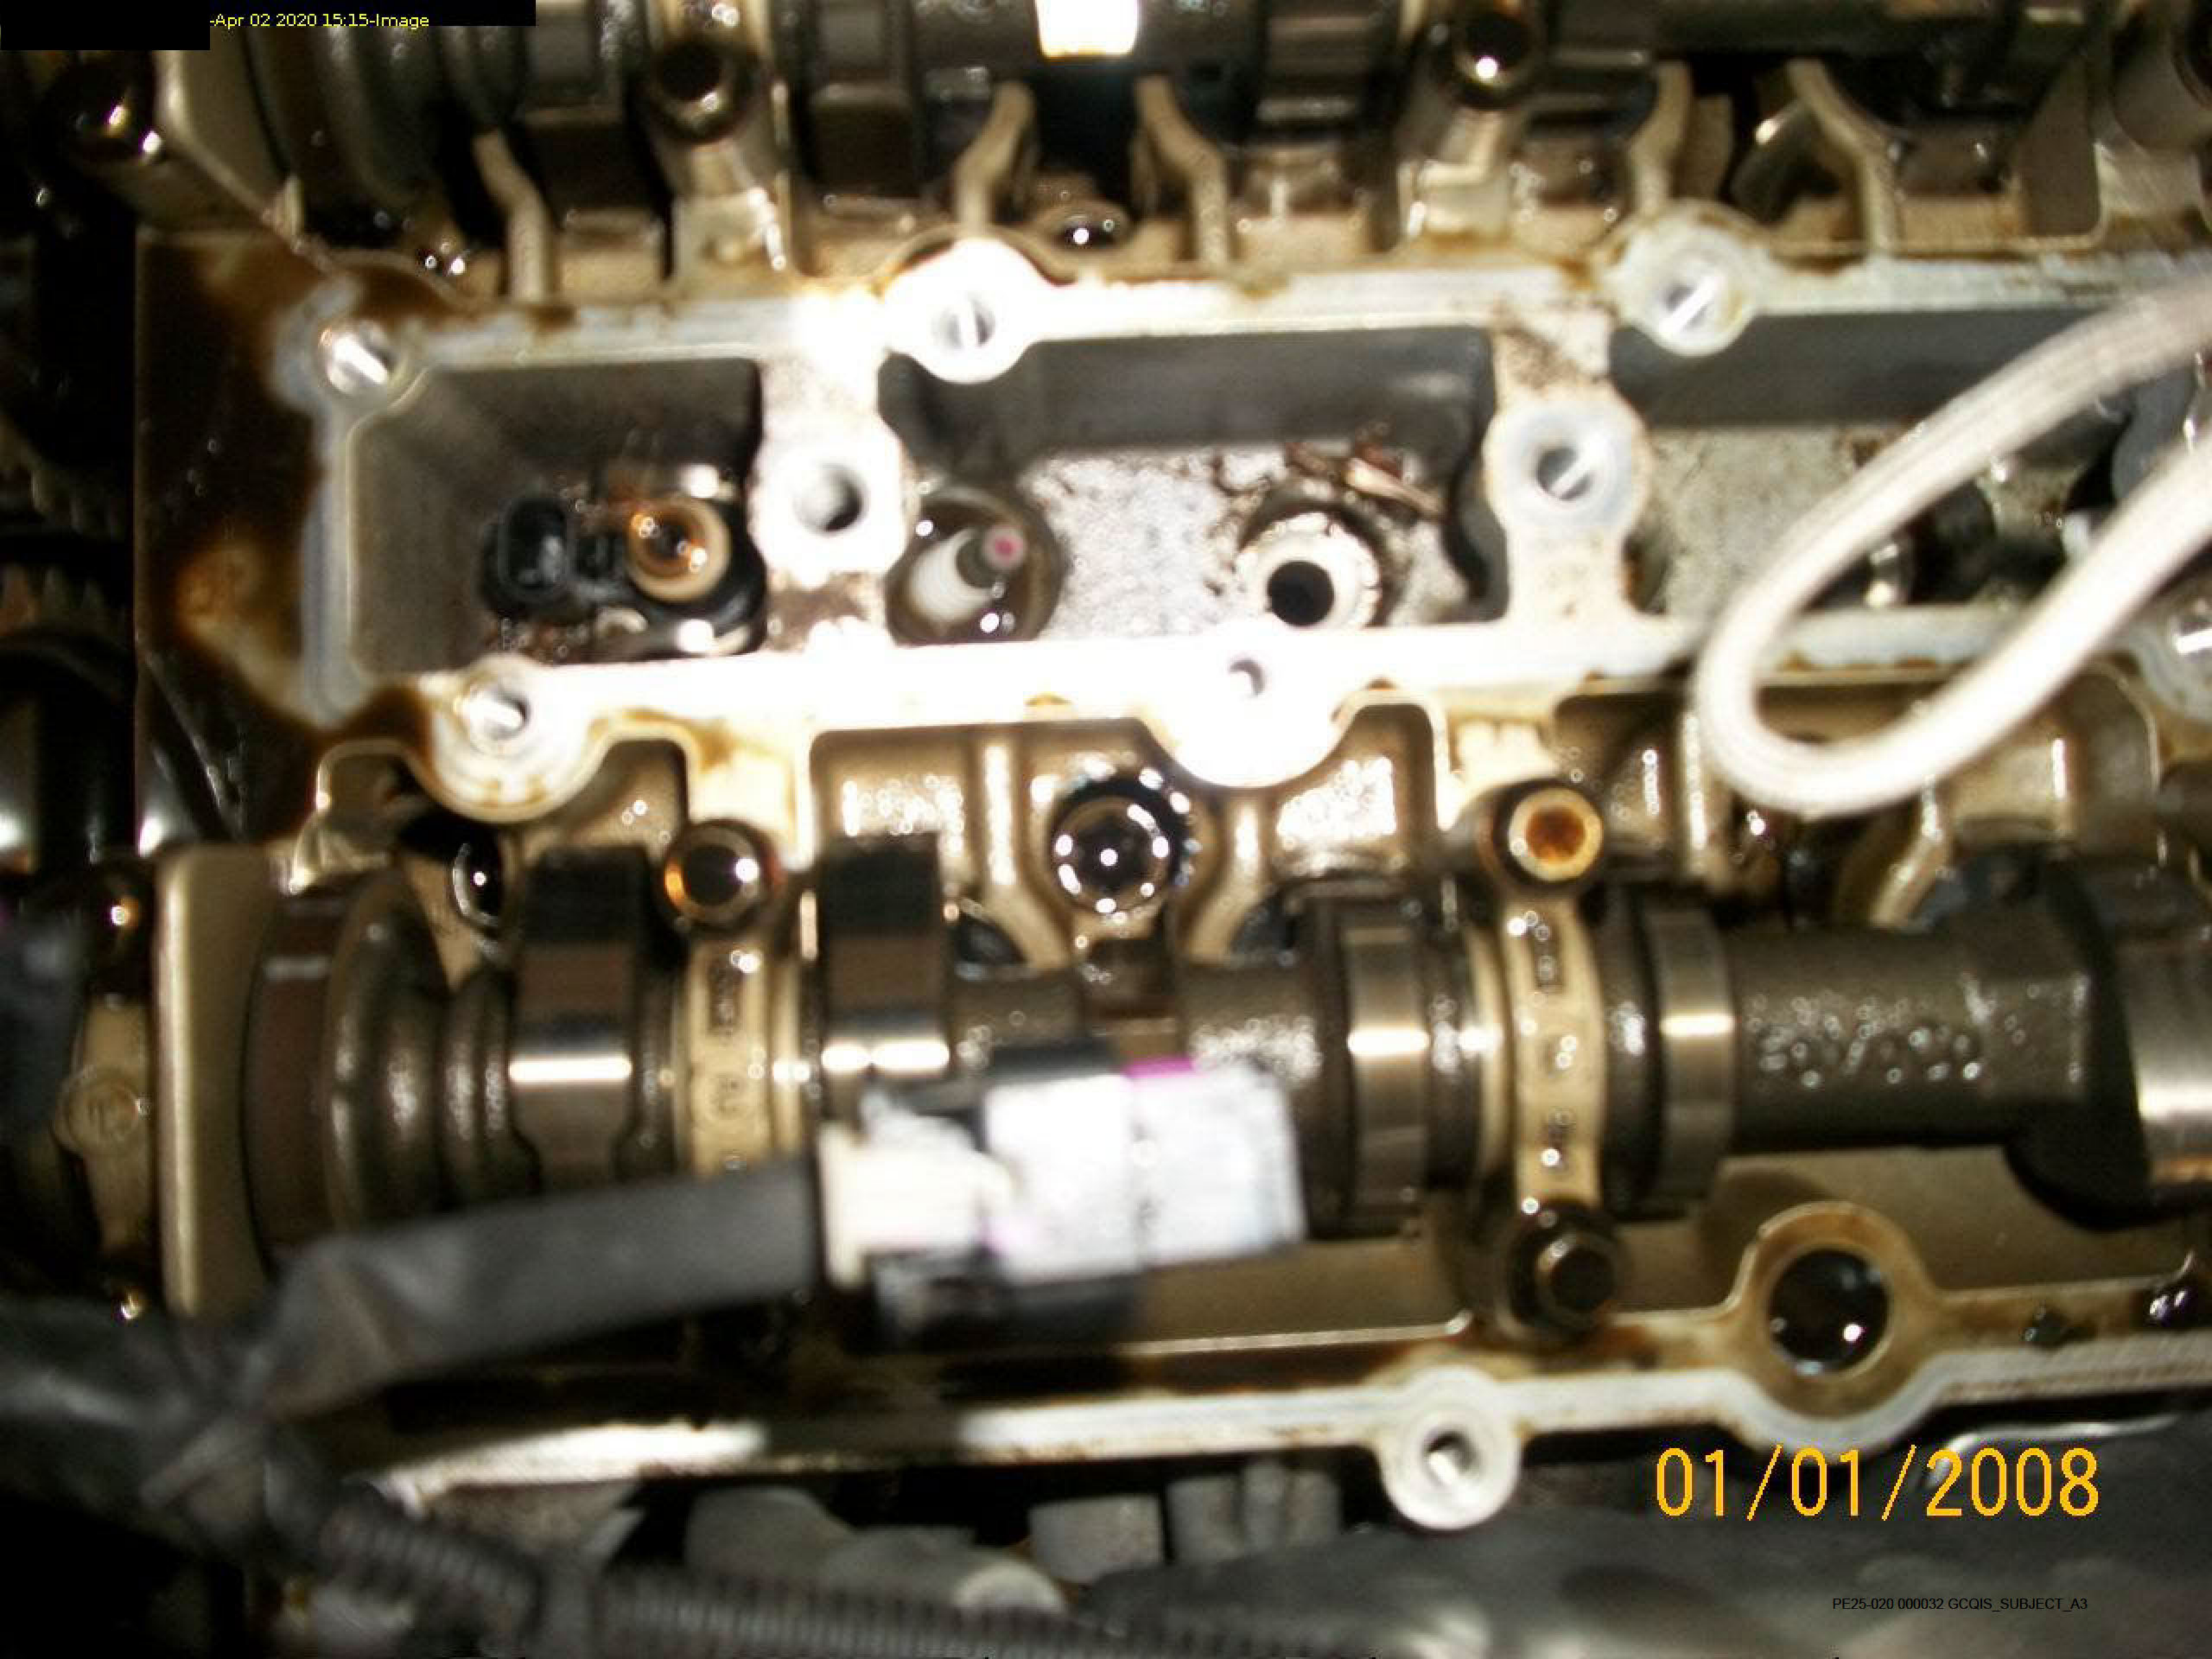
07)
CONCER 04/03/2020 09:03AM GTCGCQSP
oil pump failed look at close up off input to pump also I did not say
flakes but a fine powder like all through eng removed windage try took
pics of the drops on main caps you should see the shine spots in the
drop that is the melt tried to get good pic of the cam caps there are
grey places on them pulling it off the caps and sticking it to the
cams and on cams it has guarded and can fill them on ever one but
number 2 intake cam oil pressure when I tested it with gauge 0 psi
belt to pump looks ok cam belt shows fraying on inside but ok was
stile running but was very load . but full of oil and had stp filter.
hope this is what you needed ty sam
RECOMM 04/03/2020 09:33AM DKENYON8
Sam, Thank you for updating with the additional information and
pictures. Many of the pictures are too blurry to see anything,
however, you described that there is material transfer and signs of

material loss on the camshaft caps. This justifies having the cylinder
head on the Cost Cap. Further, the VCT components are also justified
because if the camshaft journals/caps begin to score then the VCT
components become compromised with metal debris. It can also be seen
that there is significant rod bearing damage, resulting from loss of
oil pressure. If you have found all of these to be true with this
vehicle, then per the Cost Cap, long block replacement is approved. Be
sure to also replace the intake manifold, and inspect the catalyst for
element damage that could be sucked into the new engine. Repair as
needed. Also, due to the loss of oil pressure, check the turbocharger
turbine shaft for excessive play using the free spin test. The fins
should never contact the housing. If you find damage to the
turbocharger, or you find metal debris in the oil supply filter or oil
supply or return lines, replace the turbocharger. If the turbocharger

is undamaged and no metal is seen in the lines or the oil fittings on
the turbocharger, then clean and reuse the turbocharger and replace
the oil lines and the filter. Note that Prior Approval is not required
for turbocharger replacement. Order a Remanufactured Long Block (base
part 6006) through your parts department. If a remanufactured assembly
is not available, order a new assembly. <P>Before installation, please
review the service manual and literature provided with the replacement
engine regarding intake manifold cleaning/replacement, priming the oil
system, filling the cooling system, etc. <B>Note:</B> If the intake
manifold is not attached/supplied with the assembly, it must be

thoroughly inspected to ensure that it is free of any and all metal  
thoroughly inspected to ensure that it is free of any and all metal  
debris. If contamination cannot be determined or it will not clean  
out, replace the intake manifold. Metal debris left in the intake  
manifold or oil cooler can cause subsequent failure and would not be  
warrantable. Once the repairs are completed, please refer to <A  
target= blank
