General Service Bulletin (GSB):	Engine Oil Maintenance Inspection
GSB Overview:	This bulletin provides sample engine teardown images. Examples are intended to assist the dealership in determining if maintenance records should be reviewed.
NOTE: This information is not intended to replace or supersede any warranty, parts and service policy, Work Shop Manual (WSM) procedures or technical training or wiring diagram information.

Engine Oil Maintenance Inspection

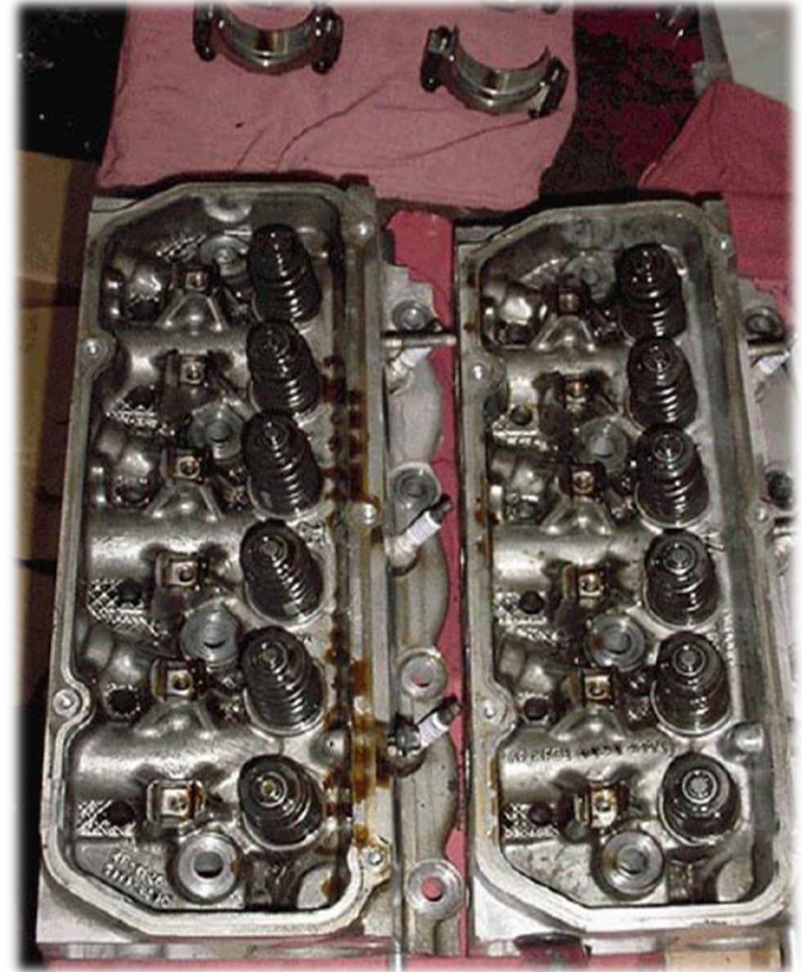
Proper Maintenance - Based on Upper End Evaluation

1999 Ford F-150, 4.2L V6 2-valve

100,000 miles

- No sludge accumulation on valvetrain
- Oil is still clean and not thick.

If failure occurred, the failure would be warrantable.

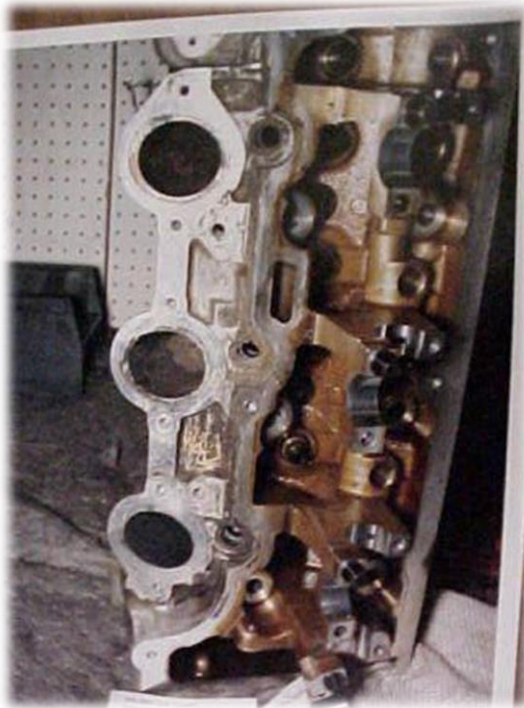
Proper Oil Change Maintenance

1997 Ford Explorer 4.0L SOHC

169,999 miles

Proper maintenance performed every 3,000-5,000 miles

- No sludge accumulation on valvetrain.
- Underside of valve cover does not have any buildup of sludge.

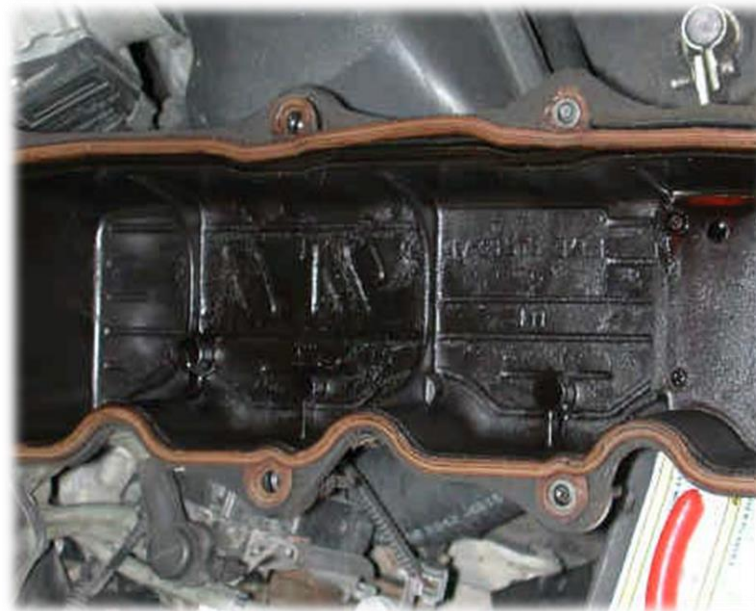
Proper Oil Change Maintenance

1994 Ford Taurus, 3.0L V6 2-valve

190,000 miles

- Oil and filter changes performed every 3000-5000 miles

- No sludge accumulation on valvetrain
- Oil is still clean after 3000 miles and not thick
- Underside of valve cover does not have buildup of sludge

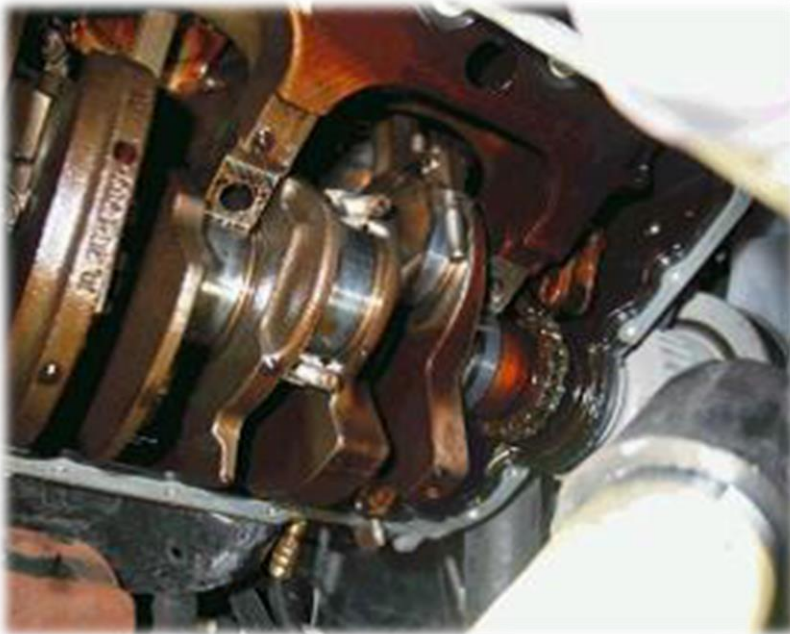
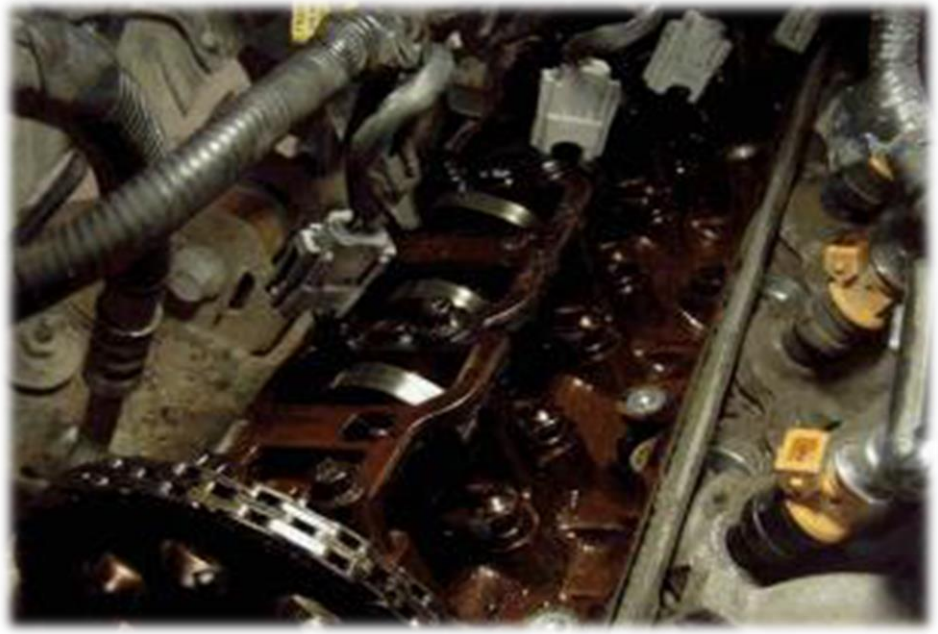
Marginal Maintenance – Varnish on Upper and Lower Engine

2000 Ford F-150, 5.4L SOHC

86,000 miles

- No sludge accumulation on valvetrain
- Oil is starting to varnish. The oil change intervals should be evaluated for timeliness.
- The level of varnish in the engine can be scraped with a fingernail.

If failure occurred, the failure could be warrantable.

Maintenance records should be evaluated prior to repairs.

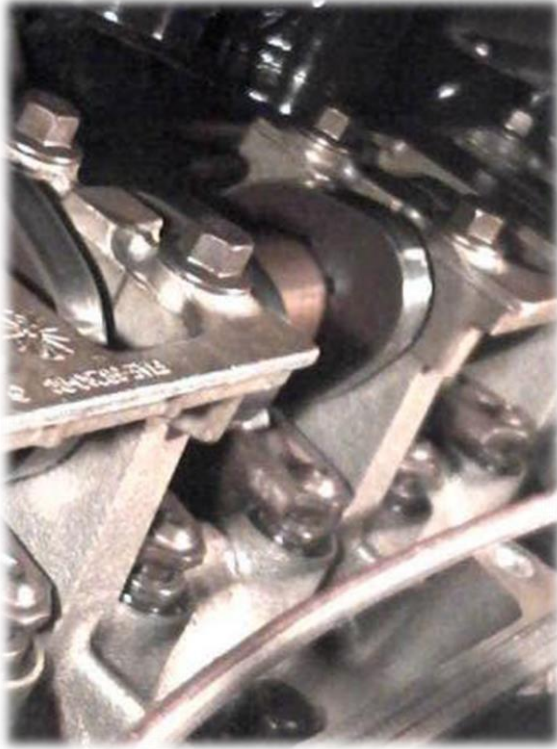
Proper Oil Change Maintenance

- 1997 Ford Crown Victoria, 4.6L SOHC
- **140,000 miles**
- Regular maintenance performed with Motorcraft oil and filters

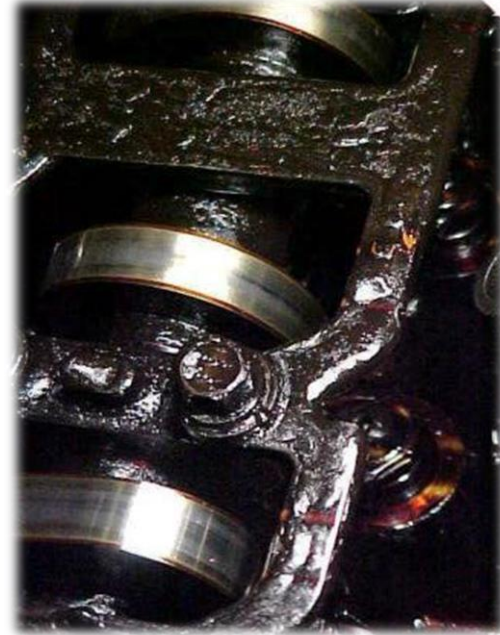
Improper Oil Change Maintenance

- 2001 Ford Expedition, 5.4L SOHC
- **27,304 miles**
- No maintenance history available
- Heavy oil sludge on valvetrain.

Any lubrication-related condition should not be covered by warranty or ESP.

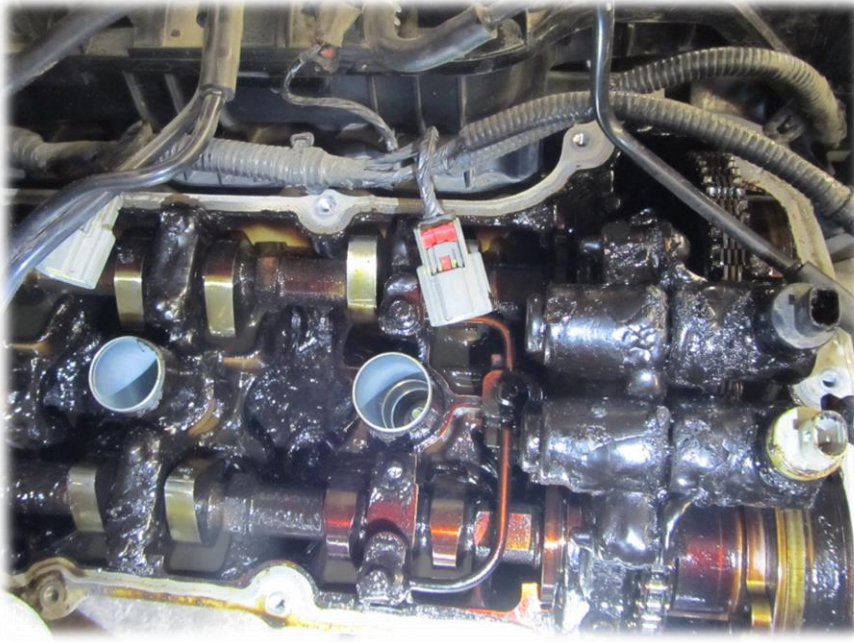
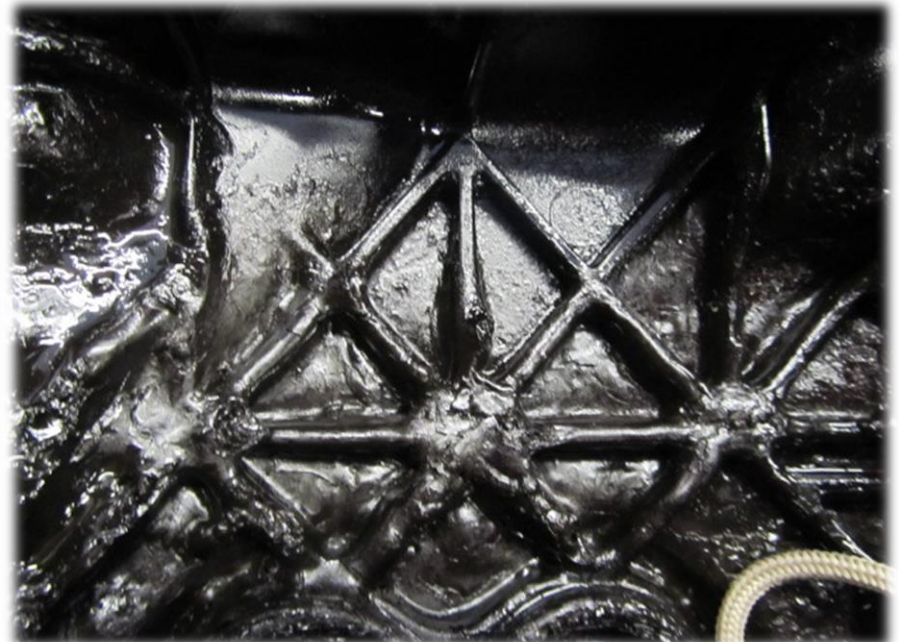
Improper Oil Change Maintenance- No Record of Service

2012 Ford F-150, 3.5L GTDI.

15,899 miles

No maintenance history

- Heavy oil sludge build-up on cam caps, head and VCT Solenoids from lack of oil changes.
- Heavy oil sludge build-up on underside of valve cover

Any lubrication-related condition should not be covered by warranty or ESP.

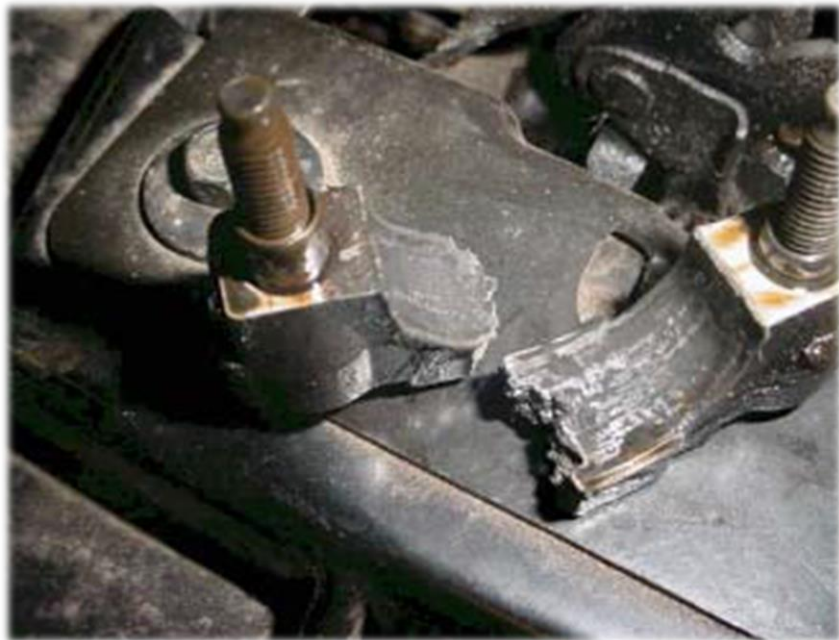
Improper Maintenance - Lower End Failure and Sludge

1999 Ford Taurus, 3.0L DOHC V6

46,000 miles

- Sludge accumulation on valvetrain.
- Oil is thick and broken down.
- The bearing shown has significant signs of lubrication restriction from sludge accumulation.

This failure is not warrantable.

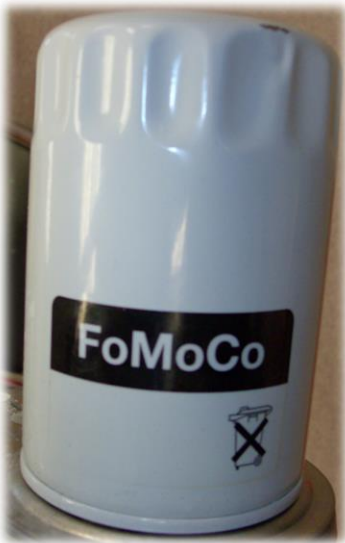
Figure – 1: White lettering in a black box

- **Original factory-installed oil filter identifiers:**
 - All-white filter can with “FoMoCo” in white lettering in a black box. (Figure - 1)
 - All-black filter can with white “FoMoCo” lettering (6.7L OEM and authorized remanufactured engines). (Figure - 2)
 - All-white filter can , line drawn labels with global language and “FoMoCo” in black. (Figure -3)
 - All-white filter can with a black or red square. (Figure - 4)
- **Service replacement oil filter identifiers:**
 - White “Motorcraft” lettering inside a red box (Figure - 5)
 - Red “Motorcraft” lettering with other labeling in black. (FL-1995) (Figure - 6)

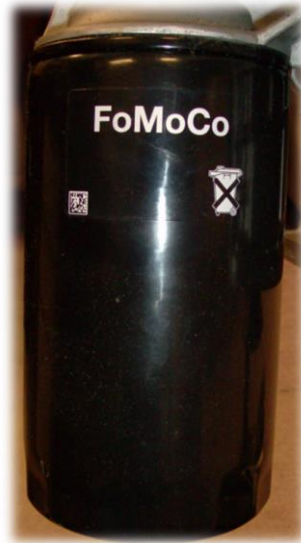
Figure – 2: Black can with white lettering

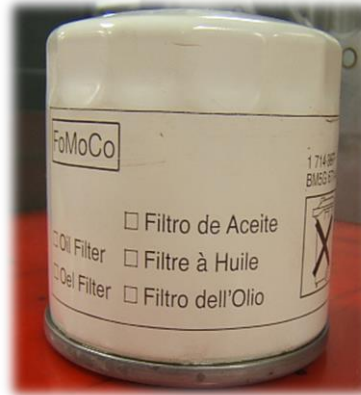
Figure – 3: Global language w/ line drawings

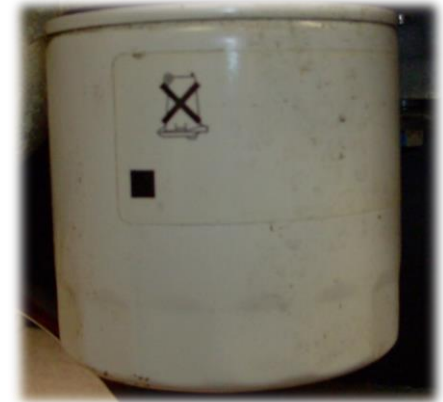
Figure – 4: Black Square w/ line drawings

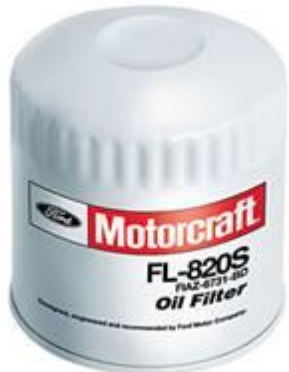
Figure – 5: White Motorcraft lettering in a red box
