22-7101

GENERAL SERVICE BULLETIN

Various Vehicles - Engine Oil Maintenance Inspection

This bulletin provides information and sample images of engine condition relating to proper and improper engine oil maintenance to determine if maintenance records should be reviewed.

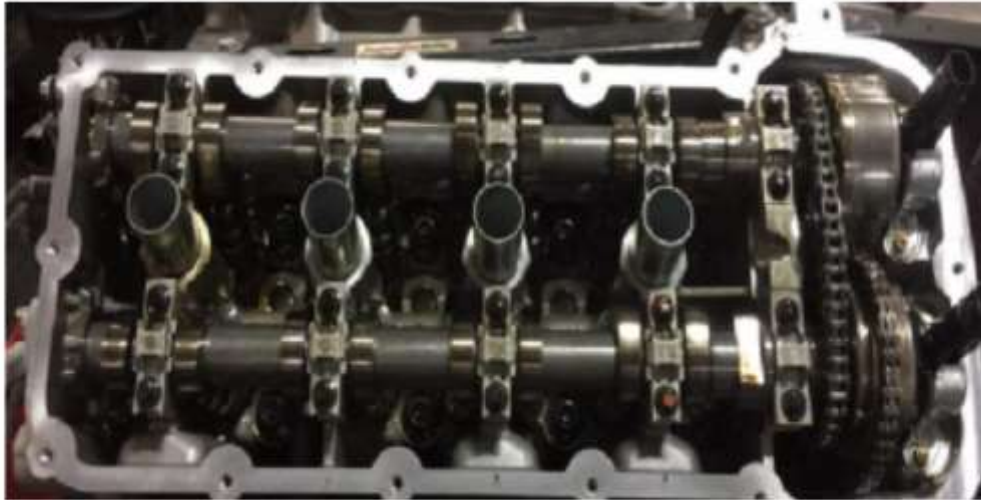
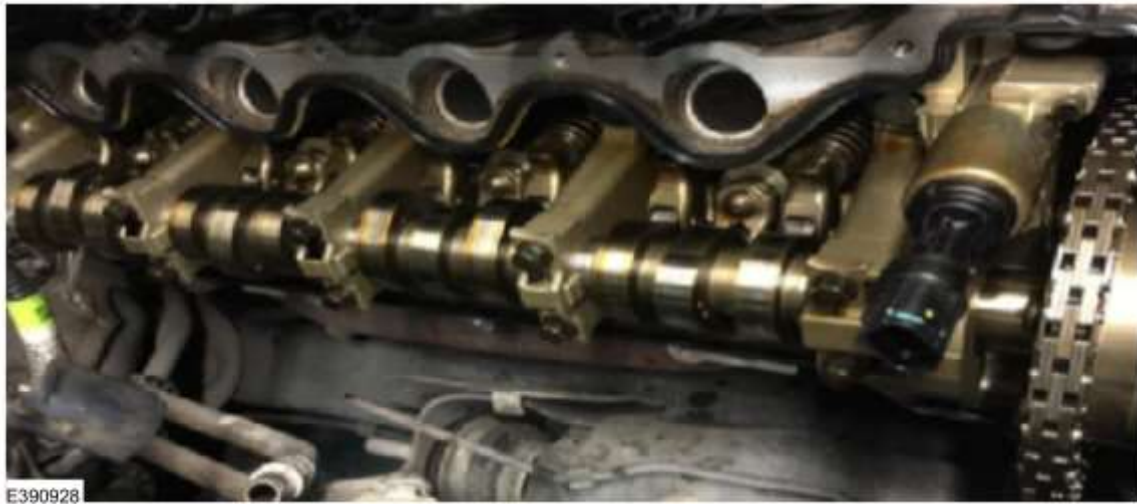
- Oil is clean and not thick.
- No sludge accumulation on the valvetrain. (Figure 1-2)

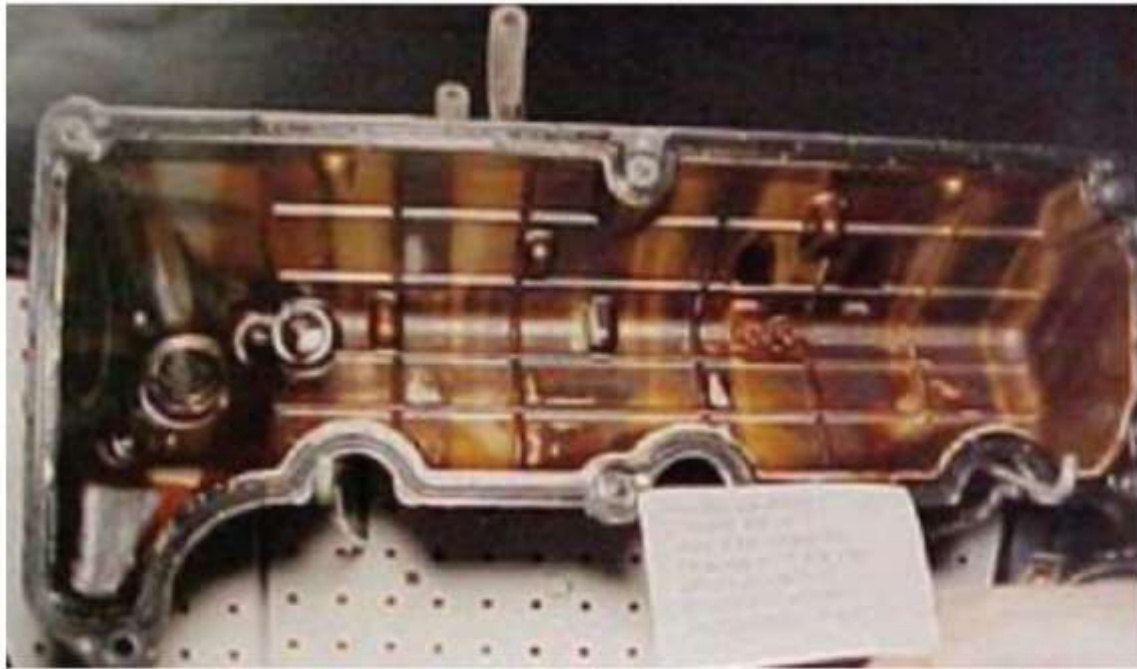
Figure 3

- No build up of sludge on the underside of the valve cover. (Figure 3)

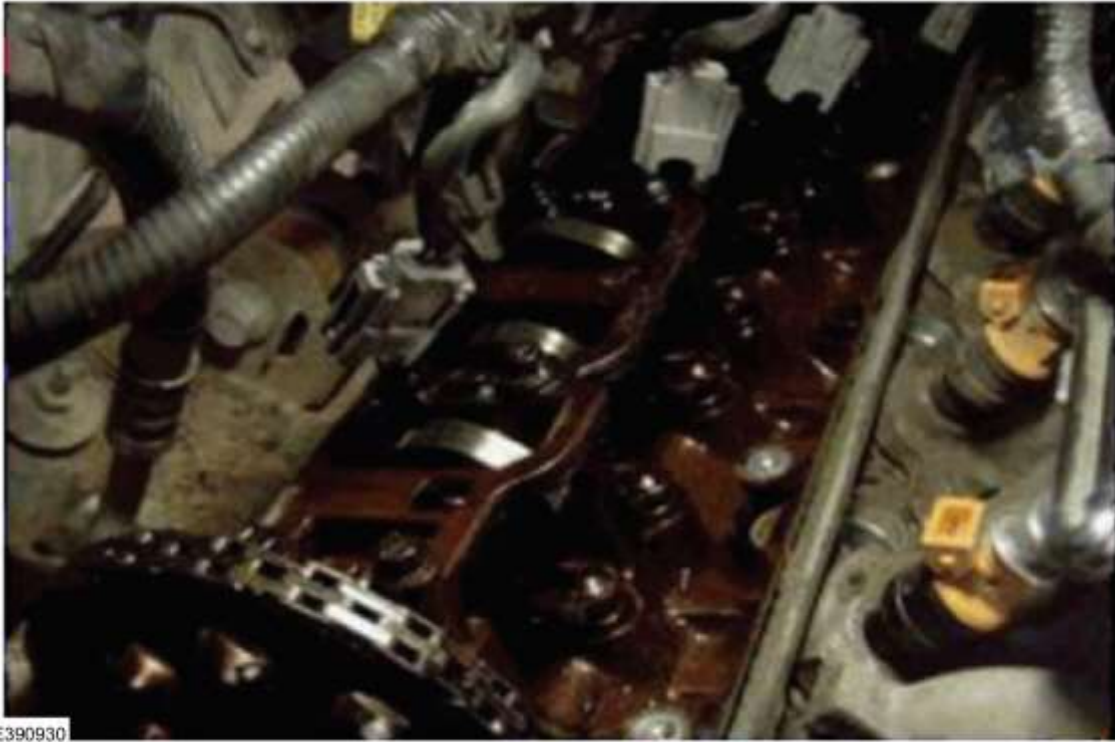
Figure 4

No sludge accumulation on the valvetrain. (Figure 4)

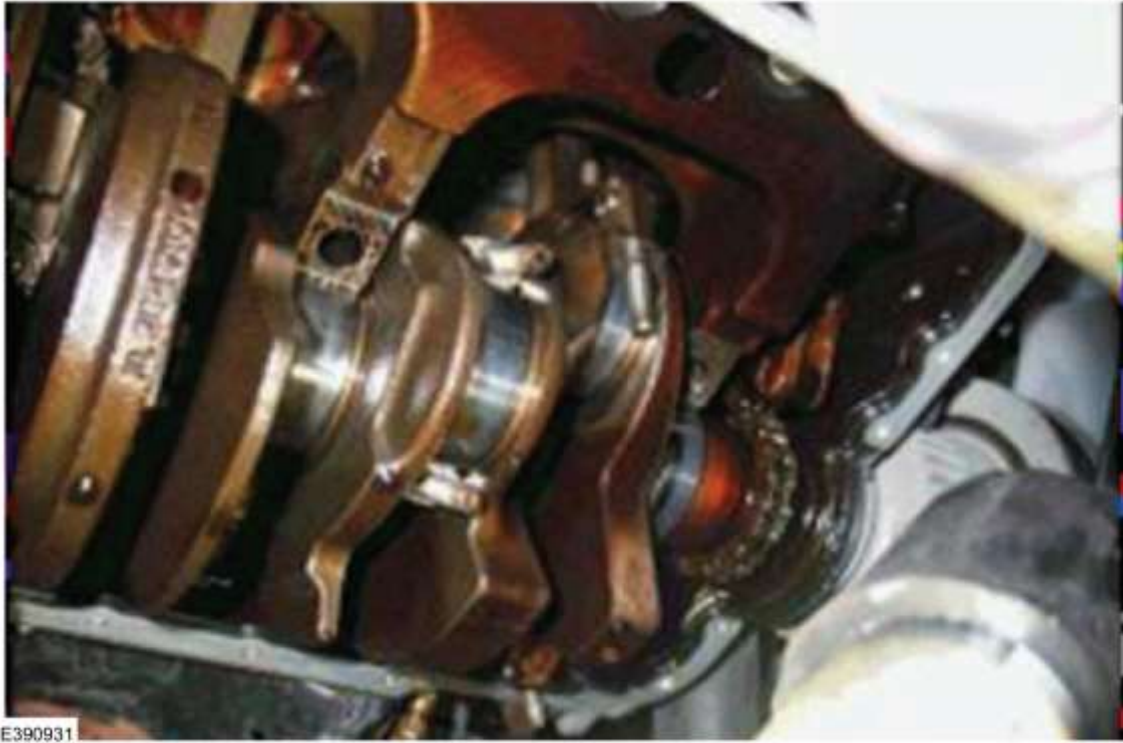
Figure 5

Oil is starting to varnish. The oil change intervals should be evaluated for timeliness.

The level of varnish in the engine can be scrapped with a fingernail. (Figure 5)

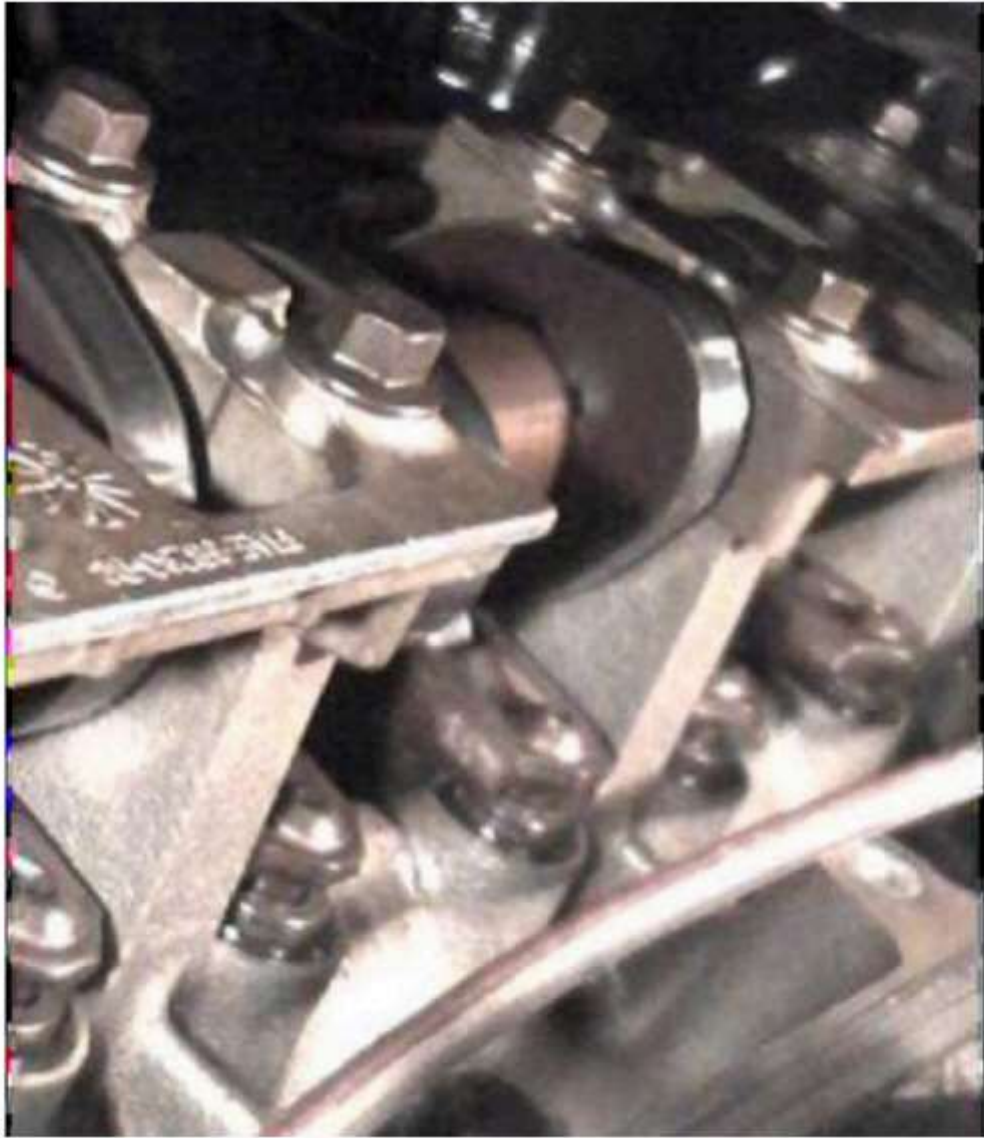
Figure 6

Example Of A Ford Engine With 140,000 Miles Where Regular Maintenance Was Performed With Motorcraft Oil And Filters (Figure 6)

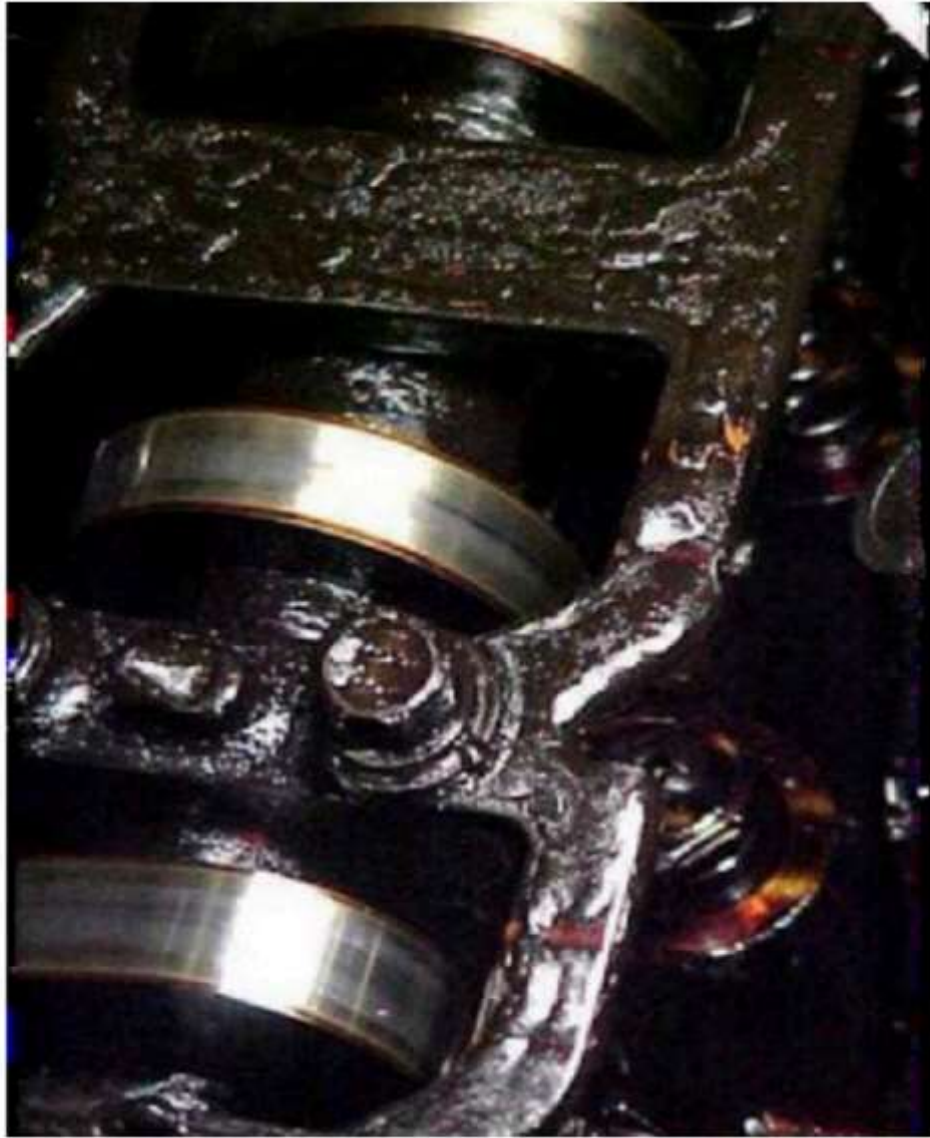
Figure 7

Example Of Ford Engine With 27,304 Miles With No Maintenance History Available And Sludge On The Valvetrain (Figure 7)

Any lubrication-related condition should not be covered by warranty or extended service plan (ESP). Consult the Warranty and Policy Manual prior to warranty cancellation.

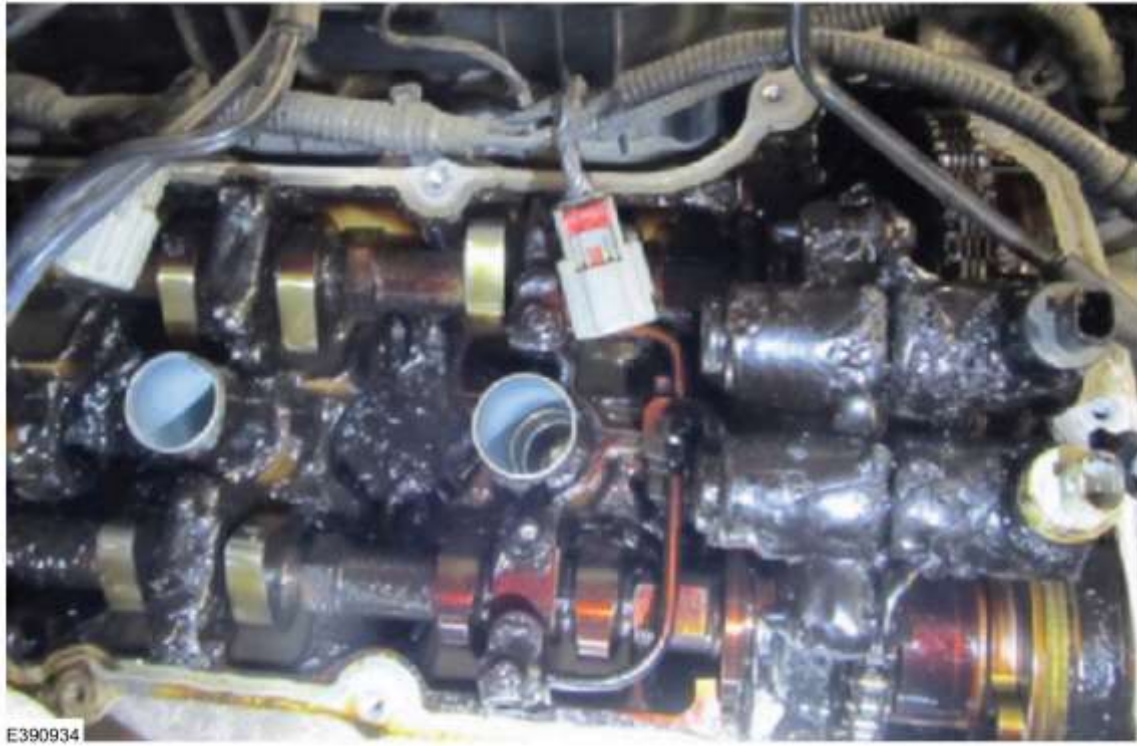
Figure 8

3.5L EcoBoost with 15,899 miles

No maintenance history.

Heavy oil sludge build-up on the cam caps, head and variable camshaft timing (VCT) solenoids from lack of oil changes. (Figure 8)

The following failures are not warrantable. Any lubrication-related condition should not be covered by warranty or ESP. Consult the Warranty and Policy Manual prior to warranty cancellation.

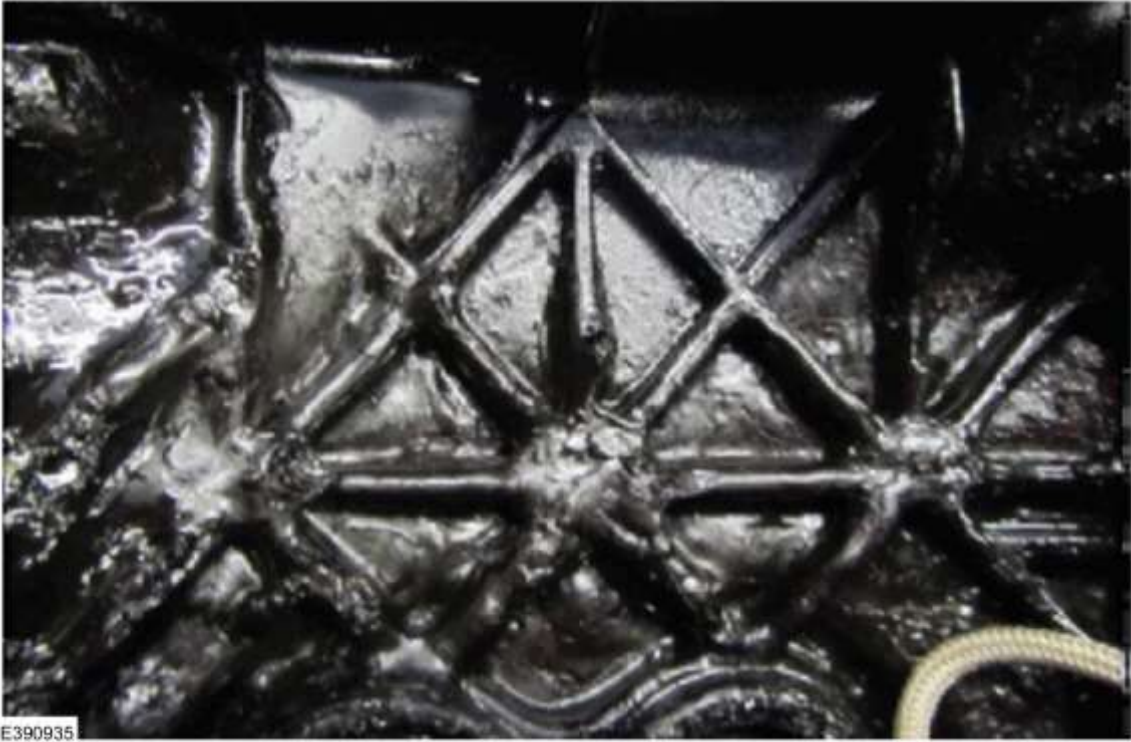
Heavy oil sludge build-up on the underside of the valve cover. (Figure 9)

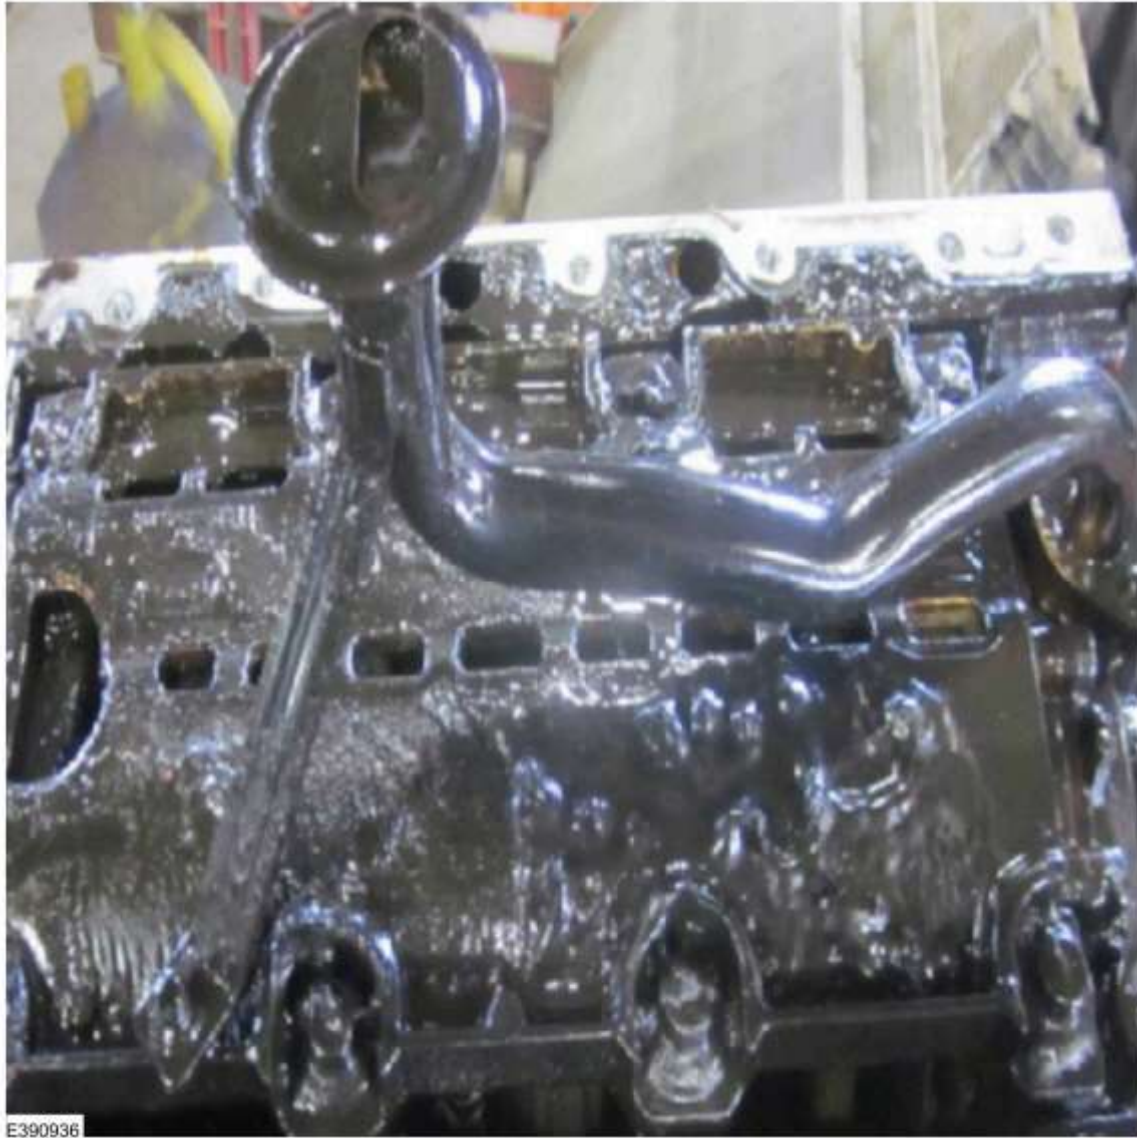
Figure 10

Sludge accumulation on the valvetrain and oil pick up tube. Oil is thick and broken down, show significant signs of lubrication restriction from sludge accumulation. (Figure 10)

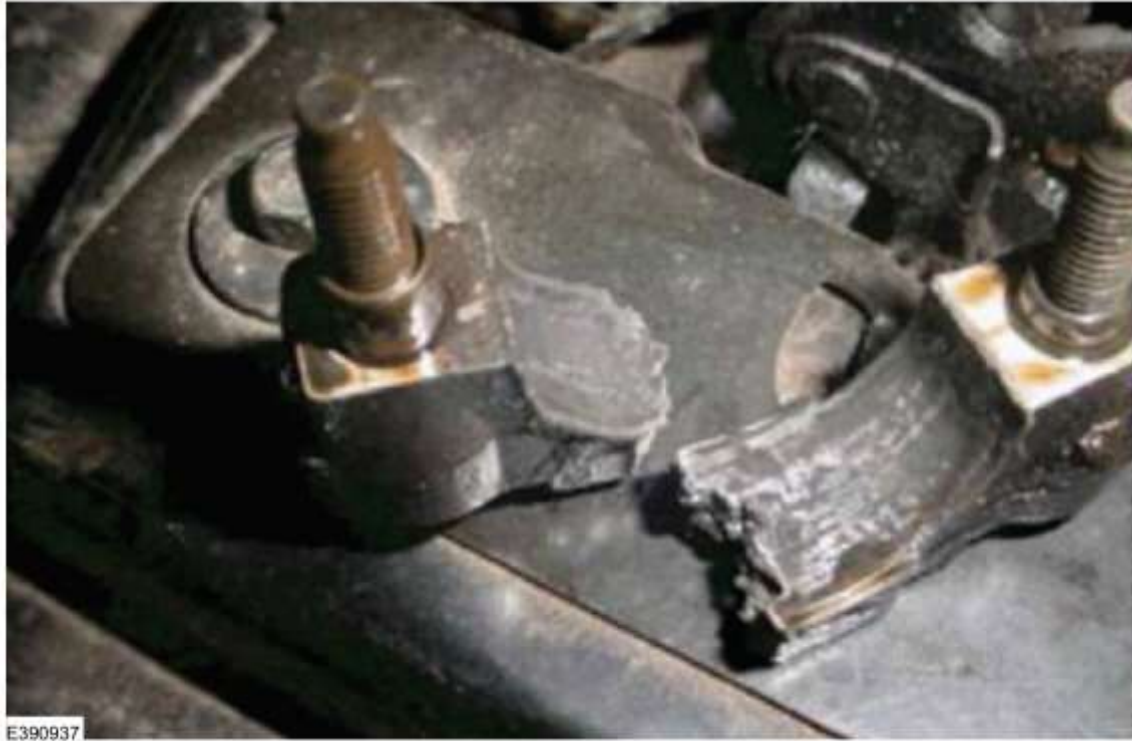
Figure 11

The bearing shown has significant signs of lubrication restriction from sludge accumulation. (Figure 11)

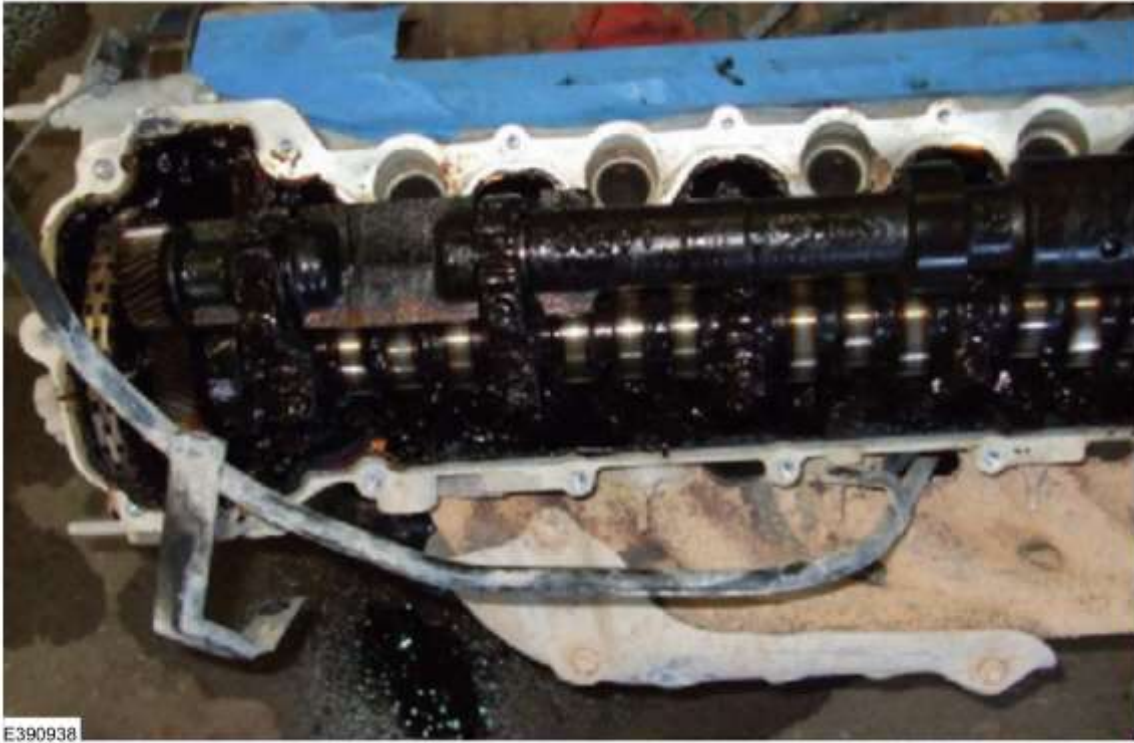
Figure 12

Positive crankcase ventilation (PCV) system issues may cause oil sludge if left uncorrected.

F-250, 6.8L 3V, 58,251 miles

Heavy oil sludge on the valvetrain. (Figure 12)

Any lubrication related condition should not be covered by warranty or ESP.

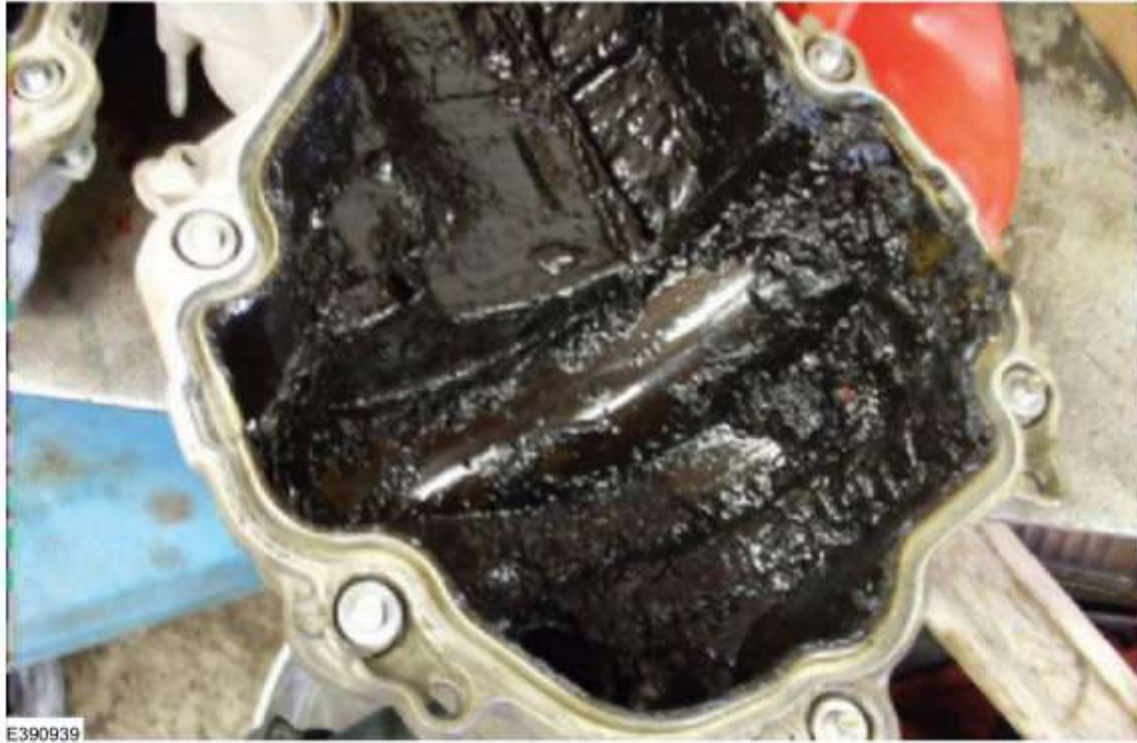
Figure 13

Heavy oil sludge on the underside of the valve cover. (Figure 13)

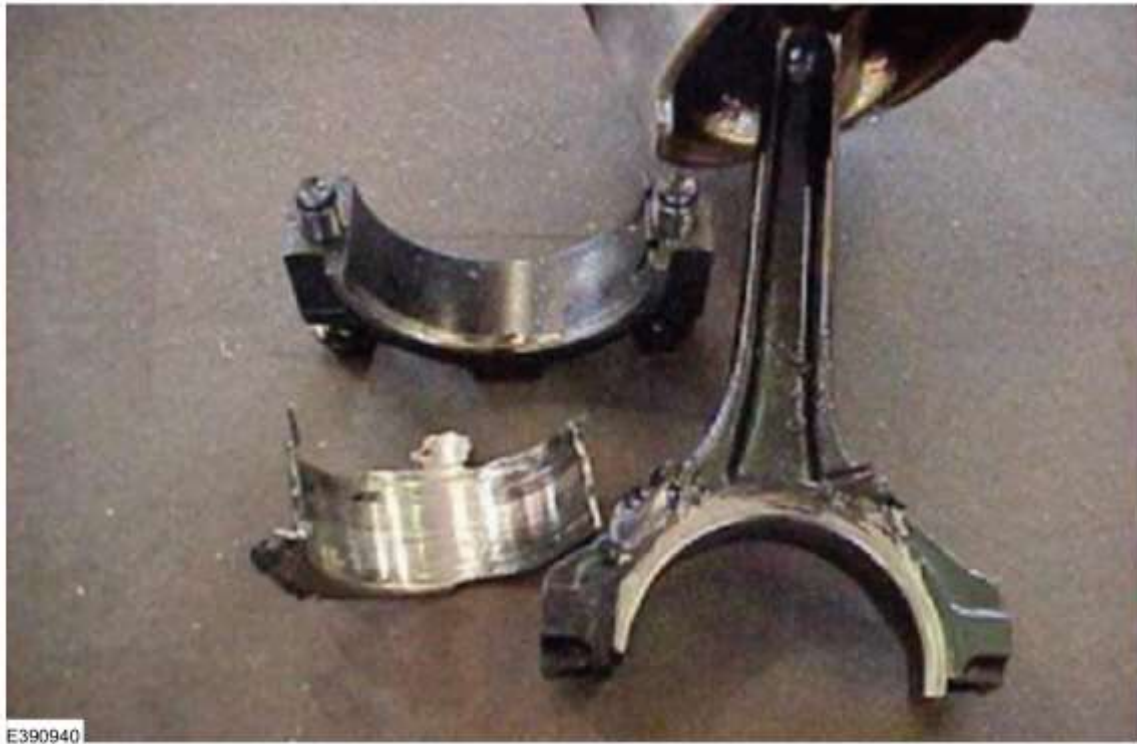
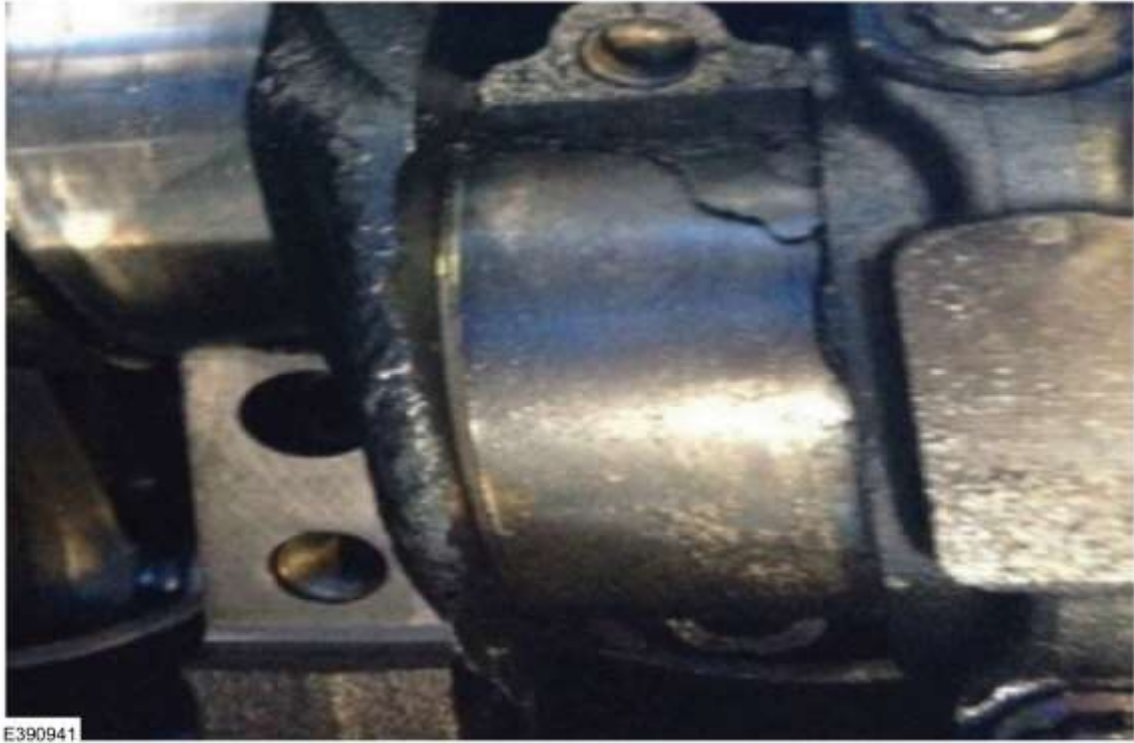
The bearing damage and bluing of the bearing cap from heat. This damage may occur when the oil deteriorates and burns (causing low level) and loses its lubrication qualities. The bearings may be damaged because they no longer have oil cooling and lubricating them which generates heat, evidenced by bluing/discoloration.

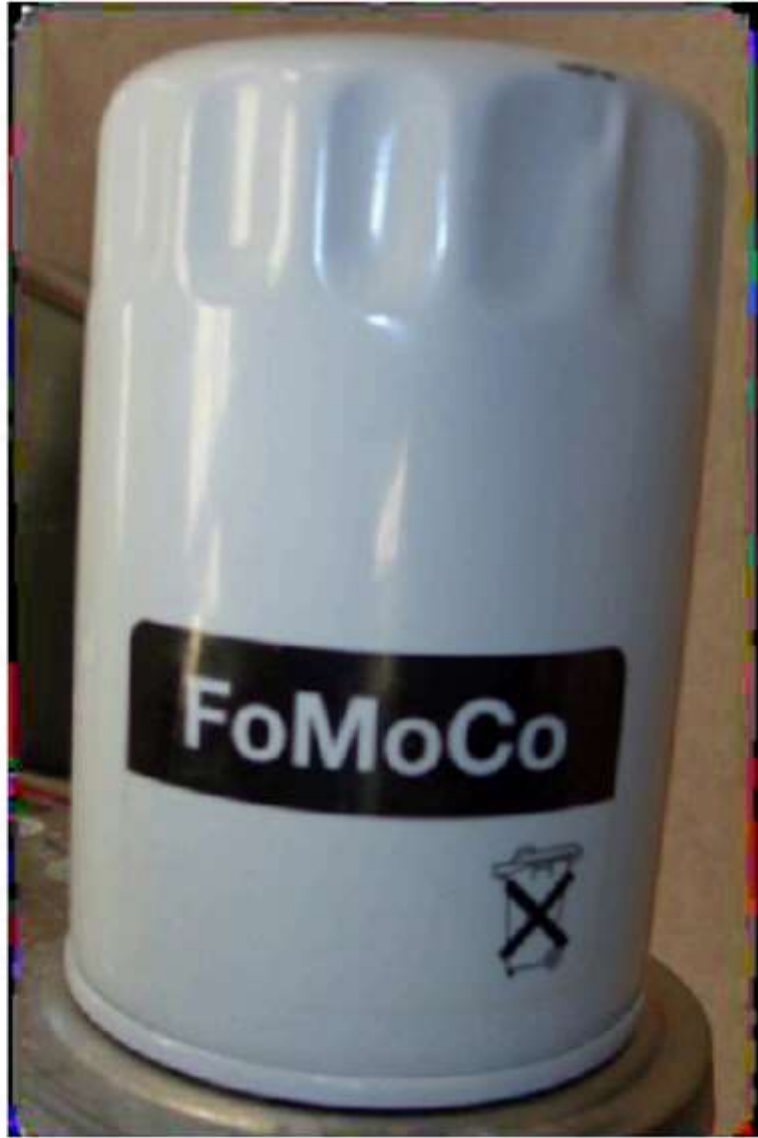
Figure 16

All-white filter can with FoMoCo in white lettering in a black box. (Figure 16)

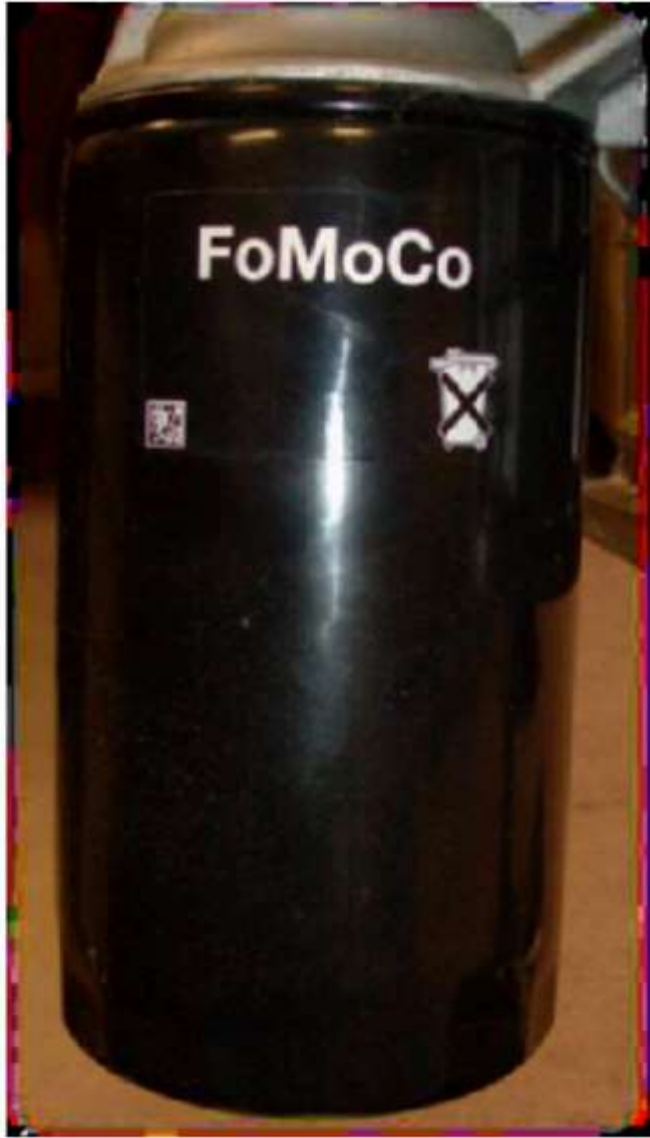
Figure 17

All-black filter can with white FoMoCo lettering (6.7L OEM and authorized remanufactured engines). (Figure 17)

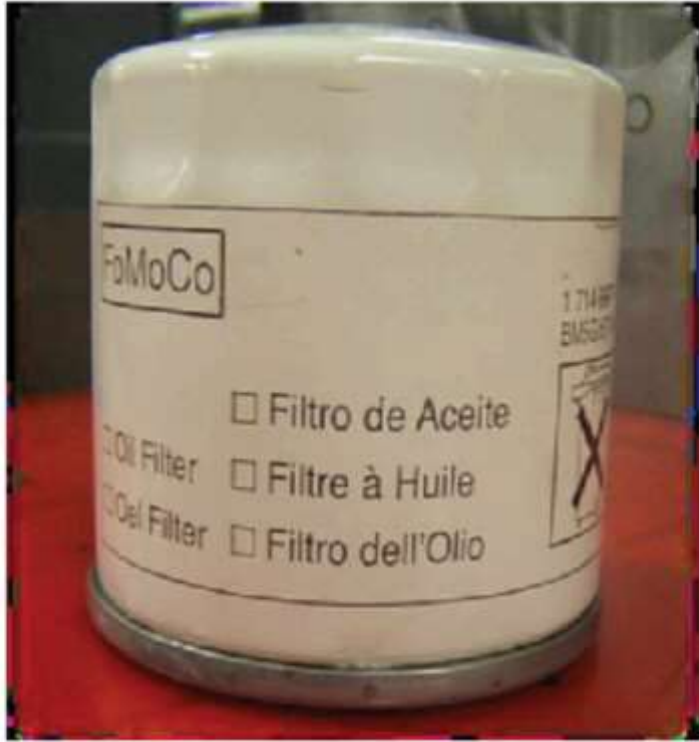
Figure 18

All-white filter can, line drawn labels with global language and FoMoCo in black. (Figure 18)

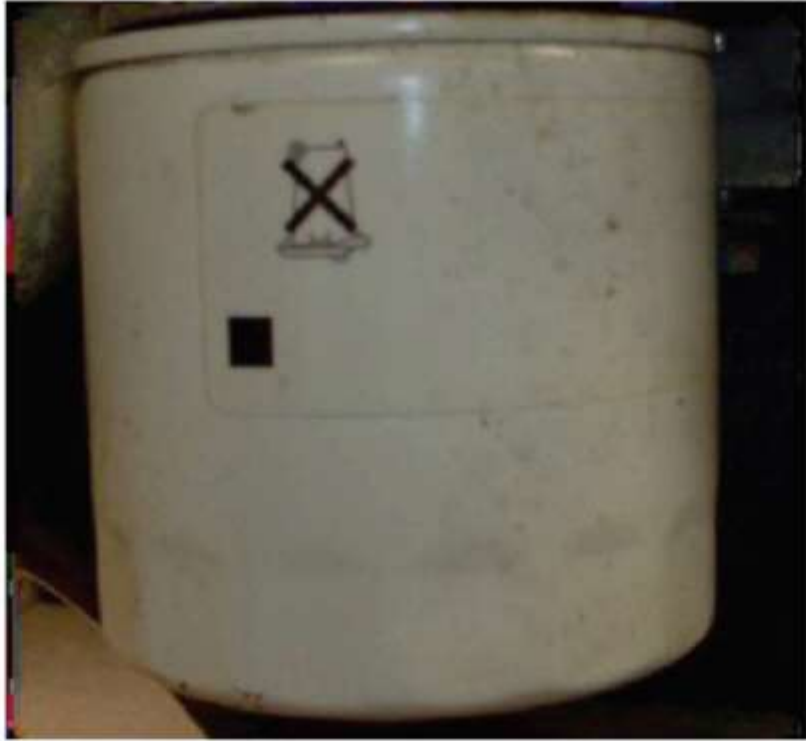
Figure 19

All-white filter can with a black or red square. (Figure 19)

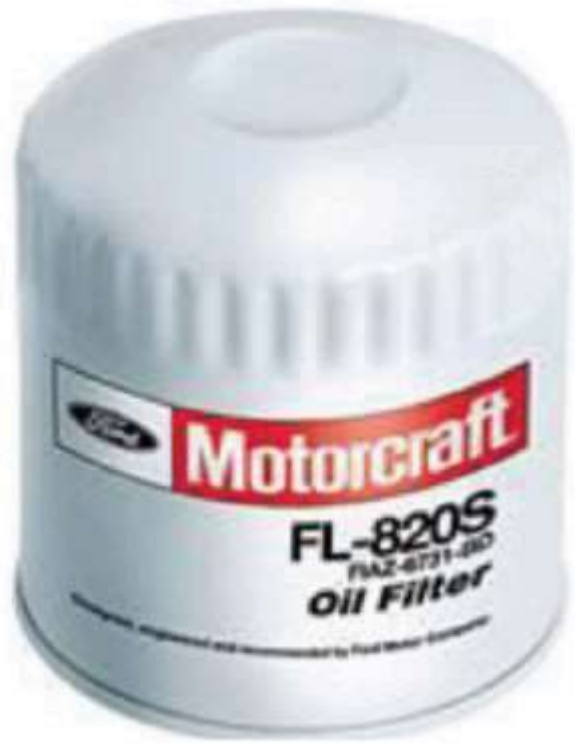
Figure 20

White Motorcraft lettering inside a red box. (Figure 20)

Although not required for warranty coverage it is highly recommended that Ford and Motorcraft® oil and filters be used. Genuine Ford and Motorcraft® replacement parts, Motorcraft and Ford-authorized branded re-manufactured replacement parts. These parts meet or exceed our specifications. If not using Ford authorized parts, they may not meet Ford specifications.

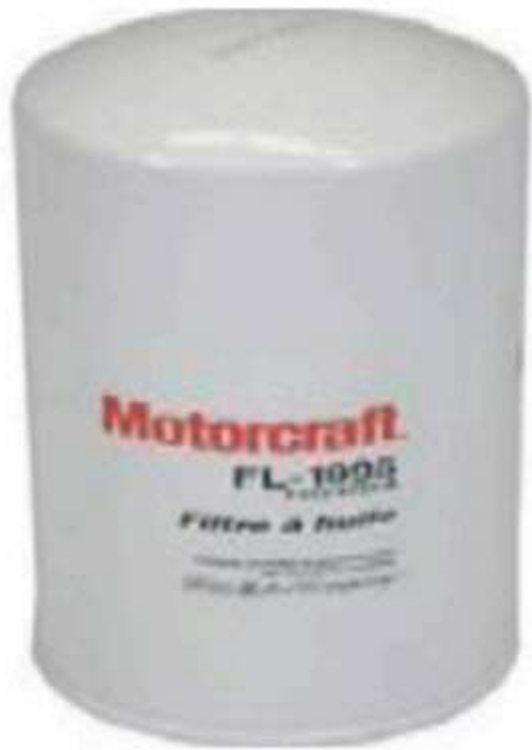
Figure 21

Red Motorcraft lettering with other labeling in black. (Figure 21)
