CAMPAIGN INSTRUCTION

MI No. 850-2300	Date July 2001	9-3
PI No.	Distr. US

Recall 15200: Replacement of airbag alert label

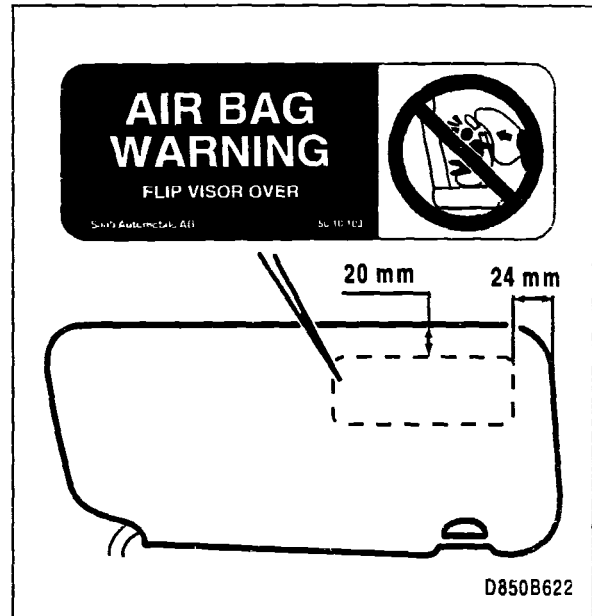
- 3 Fit the new sticker on the sun visor according to the figure.

- 1 Remove the old sticker from the left sun visor.
- 2 Thoroughly clean the sun visor with the cleaner on a lightly dampened cloth.

It is very important that 30 15 815 Cleaner is used.

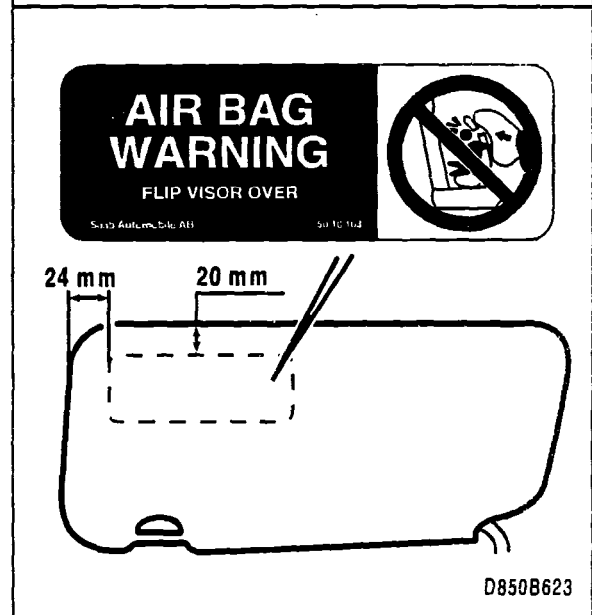
- 6 Fit the new sticker on the sun visor according to the figure.

- 4 Remove the old sticker from the right sun visor.
- 5 Thoroughly clean the sun visor with the cleaner on a lightly dampened cloth.

It is very important that 30 15 815 Cleaner is used.

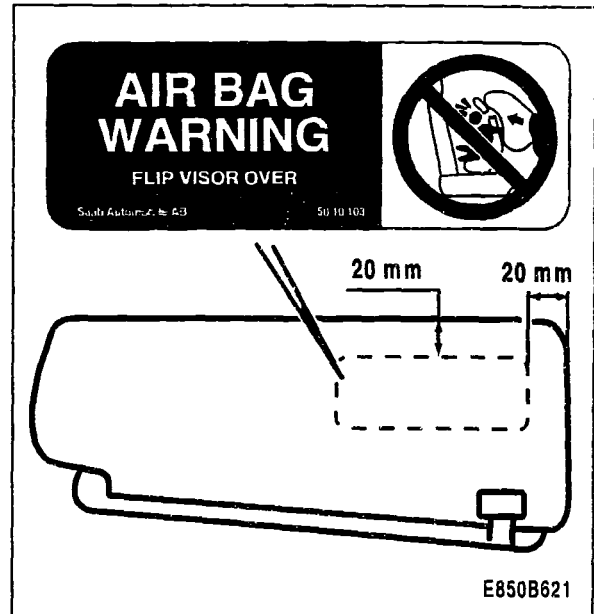
- 3 Fit the new sticker on the sun visor according to the figure.

- 1 Remove the old sticker from the left sun visor.
- 2 Thoroughly clean the sun visor with the cleaner on a lightly dampened cloth.

It is very important that 30 15 815 Cleaner is used.

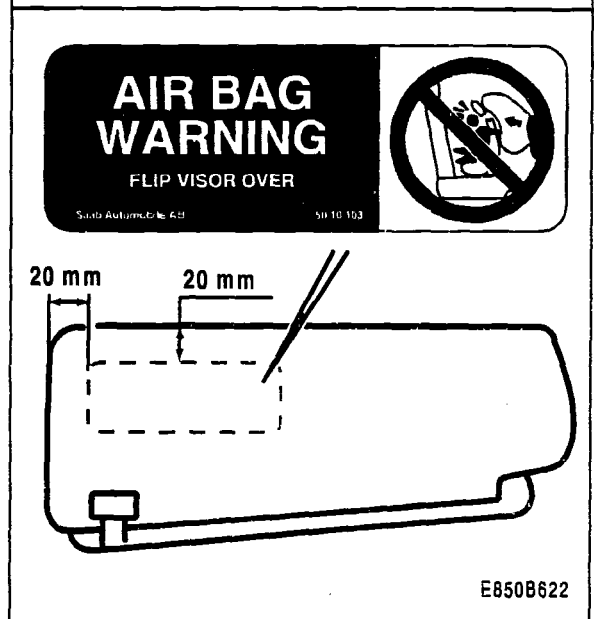
- 6 Fit the new sticker on the sun visor according to the figure.

- 4 Remove the old sticker from the right sun visor.
- 5 Thoroughly clean the sun visor with the cleaner on a lightly dampened cloth.

It is very important that 30 15 815 Cleaner is used.
