TECHNICAL INFORMATION

SUBJECT: <b>HYDRAULIC BRAKE BOOSTER ACCUMULATOR — SAFETY RECALL CAMPAIGN</b>		No: <b>SR-01-008REVII</b>	
		DATE: <b>October, 2001</b>	
		MODEL: <b>See below</b>	
CIRCULATE TO:	<input checked="" type="checkbox"/> GENERAL MANAGER	<input checked="" type="checkbox"/> PARTS MANAGER	<input checked="" type="checkbox"/> TECHNICIAN
<input checked="" type="checkbox"/> SERVICE ADVISOR	<input checked="" type="checkbox"/> SERVICE MANAGER	<input checked="" type="checkbox"/> WARRANTY PROCESSOR	<input checked="" type="checkbox"/> SALES MANAGER

## PURPOSE

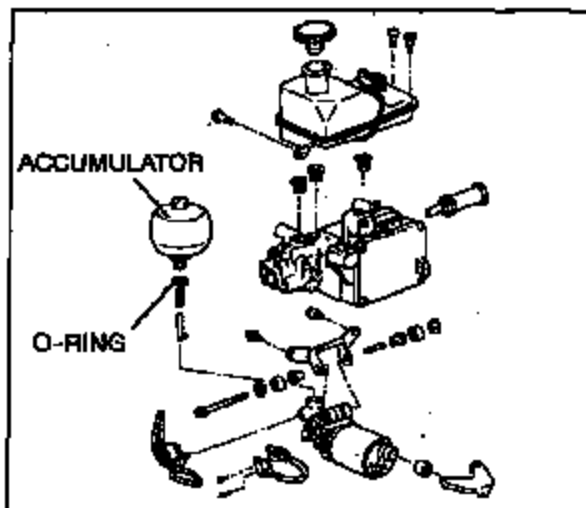
1. Inspect the color of the nut at the top of the hydraulic brake booster accumulator.
  - a. If the nut is painted pink, **STOP**. The improved accumulator has already been installed. Do not continue with this campaign procedure.
  - b. If the nut is **not** painted pink, continue with Step 2 to replace the hydraulic brake booster accumulator.
2. With the ignition turned to the LOCK position, depress the brake pedal repeatedly (up to 40 times) until the pedal becomes hard (high pedal effort). This will relieve the pressure in the accumulator.

**If pressure is left in the power assist system, brake fluid will spill when removing the accumulator.**

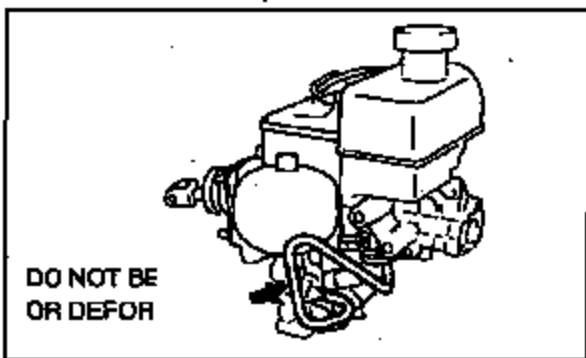
3. Use a 21 mm socket to remove the accumulator. Place a cloth under the accumulator to prevent brake fluid spillage.

Remove the accumulator **vertically**, to prevent metal shavings from accidentally entering the HBB. Remove the O-ring.

**DO NOT USE AIR TOOLS TO REMOVE OR INSTALL THE ACCUMULATOR.**

Use of air tools will likely result in shearing the nut from the top of the accumulator.

**USE CARE TO PREVENT BENDING OR DEFORMING THE TUBE.**

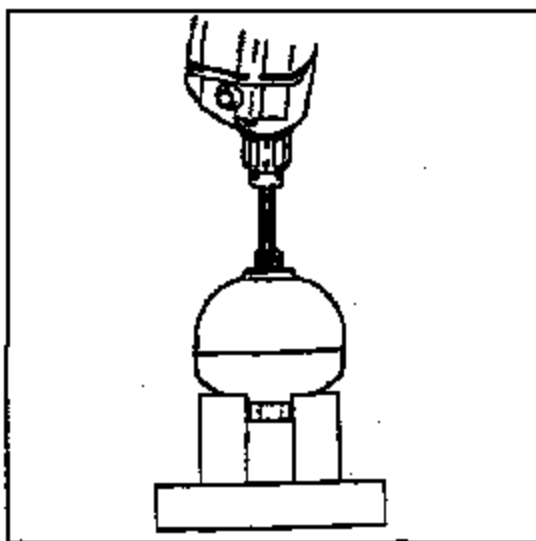
- ▶ a. Discharge the accumulator in an area away from all vehicles, to prevent any possible damage from brake fluid, rubber and plastic particles that may spray out.

- ▶ b. Secure the accumulator in a vise, with the threaded nipple pointing upward.
- ▶ c. Insert a 4mm drill bit in the hole in the nipple. Then **SLOWLY** drill through the hole in the nipple. You will hear a hissing sound as the nitrogen gas is released. The gas is odorless, colorless, and harmless.  
NOTE: Small pieces of plastic and/or rubber may spray out from the drilled hole.
- ▶ d. Scratch a large X on the accumulator near the nipple, to identify that it has been discharged.
- ▶ e. If any brake fluid remains in the accumulator, drain the fluid out.
- f. Dispose of the accumulator in compliance with Federal, state, and local laws.

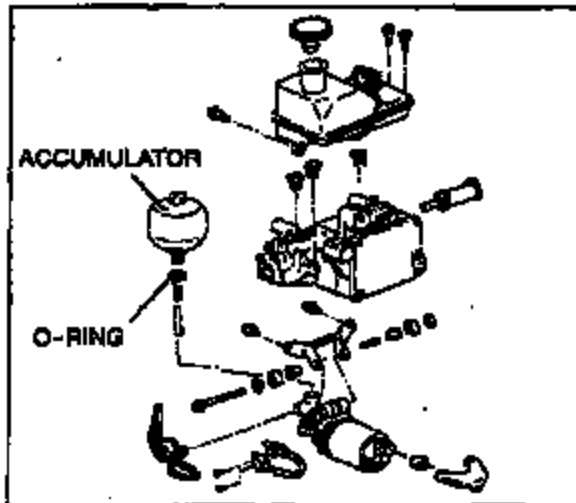
1. Inspect the color of the nut at the top of the hydraulic brake booster accumulator.
  - a. If the nut is painted pink, **STOP**. The improved accumulator has already been installed. Do not continue with this campaign procedure.
  - b. If the nut is not painted pink, continue with Step 2 to replace the hydraulic brake booster accumulator.
2. With the ignition turned to the LOCK position, depress the brake pedal repeatedly (up to 40 times) until the pedal becomes hard (high pedal effort). This will relieve the pressure in the accumulator.

If pressure is left in the power assist system, brake fluid will spill when removing the accumulator.

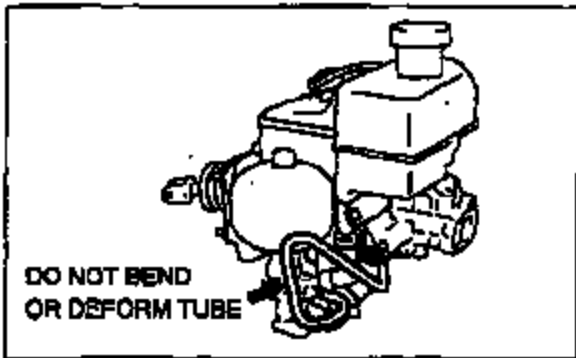
3. Use a 21 mm socket to remove the accumulator. Place a cloth under the accumulator to prevent brake fluid spillage.

Remove the accumulator vertically to prevent metal shavings from accidentally entering the HBB. Remove the O-ring.

**DO NOT USE AIR TOOLS TO REMOVE OR INSTALL THE ACCUMULATOR.**  
Use of air tools will likely result in shearing the nut from the top of the accumulator.

**USE CARE TO PREVENT BENDING OR DEFORMING THE TUBE.**

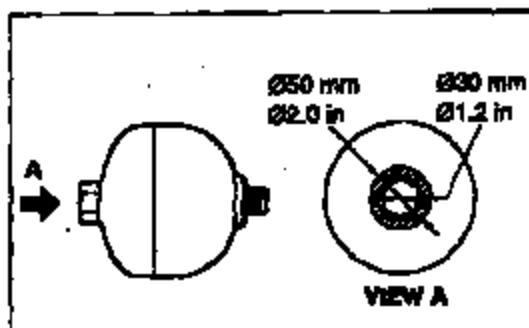
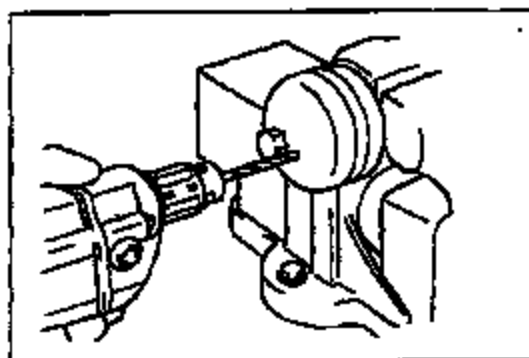
- a. Secure the accumulator in a vise.
- b. Use a punch at the location shown to create a small dimple for drilling.

- c. Using a drill with a 4 mm drill bit, slowly drill a hole in the accumulator to discharge the nitrogen gas. The accumulator will not burst during drilling.

**NOTE:** You will hear the nitrogen gas discharge. The discharged nitrogen gas is colorless, odorless, and harmless.
