Recall Campaign to Check Tire Bead

E85 Z4

Recall Campaign No. 03V-XXX: Front Tire Mounting

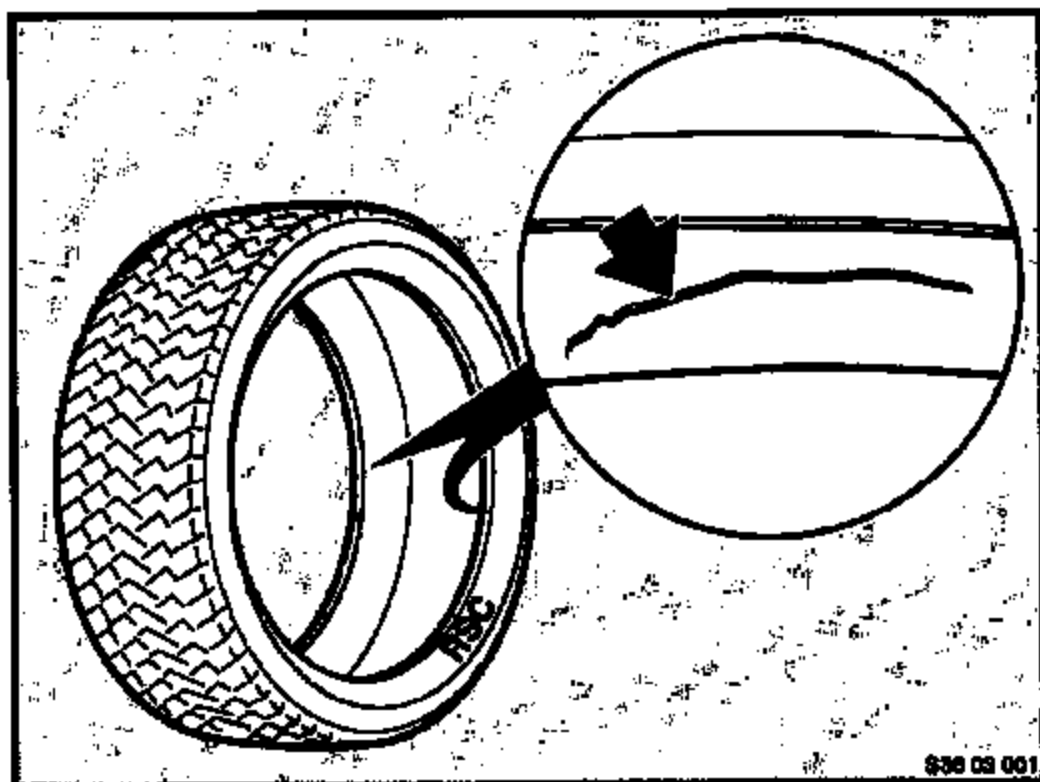
If the car is equipped with the affected tires, remove both front tires from the rims to check for damage. Carefully inspect the inside of both beads for tears in the rubber, as illustrated below.

If any tears are found in the rubber, the tire must be replaced and returned to BMW NA. If no damage is found, the tire may be reinstalled.

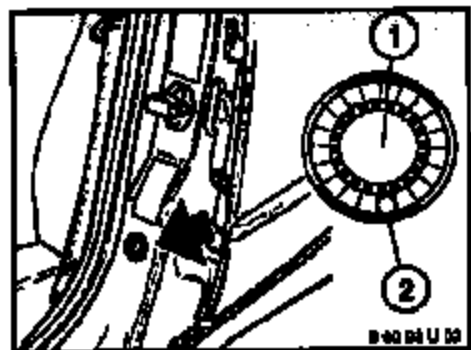
LABEL INSTRUCTIONS

This Recall Campaign has been assigned code number 362. After the vehicle has been checked, and corrected if necessary, obtain a label (SD 92-215) and:

- emboss your BMW dealer warranty number in the middle of the label (1);
- punch out code number 362 printed on the label and,

c. affix the label to the B pillar as shown.

If the vehicle already has a label from a previous Service Action/Recall Campaign, affix the new label next to the old one. Do not affix one label on top of another one because a number from an underlying label could appear in the punched-out hole of the new label.
