**VAN HOOL SERVICE BULLETIN #1126 - OWNER'S NOTIFICATION LETTER UPDATE**  
**IMPORTANT MESSAGE PLEASE READ IMMEDIATELY**

Re.: NHTSA Safety Recall Program-Campaign number 04V - 422  
Van Hool Service Bulletin N°. 1126 "Main junction box – top cover", section Parts and products

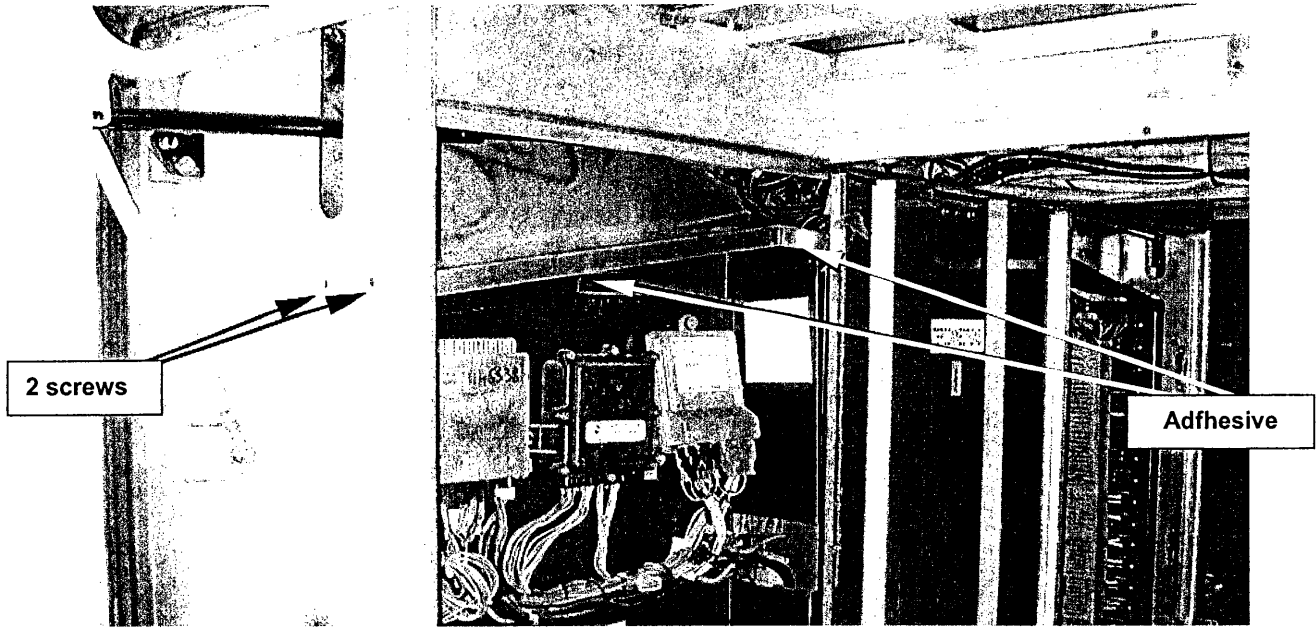
**Figure 1:**  
VH 10906063 old  
and new – do not  
use the shorter  
version

Please find enclosed a replacement top cover, which has been tailored to your coach's junction box. The new part is 4 inches longer than the old part (see Figure 1) and can be attached to the junction box center section using adhesive, and to the junction box side wall with two sheet metal screws (see Figure 2).

**IMPORTANT:** Please do not use the shorter version of Van Hool cover VH 10906063. Scrap it instead.
