RE: 04V-143/Sealco Spring Brake Valve

RE: Recall #04V-143

**Re: Notice Of Defect
NHTSA I.D. #02E-028**

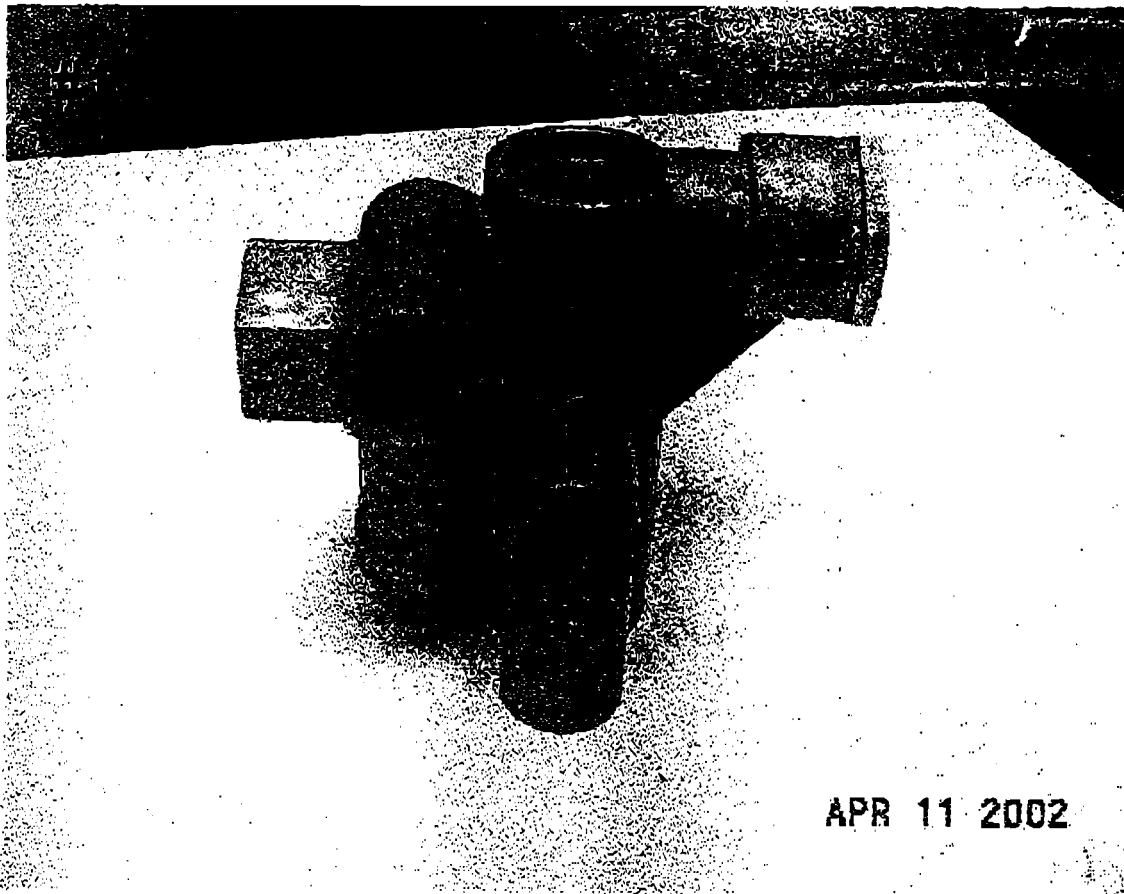
Photograph #1 – Old design #110700 SBCV with Snap Ring on top

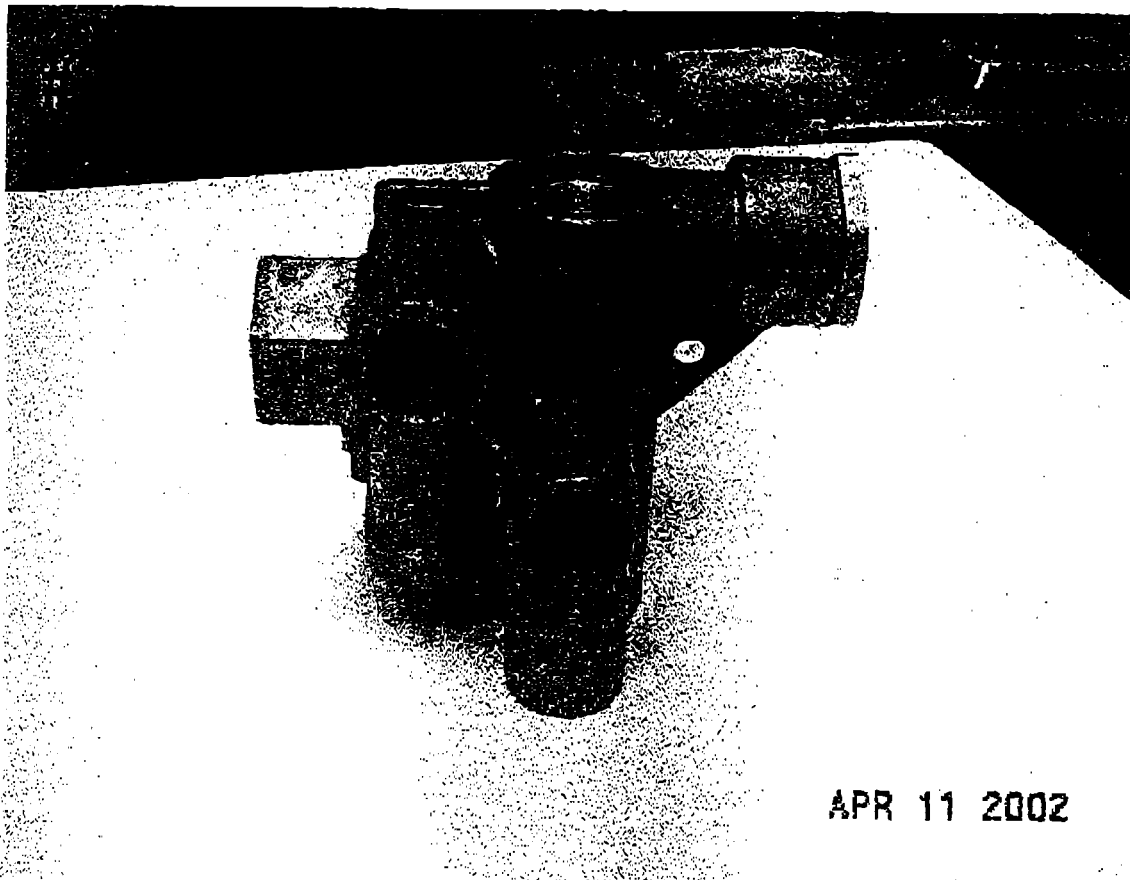
Photograph #2 – Old design #110800 SBCV with Snap Ring on top

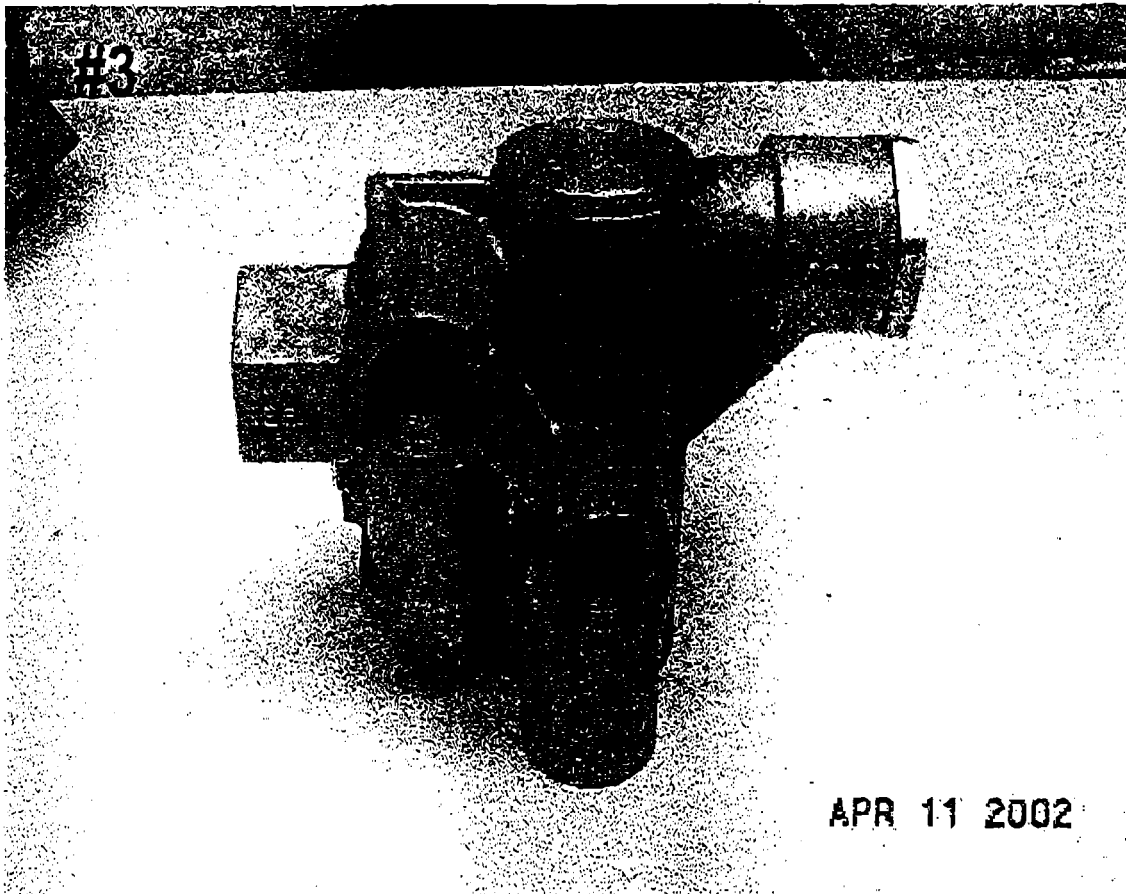
Photograph #3 – New Design #110700 with Screw Cap on top

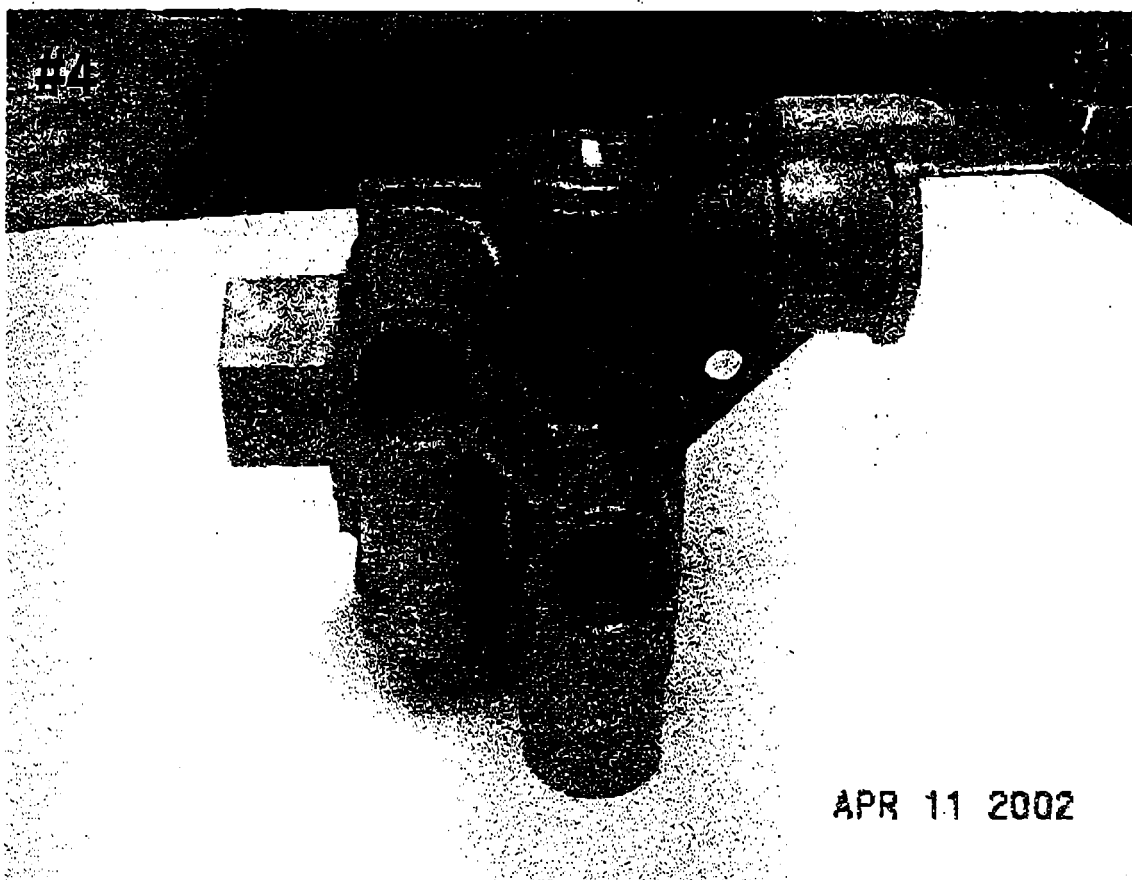
Photograph #4 – New design #110800 with Screw Cap on top
