Coachmen RV Company has decided that a defect which relates to motor vehicle safety exists in 2004 Mirada 290 motorhomes built from June 14, 2003 through March 31, 2004.

**SAFETY DEFECT**

The following is a field program procedure to ensure that the LP tank has proper clearance from the leaf spring shackle on the Mirada 290 Motorhome. Please follow each step carefully to ensure the proper attachment method will be obtained when you are complete. There are no replacement parts needed unless a part is damaged or LP tank is dented.

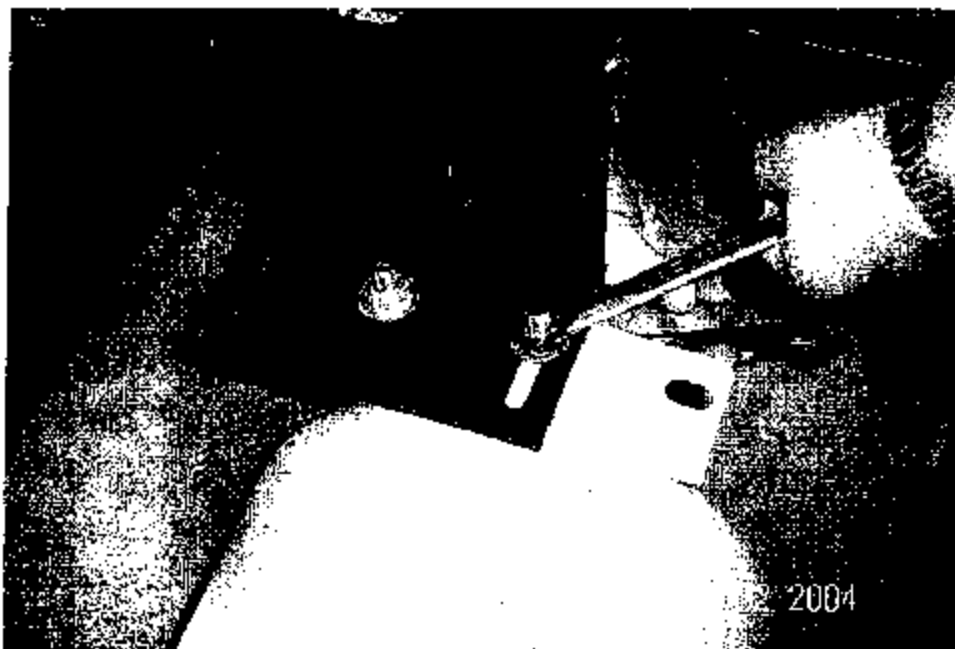
**STEP 4 :** Reinstall LP tank after holes are drilled in mounting brackets. Use the newly drilled holes for your back mounting bolt and the front slot will be used for your front mounting bolt as shown. This should move your tank away from your leaf spring shackle approx. 3-1/4". Each bolt should have a flat washer on the bottom and a flat washer, lock washer with a hex nut on top. After LP tank is installed in the proper location, torque bolts to 48-56 ft-lbs.
