**SAFETY RECALL NOTICE****VOLVO****SAFETY RECALL RVXX0406  
APRIL 2005**

Volvo Trucks North America, Inc. has decided that a defect, which relates to motor vehicle safety, exists in certain Volvo VN and Volvo VHD model vehicles built between July 1, 2000 and June 18, 2004.

**SAFETY DEFECT:** The windshield wiper motor may be susceptible to road salt spray intrusion that could possibly lead to a wiper motor connector malfunction.

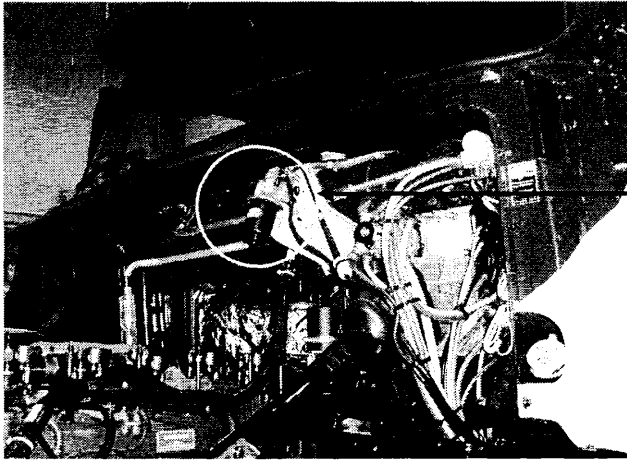
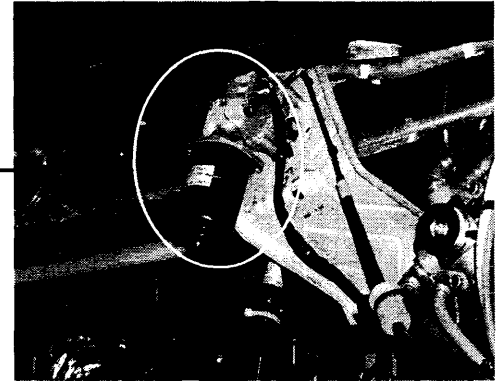
The windshield wiper motor is located under the hood on the upper bulkhead on the driver's side of the vehicle. The following image shows the location of the wiper motor:

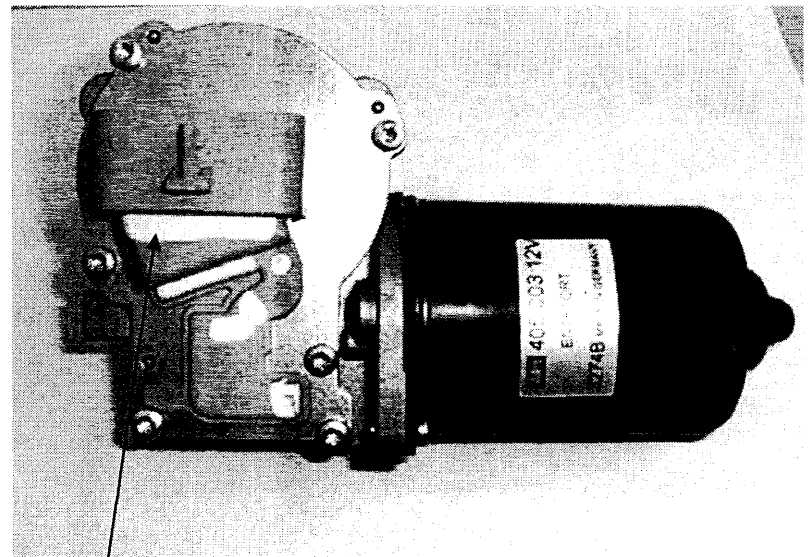
Connector (depicts recall solution)

**REPAIR:** A Volvo Truck Dealer will replace the connector on the wiper motor at no charge to you regardless of your vehicle's age or mileage. The labor time required to repair your vehicle is approximately 30 minutes.

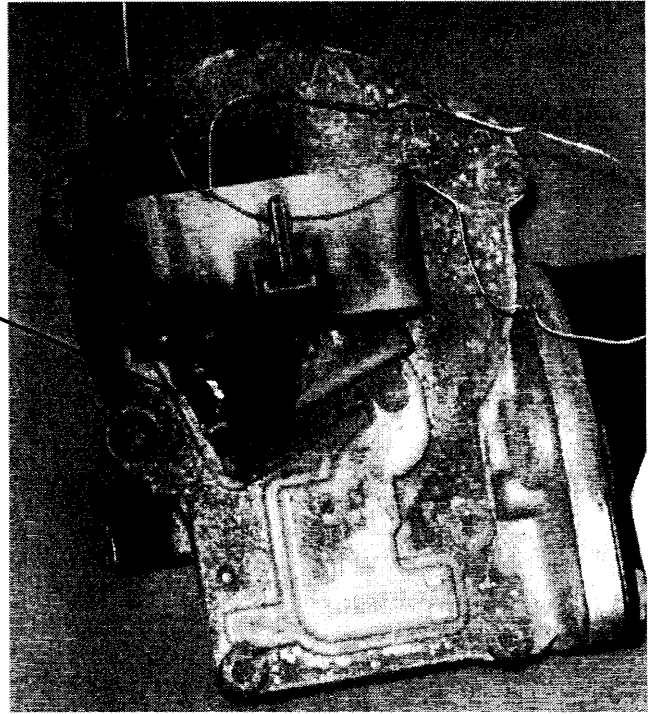
The two images below show connectors that exhibit signs of overheating:

Example of melted connector:  
(Plastic melted and charred)

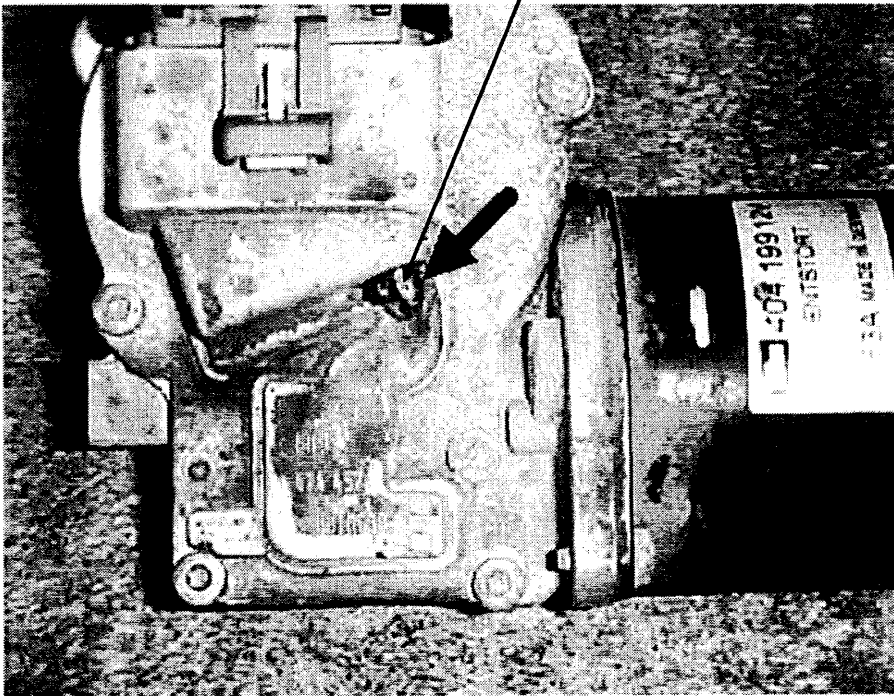
Example of melted connector (plastic deformed)
