RECALL 91

INSTRUCTIONS TO PERFORM CAMPAIGN #91
Inspection of Driver Side Dash Wiring Shield
on Winnebago Vectra and Itasca Horizon motor homes
built on Freightliner chassis with Cummins 400 diesel engine

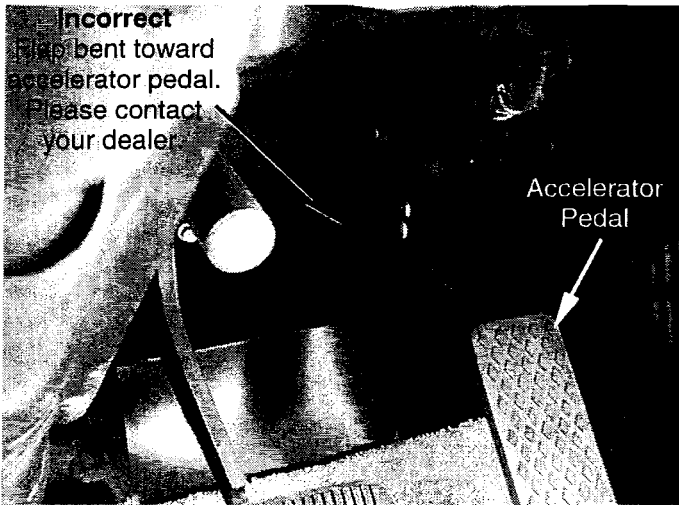
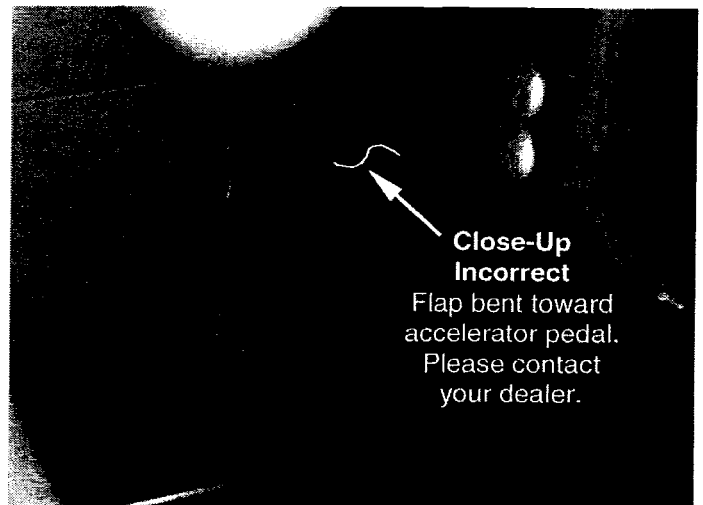
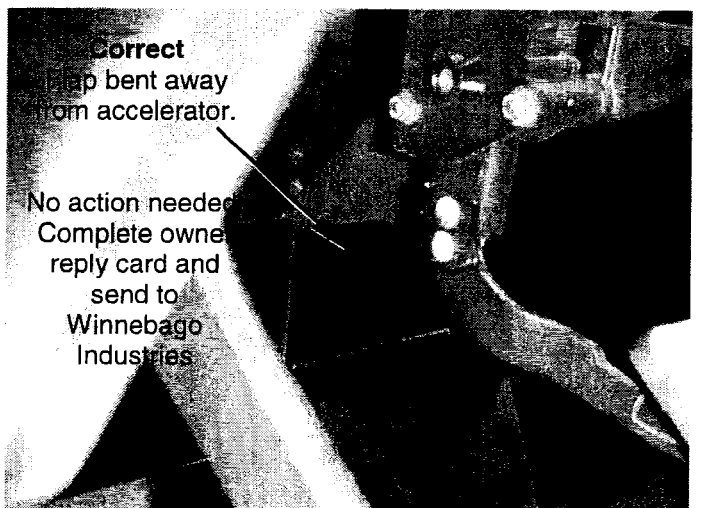
The basic procedure involves inspecting the dash wiring shield beneath the driver side of the dash. See the following photos which show improper and proper orientation of the access flap on the wiring shield. Please inspect the wire cover, then depending on condition, contact your dealer or complete the Owner Reply Card and send to Winnebago Industries as described in the photos below.

Wiring shield beneath driver side of dash on Winnebago Vectra or Itasca Horizon)

Winnebago Industries, Inc. has provided instructions for you to inspect and, if necessary have the wire cover repaired. If you do not feel comfortable performing this inspection, you have the option to have a dealer inspect and repair, if necessary at no charge to you.
