MODEL
Sephia/
Sportage

DATE
August 2004

Technical Service Bulletin

SUBJECT **Recall Campaign: Front Seat Belt Buckle Replacement**

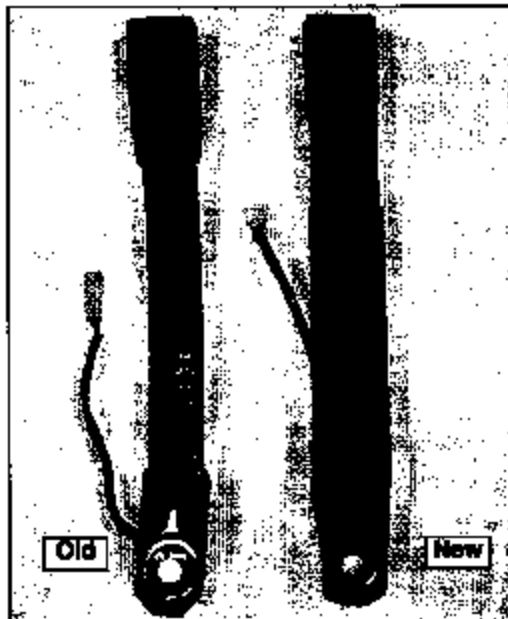
Sportage Buckle

This bulletin provides information related to a recall on 1999-2000MY Sephia and Sportage vehicles to replace the front seat belt buckles. The buckles may emit a clicking sound during latching which could indicate to the customer that the belt was latched when the belt may not be latched. If this occurs, the buckle would not provide restraint and could pull out at any time, including in a collision.

To correct this potential safety defect, Kia is recalling the affected 1999-2000MY Sephia and Sportage vehicles to replace the front seat belt buckles.
