# ***SERVICE PROCEDURE***

G-04510-R1  
February 2006

**SUBJECT:** SAFETY RECALL (U.S., EXPORT)  
BATTERY CABLES on certain HPV models built  
11/20/2000 thru 5/20/2004 with Cummins,  
Caterpillar or International DT/HT530 engines.

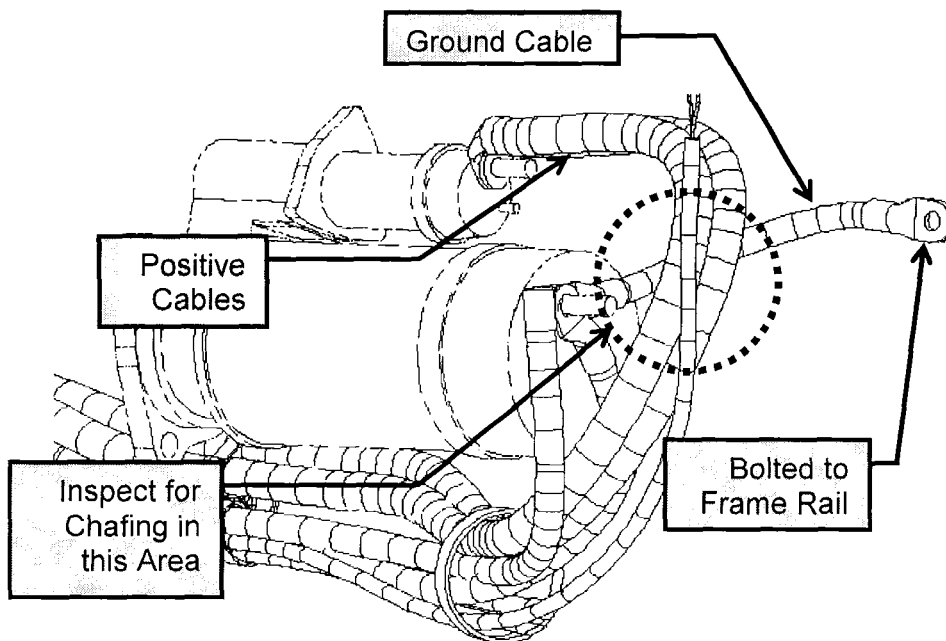
**Figure 1 – Engine Removed for Clarity**

The positive battery cable between the batteries and the starter may rub against an electrical ground cable between the starter and frame rail possibly causing an electrical short and/or fire. This may result in **property damage, personal injury or death**.

1. Inspect positive (red) battery cables, conduit and ground cable (black) in areas indicated below:

2. If ANY indication of chafing or rubbing is evident, replace any affected cables and continue to step 4.

3. If there is NO indication of chafing or rubbing, continue onto step 4.

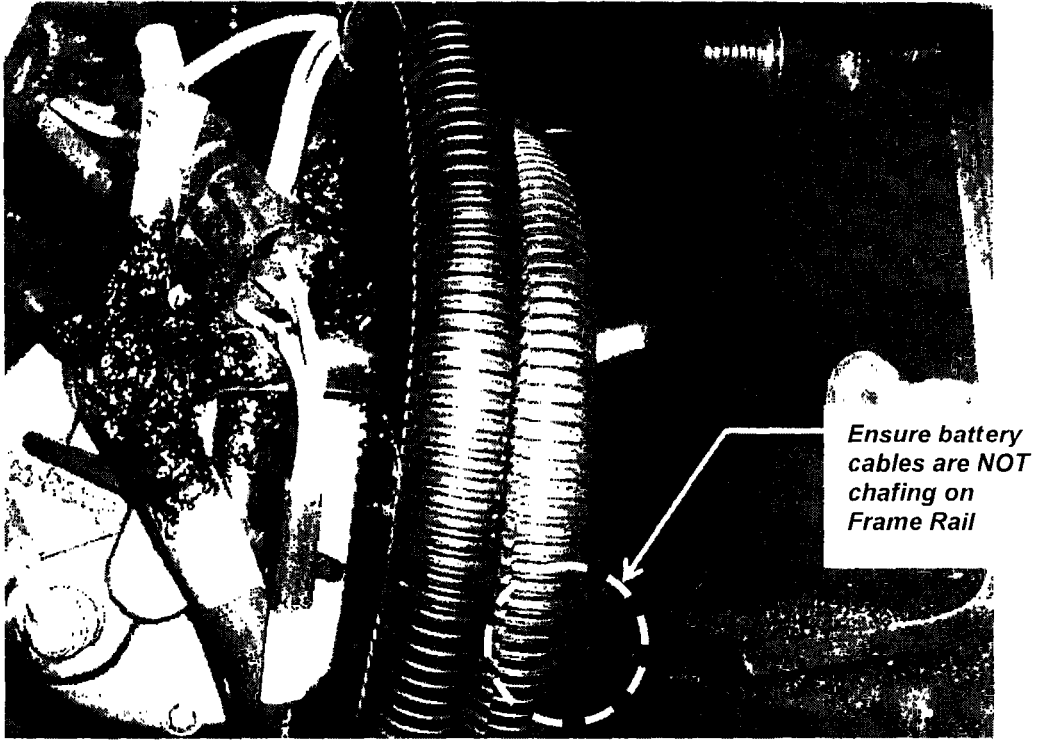
**Figure 5 – Battery Cables to frame rail rub**

- Regardless of whether or not the saddle clamp was installed, please perform this final inspection on *all* vehicles to ensure the electrical cables are properly routed.
- Please inspect the starter electrical cable routing for rubbing or chafing in the following areas:
  - Battery Cables to frame rail.
  - Battery Cables to FRAME ground cable.
  - Battery Cables to ENGINE BLOCK ground cable .
  - Battery Cables to starter case, starter terminal studs or other starter components and wiring.
  - Battery Positive Cable to BATTERY ground cable.
  - Battery Positive Cable to FUEL FILTER housing.
- It may be necessary to loosen and/or remove a battery cable to re-orient it.
- It may also be necessary to loosen/replace routing/clipping points (p-clamps, extension clips, etc...) to facilitate a no-rub condition.
- See figures below for a representation of rub conditions that require remedied.

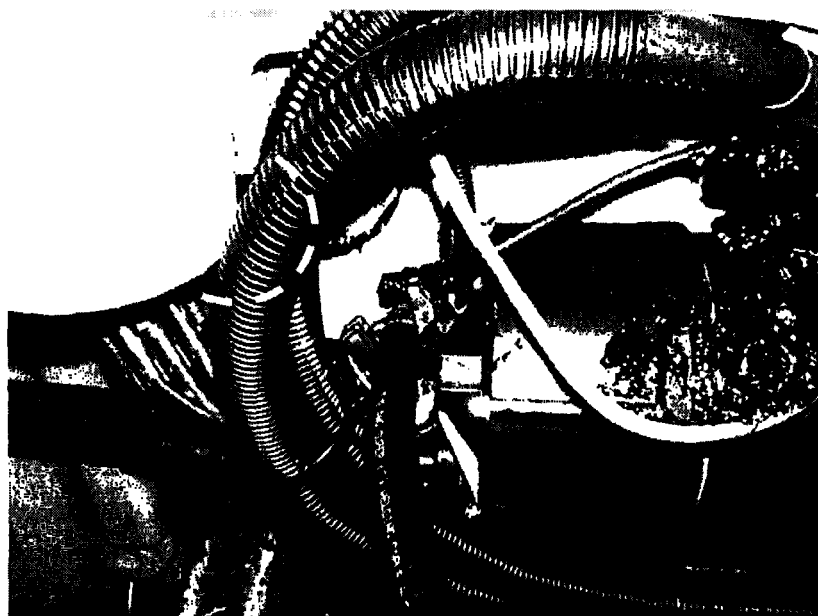
**Figure 5e – Battery POSITIVE cables Rubbing on Fuel Filter housing  
(CAT engine shown, however condition may also exist on Cummins ISM)**
