# VEHICLERECALL

## SC288

**Date:** 1/25/05 (Supersedes SC288 dated 10/14/04)

**Subject:** Steering Gear Mounting Bolt Torque — CX and CH Model Chassis

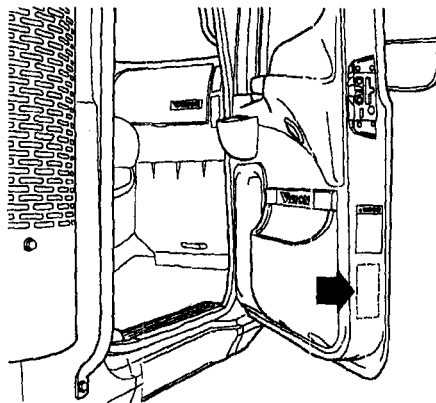
Figure 1 — Campaign Label Location

Before proceeding, check campaign status in the MACKnet system to see if the campaign has already been completed. Campaign status can also be checked by looking at the Campaign Completion Label located on the lower edge of the passenger-side door. If the campaign has been completed, the campaign number (SC288) and the completion date should be written on the label.

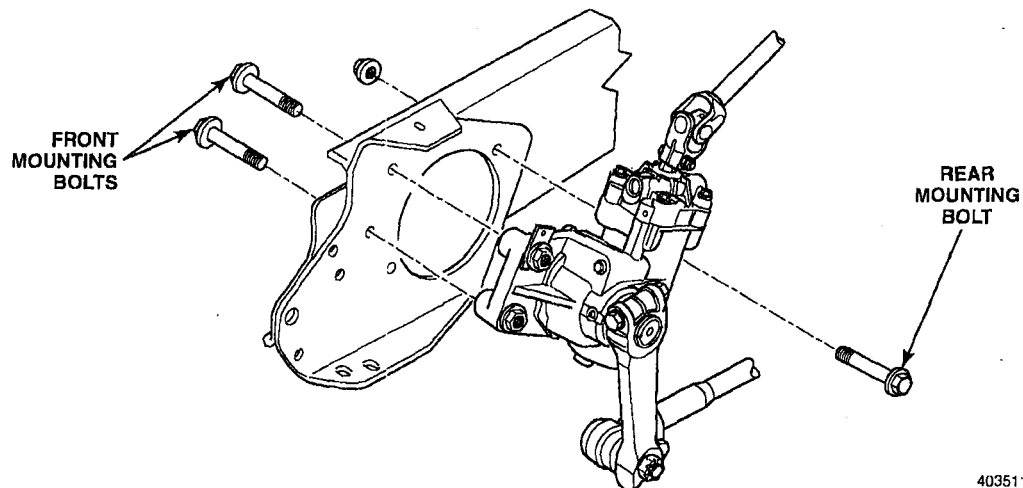
Figure 2 — Steering Gear Mounting Arrangement — CX and CH Models

On CX and CH models, the two front steering gear mounting bolts are installed from inside of the frame rail. On CX models, clearance between the frame rail and the charge air cooler is not sufficient to allow removal of the two front bolts, making it necessary to move the steering gear away from the frame rail to cut the mounting bolts as close to the frame as possible. On CH models, however, replacing the steering gear mounting bolts is simply a matter of removing each bolt, one at a time, and replacing with new bolts, nuts and hardened flat washers. On both CX and CH models, the replacement bolts are to be installed from the outside of the steering gear. The procedures outlined below that cover moving the steering gear away from the frame rail and cutting the mounting bolts, apply to CX model chassis only.

- REV
1. Secure the chassis for service, apply the parking brakes and block the wheels to prevent the vehicle from moving.
  2. If equipped with a steel bumper and the left-side bumper mounting bracket interferes with removal of any of the steering gear mounting bolts, remove the bumper and left-side mounting bracket.
  3. Attach a hoist to the steering gear to provide support once the mounting bolts are removed.

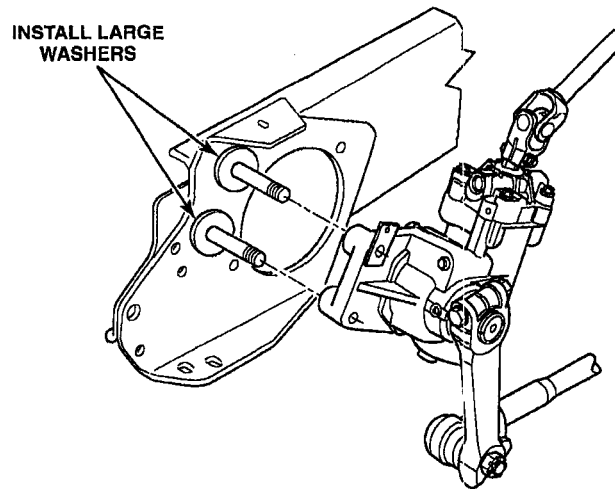
**Figure 3 — Preparing to Cut Mounting Bolts — CX Models**

4. Remove the nuts from the three steering gear mounting bolts, and then remove the rear mounting bolt from the steering gear.
5. With the hoses and linkages (input shaft and drag link) still attached, pull the steering gear away from the frame rail far enough to clear the two mounting bolts remaining in the frame.
6. Install a large washer (having an inside diameter of at least 5 1/64") over each of the two bolts. These washers will help protect the frame rail from damage as the bolts are being cut with the torch.

7. Using a torch, very carefully cut the two mounting bolts flush with the washers.
8. Remove the two bolt heads from the frame rail.

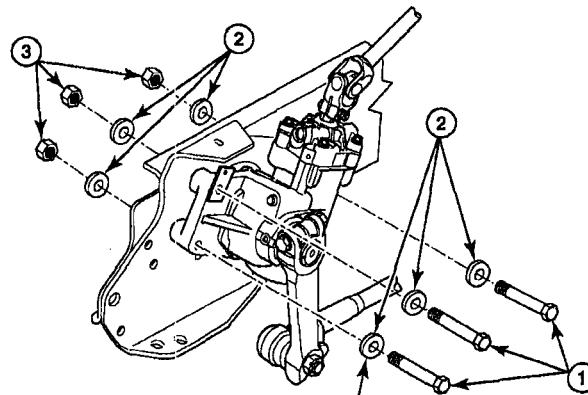
Figure 4 — Install Steering Gear Mounting Bolts — CX and CH Models

9. Move the steering gear back into position against the frame rail, and then install new mounting bolts, washers and nuts (refer to the table below for part numbers). The bolts are to be installed from the outside of the frame rail as shown in the following illustration. Install hardened flat washers under the head of each bolt and under each nut.

On CX models regardless of steering gear model, use

- One washer if equipped with 8 mm frame rails
- Two washers if equipped with 6 mm frame rails

under the head of the forward most bolt (as shown in the following illustration).

CX MODELS:  
USE ONE WASHER AT THIS LOCATION WITH  
8 MM FRAME RAILS, TWO WASHERS  
WITH 6 MM FRAME RAILS

10. Tighten the steering gear mounting bolts to 375 lb-ft (508 N·m). Torque must be applied to the heads of the mounting bolts, not the nuts. Torque the bolts dry; DO NOT apply oil to the threads.
11. If removal of the front bumper and the left-side bumper mounting bracket was necessary, reinstall the bracket and bumper assembly.
12. Remove the hoist.

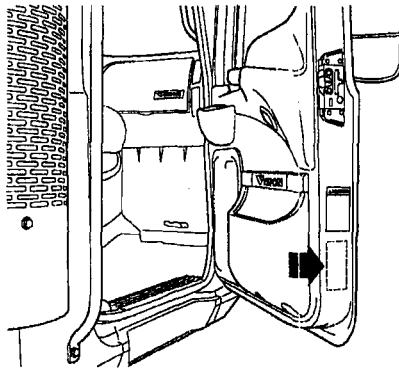
Figure 5 — Campaign Label Location

To signify that the campaign has been completed, use a permanent-type marker (such as a Sharpie®) to write the campaign number (SC288) and completion date in the spaces provided on the Campaign Completion label located on the lower edge (below the door latch) of the passenger-side door. If a label is not already affixed to the door, apply a label (part No. TS897) and supply the information as required. Campaign Completion labels are available in packs of 50 and can be ordered by faxing a completed BR313 to Pacesetters Business Services at 610-264-9465.
