## RECALL Replace Non-Compliant A-Pillar Trim

No: RB176  
Ref:  
Issue: 1  
Date: 06 December 2004

Freelander (LN)

## Part Numbers and Warranty Claims Processing - Recall B176

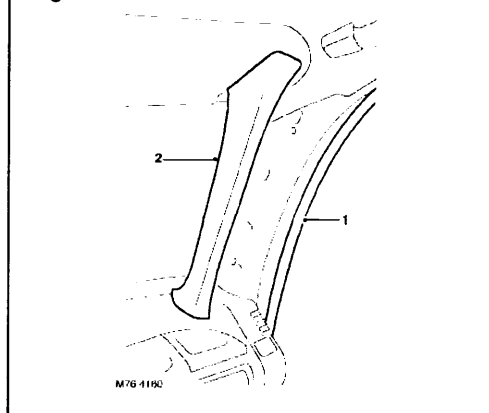
Figure 1

1. Refer to GTR section 76.13.26 and remove both left hand and right hand A-pillar trim. (Figure 1)

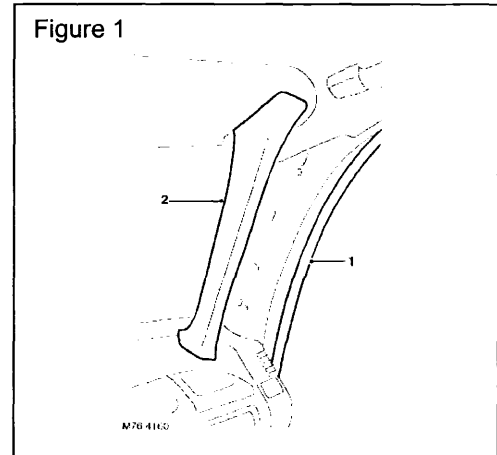
1. Refer to GTR section 76.13.26 and remove both left hand and right hand A-pillar trim. (Figure 1)
2. If the vehicle is a 5-door variant, remove the white plastic upper mounting clip from the replacement trim panel using wire cutters or other suitable cutting tool to cut the plastic rivet. (Figure 2)
3. Install the latest configuration left and right hand A-pillar components following the GTR procedure.
