SERVICE BULLETIN No.1152

COACH MODEL	: C2045
BULLETIN TYPE	: Safety Recall Program -- NHTSA Campaign number 04V-423
MANUAL & SECTION	: N/A
DATE	: December 3, 2004
SUBJECT	: Air tank retention
TERMS & CONDITIONS	: Refer to the Warranty Information in this Bulletin.

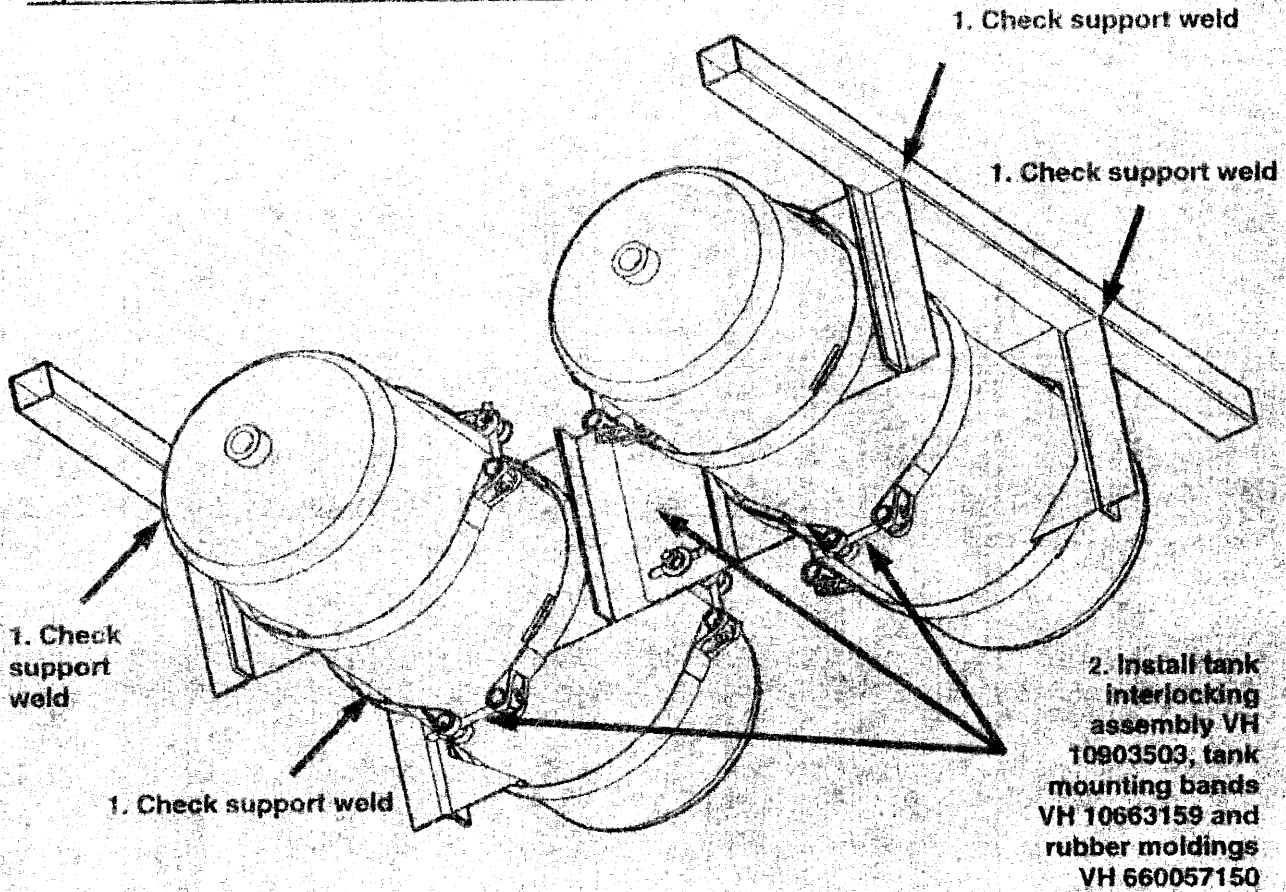
Figure 1a: Air tank bolt-on assembly – drive axle area

- 1) Using a flashlight, inspect the area where the air tank support brackets have been welded to the chassis rails (see Figures 1a and 10).

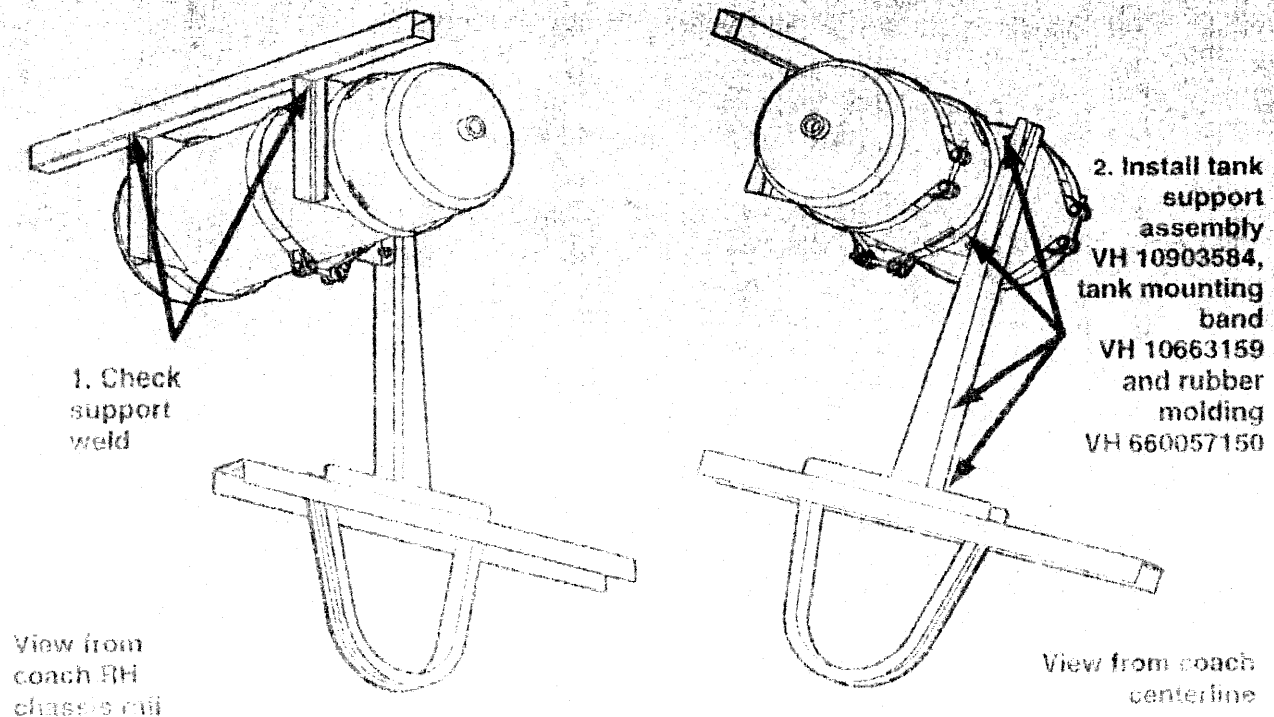
Figure 1b: Air tank bolt-on assembly – tag axle area

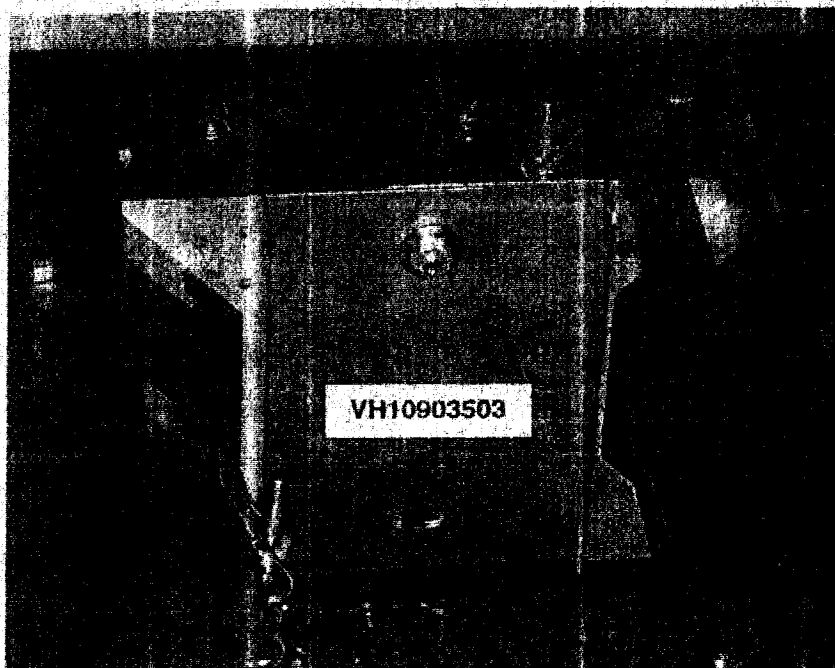
Figure 2: Tank interlocking assembly VH 10903503 for auxiliary and drive axle service brake tanks

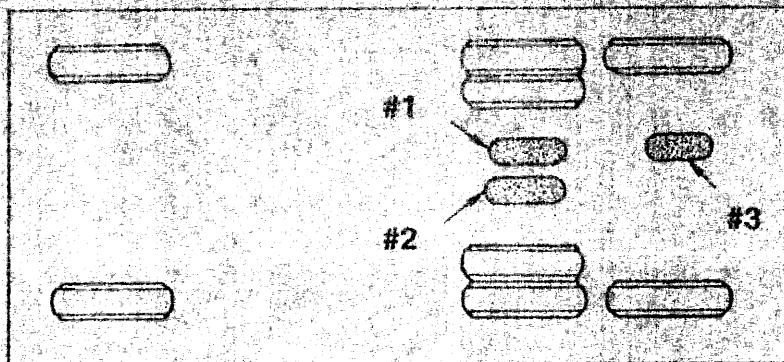
Figure 7: Air tank location

1. Auxiliaries
2. Drive axle service brakes
3. Tag axle brakes

Tank	Location	Refer to
#1 Auxiliary	Above drive axle	1, Figure 7 (page 5 of 10)
#2 Drive axle service brake	Above drive axle	2, Figure 7 (page 5 of 10)
#3 Tag axle brake	Above tag axle	3, Figure 7 (page 5 of 10)

- 4) Locate the affected air tanks (see 1, 2 and 3, Figure 7, Figure 8 and Figure 9).

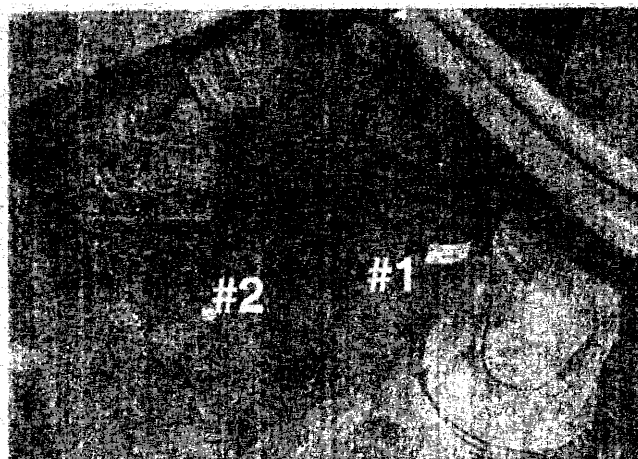
Figure 8: Air tanks #1 and #2

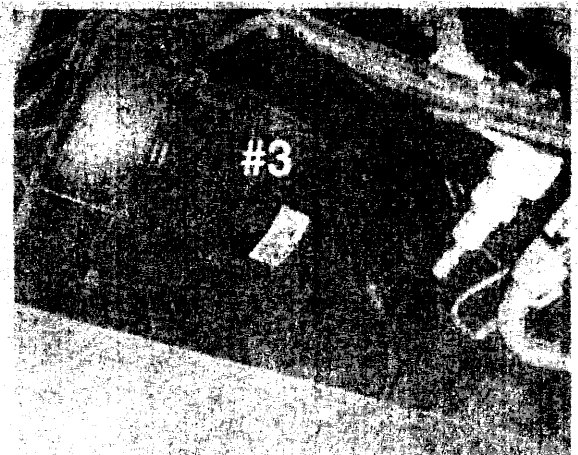
Figure 9: Air tank #3

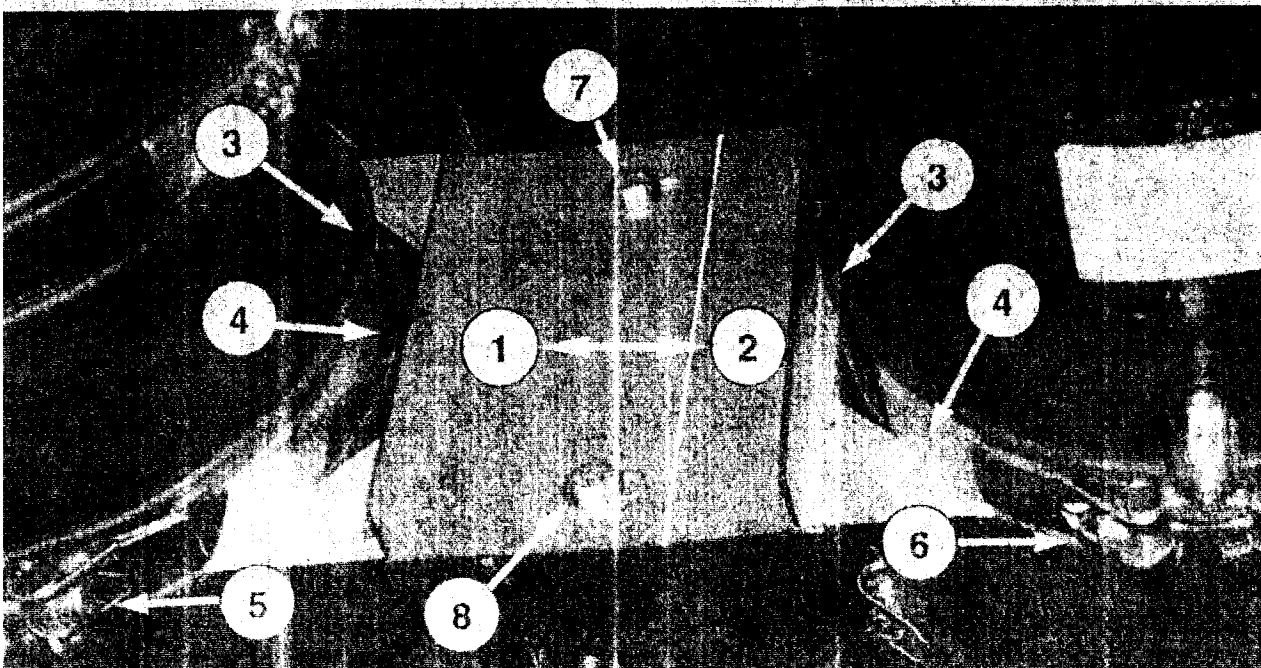
Figure 11: Air tank interlocking assembly installation

- 1) Assemble the interlocking assembly halves and the accompanying fasteners for a loose fit.
- 2) Install the interlocking assembly between both air tanks (1 and 2, Figure 11).
- 3) Using two tank mounting bands and rubber moldings (3 and 4 Figure 11), secure each one of the interlocking assembly halves to tank #1 and tank #2 respectively. Secure the bands hand tight with the Allen bolts (5 and 6, Figure 11). Figure 12 shows one half of the assembly.
- 4) Tighten interlocking assembly bolts (7 and 8, Figure 11) to a torque of 15 ft.lbf (20 Nm).

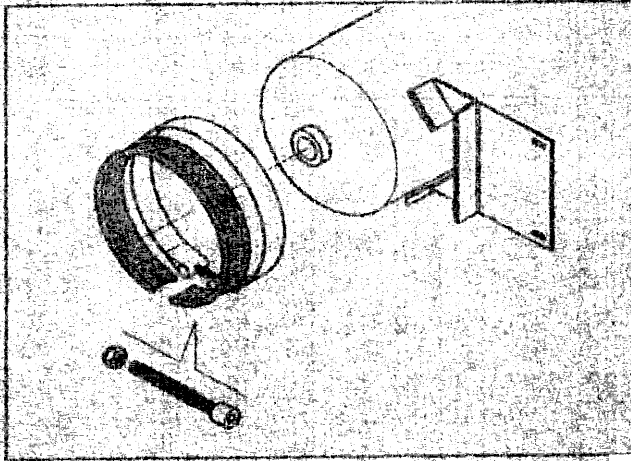
Figure 12: Tank interlocking assembly (one half shown)

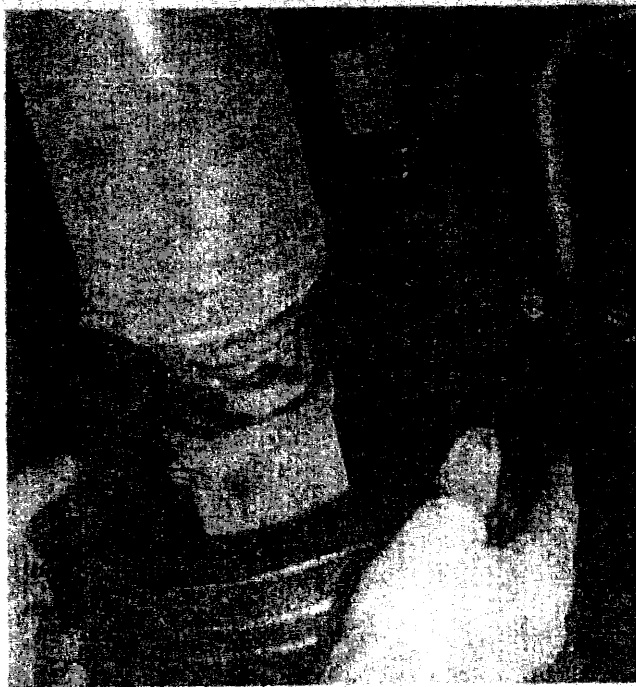
Figure 13: Dry-build showing the installation of the tag axle tank support assembly, the upper cross member, the propeller shaft and the propeller shaft safety guard

- 1) Assemble the tag axle tank support assembly and the upper cross member without the propeller shaft for a loose fit.
- 2) Using a tank mounting band and a rubber molding, attach the support assembly to the tank, half way between the mounting bands already installed. Do not tighten the Allen bolt yet.

- 3) Move the tank mounting band fore/aft until the bolt holes of the cross member line up with those in the chassis mounting brackets.
Install the crossmember to chassis bolts.
- 4) Secure the tank mounting band hand tight with the Allen bolt.
Tighten the tank mounting bracket to the tank support assembly bolts.
Tightening torque of the bolts: 15 ft.lbf (20 Nm).
- 5) Secure the upper cross member to the chassis.
Tightening torque of the bolts: 30 ft.lbf (42 Nm).

- 1) Reinstall the propeller shaft. Tightening torque for the transmission to propeller shaft mounting bolts: 150 ft.lbf (200 Nm).
- 2) Reinstall the propeller shaft safety guards.
Connect the rear most safety guard to the upper cross member and the tag axle air tank support assembly using longer bolts VH 660229912.
Tightening torque of the bolts: 30 ft.lbf (42 Nm).
