# SERVICE BULLETIN No.1153

<b>COACH MODEL</b>	: T2145 and C2045
<b>BULLETIN TYPE</b>	: Safety Recall Program -- NHTSA campaign number 04V-424
<b>MANUAL &amp; SECTION</b>	: Maintenance Manual: Chapter 7 - Steering Spare Parts Manual: Section 651209 Steering -- hydraulic system
<b>PARTS BOOK REVISION</b>	: No
<b>DATE</b>	: December 3, 2004
<b>SUBJECT</b>	: <b>Power steering line - inspection</b>
<b>TERMS &amp; CONDITIONS</b>	: Refer to the Warranty Information in this Bulletin.

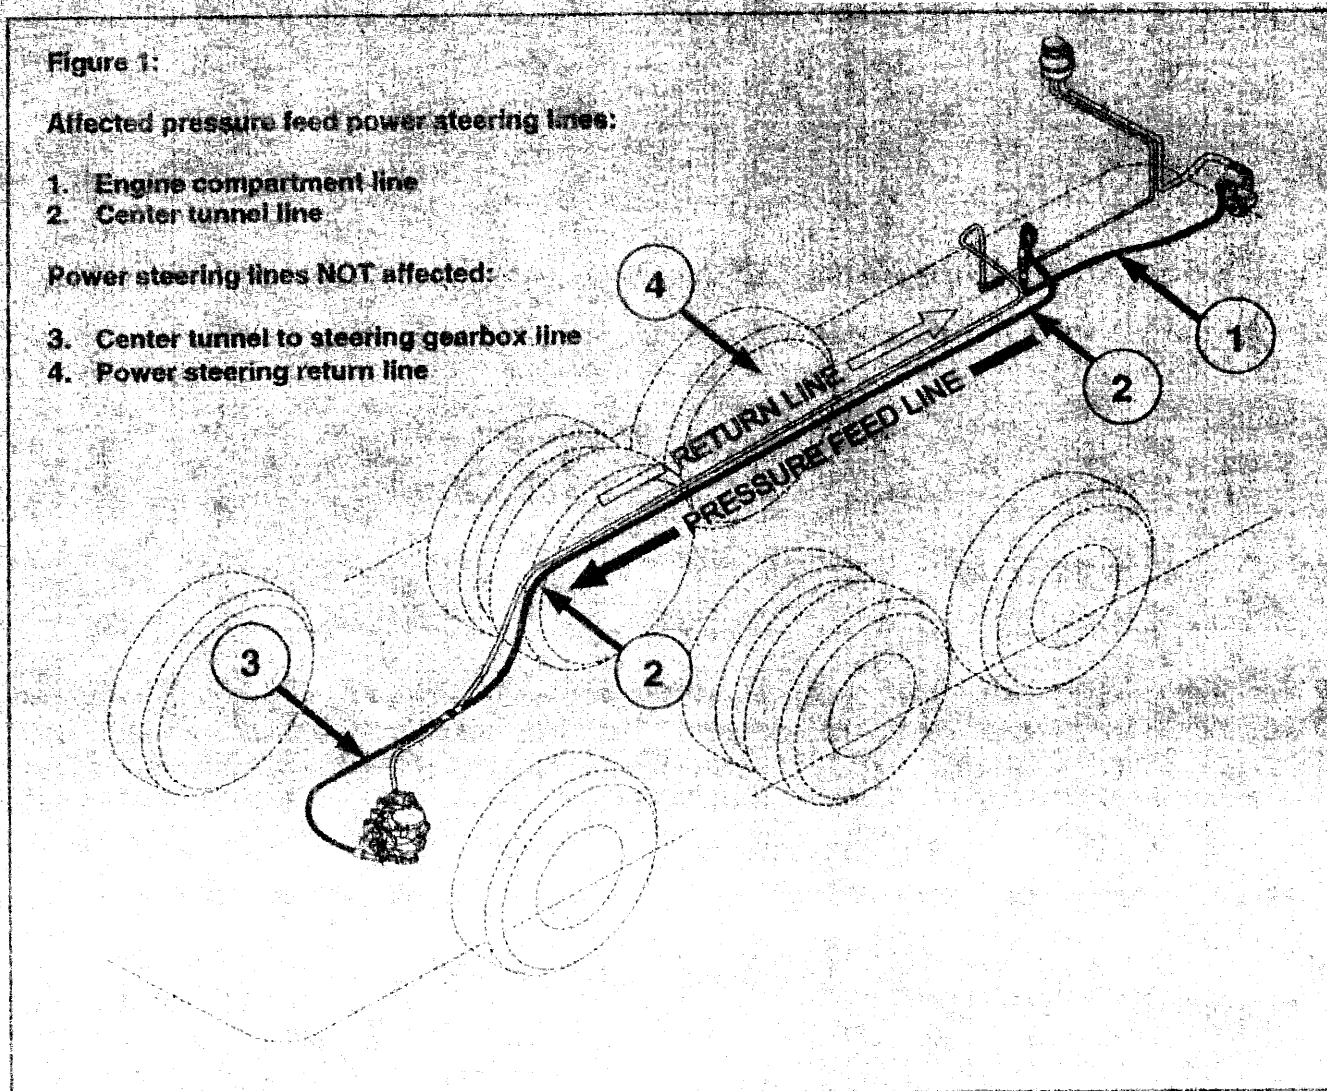
Engine compartment and center tunnel lines listed only. The center tunnel to steering gearbox line assembly VH 10594097 is not affected (see Figure 1).

Model	Engine	Part No.	Description	Location	L (ft)	Qty.
T2145	Cummins	VH 10726443	Hose assembly, pressure feed	1, Figure 1	8.79	1
		VH 10726440	Hose assembly, pressure feed	2, Figure 1	30.93	1
	Detroit Diesel	VH 10726443	Hose assembly, pressure feed	1, Figure 1	8.79	1
		VH 10726440	Hose assembly, pressure feed	2, Figure 1	30.93	1
C2045	Cummins	VH 10864465	Hose assembly, pressure feed	1, Figure 1	5.87	1
		VH 10726442	Hose assembly, pressure feed	2, Figure 1	35.85	1
	Detroit Diesel	VH 10726446	Hose assembly, pressure feed	1, Figure 1	6.33	1
		VH 10726442	Hose assembly, pressure feed	2, Figure 1	35.85	1

**NOTE:** Plastic caps VH 637101760, which come with the new hoses, need to be recovered for further use during installation of the new center tunnel line.

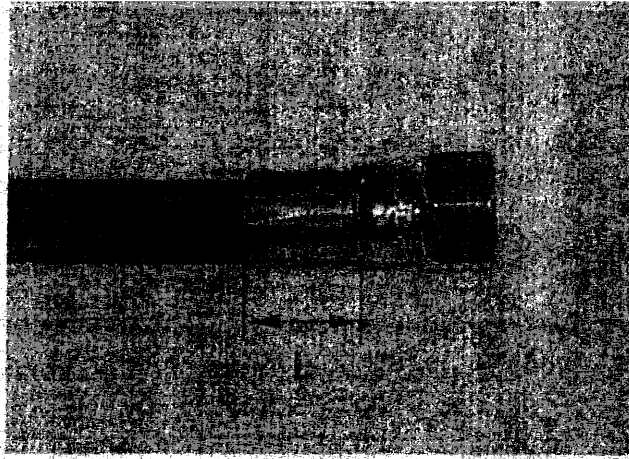
1. the crimp length of the affected hose fittings, which should be at least 0.944 inch (24 mm) as indicated in Figure 2.
2. the crimp diameter of the affected hose fittings, which should be 0.893 inch (22.7 mm) maximum as indicated in Figure 3.

**Figure 2: Fitting crimp length L should be at least 0.944 inch**

1. a fitting with a crimp length *less* than the above-mentioned value (see Figure 4) should be put out of service.
2. a fitting with a crimp diameter *higher* than the above-mentioned value should be put out of service.

- 3) Measure the crimp length and crimp diameter of each fitting referring to Figures 1 and 2.
- 4) If a line fitting is out of spec, replace the affected hose section referring to subsection 5 "To replace the power steering pressure feed lines in the engine compartment and/or center tunnel"
- 5) If all fittings checked are within spec, fill out the OWNER'S CERTIFICATION LETTER, which has been attached to this Bulletin, and mail it back to ABC Customer Care & Parts Source.

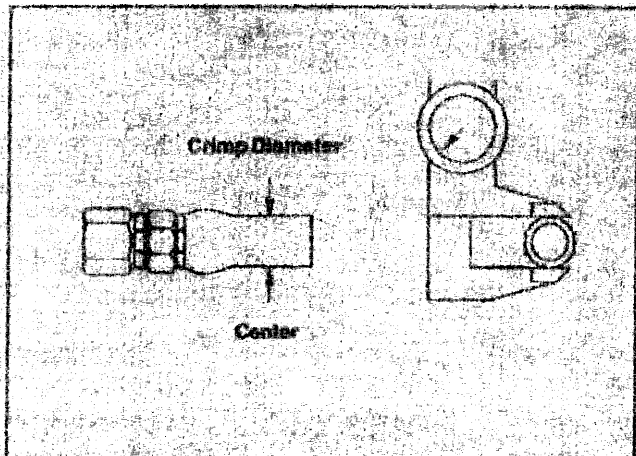
**Figure 3: Fitting crimp diameter should be 0.893 inch at most. The crimp diameter is measured in the center of the crimping area**

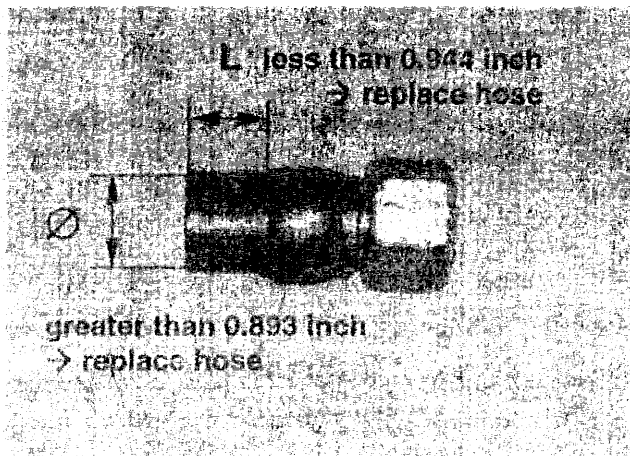
**Figure 4: Hoses with fittings having a crimp length less than 0.944 inch and/or a crimp diameter greater than 0.893 inch should no longer be used**

A new hose with properly installed fittings should replace the hose put out of service.

*NOTE: If the center tunnel hose has improperly crimped fittings, it can remain installed, but should be capped and labeled, so as to prevent future use.*

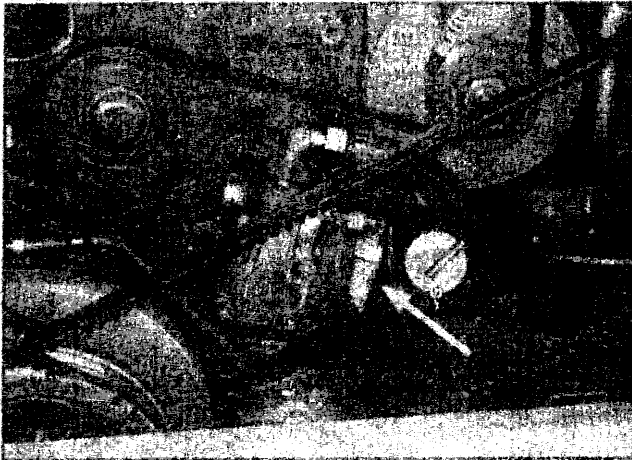
Figure 5: Behind rear engine compartment door - C2045 and T2145 w/ Detroit Diesel engine - pressure feed line at hydraulic pump. Check one crimp fitting.

2) Referring to Figures 5 through 10, locate the crimp fittings.

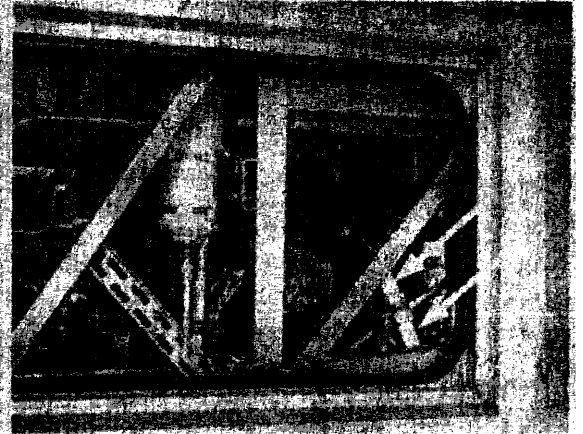
Figure 8: C2045 - Behind the RH engine compartment side door - engine compartment to central tunnel line connection. Check two crimp fittings.

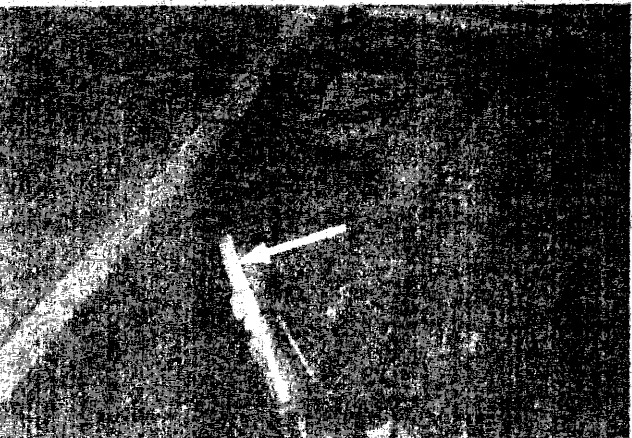
Figure 9: Below the aisle front trap door - T2145 - central tunnel line to steering gearbox line connection. Check one crimp fitting.

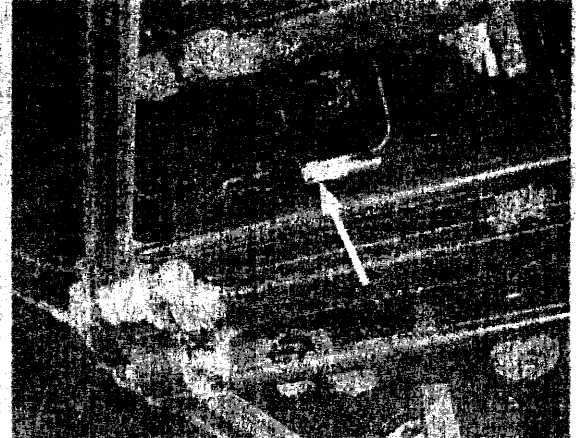
Figure 10: Beneath the coach at the front - C2045 - central tunnel line to steering gearbox line connection. Check one crimp fitting.

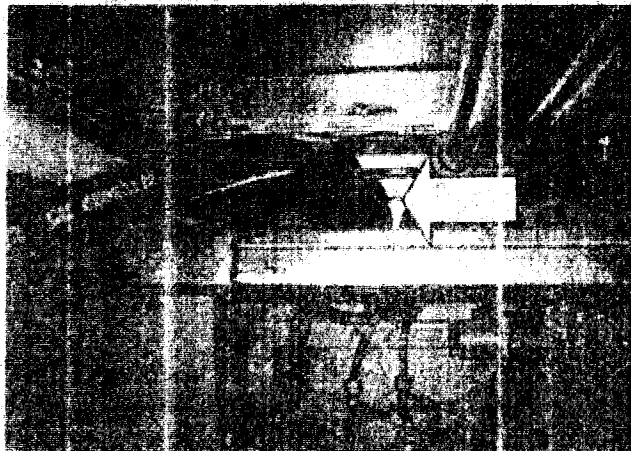
Figure 12: Spare line duct at the rear of the coach with new central tunnel line installed

- 1) After disconnecting the old central tunnel line from the engine compartment line at the rear, and the chassis to steering gearbox line at the front, blow it through with compressed air (30 psi maximum) while an assistant catches the fluid inside the line in a suitable container. Cap the line (using the plastic caps 7H 637101760, which come with the new hoses) to avoid fluid spillage. Leave the line in place. Do add a label at both ends indicating that this line should not be re-used.
- 2) Run the new hose through the spare line duct above the fuel tank at the front (see Figure 11).
- 3) Next run the new hose along the old central tunnel line in the luggage compartment.
- 4) Finally, run the new hose to the engine compartment via the spare line duct above the drive and tag axes (see Figure 12).
