# VEHICLE RECALL

## SC289

**Subject:** Steering Gear Mounting Bolt Quality — CX and CH Model Chassis

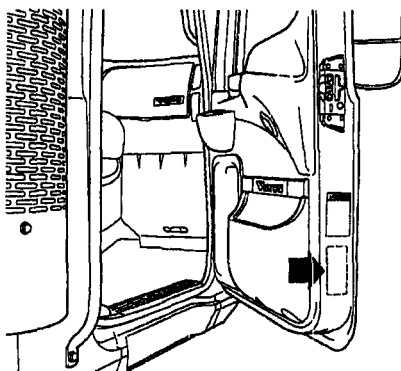
Figure 1 — Campaign Label Location

Before proceeding, check campaign status in the MACKnet system to see if the campaign has already been completed. Campaign status can also be checked by looking at the Campaign Completion Label located on the lower edge of the passenger-side door. If the campaign has been completed, the campaign number (SC289) and the completion date should be written on the label.

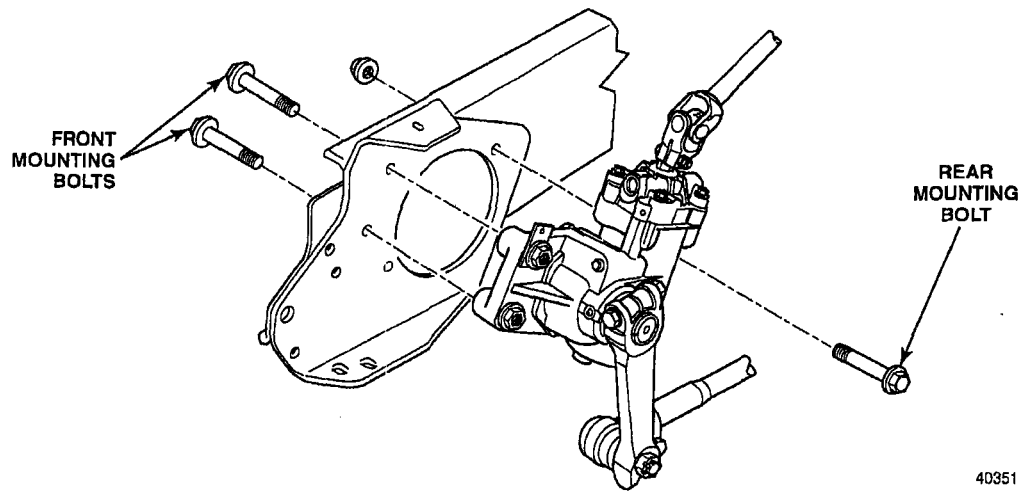
Figure 2 — Steering Gear Mounting Arrangement — CX and CH Models

On CX and CH models, the two front steering gear mounting bolts are installed from inside of the frame rail. On CX models, clearance between the frame rail and the charge air cooler is not sufficient to allow removal of the two front bolts, making it necessary to move the steering gear away from the frame rail to cut the mounting bolts as close to the frame as possible. On CH models, however, replacing the steering gear mounting bolts is simply a matter of removing each bolt, one at a time, and replacing with new bolts, nuts and hardened flat washers. On both CX and CH models, the replacement bolts are to be installed from the outside of the steering gear. The procedures outlined below that cover moving the steering gear away from the frame rail and cutting the mounting bolts, apply to CX model chassis only.

1. Secure the chassis for service, apply the parking brakes and block the wheels to prevent the vehicle from moving.
2. If equipped with a steel bumper and the left-side bumper mounting bracket interferes with removal of any of the steering gear mounting bolts, remove the bumper and the left-side mounting bracket
3. Attach a hoist to the steering gear to provide support once the mounting bolts are removed.

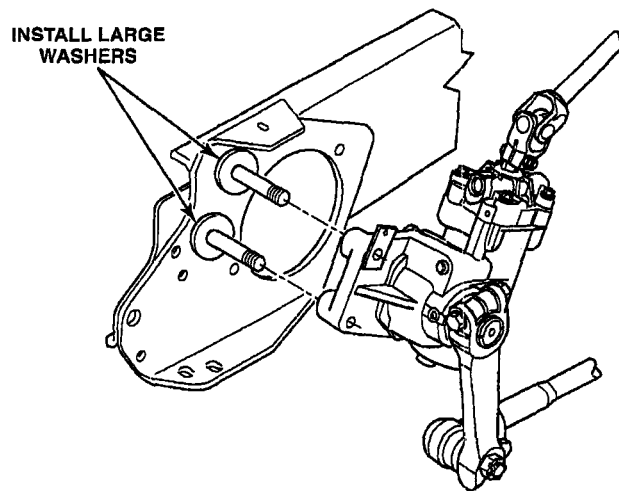
**Figure 3 — Preparing to Cut Mounting Bolts — CX Models**

4. Remove the nuts from the three steering gear mounting bolts, and then remove the rear mounting bolt from the steering gear.
5. With the hoses and linkages (input shaft and drag link) still attached, pull the steering gear away from the frame rail far enough to clear the two mounting bolts remaining in the frame.
6. Install a large washer (having an inside diameter of at least  $51/64$ "") over each of the two bolts. These washers will help protect the frame rail from damage as the bolts are being cut with the torch.

7. Using a torch, very carefully cut the two mounting bolts flush with the washers.
8. Remove the two bolt heads from the frame rail.

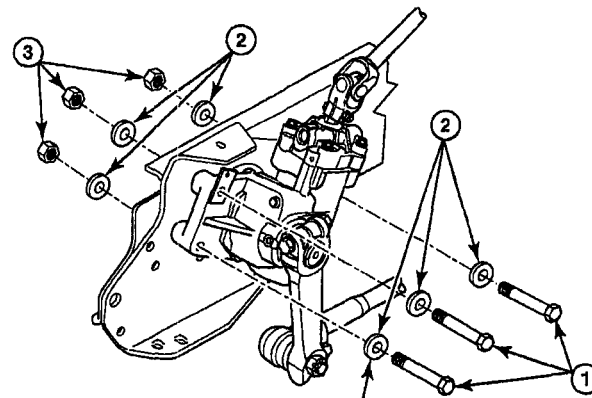
**Figure 4 — Install Steering Gear Mounting Bolts — CX and CH Models**

9. Move the steering gear back into position against the frame rail, and then install new mounting bolts, washers and nuts (refer to the table below for part numbers). The bolts are to be installed from the outside of the frame rail as shown in the following illustration. Install hardened flat washers under the head of each bolt and under each nut.

On CX models regardless of steering gear model, use

- One washer if equipped with 8 mm frame rails
  - Two washers if equipped with 6 mm frame rails
- under the head of the forward most bolt (as shown in the following illustration).

**CX MODELS:**  
USE ONE WASHER AT THIS LOCATION WITH  
8 MM FRAME RAILS, TWO WASHERS  
WITH 6 MM FRAME RAILS

10. Tighten the steering gear mounting bolts to 375 lb-ft (508 N·m). Torque must be applied to the heads of the mounting bolts, not the nuts. Torque the bolts dry; DO NOT apply oil to the threads.
11. If removal of the front bumper and the left-side bumper mounting bracket was necessary, reinstall the bracket and bumper assembly.
12. Remove the hoist.
13. Remove the blocks at the wheels and return the chassis to service.

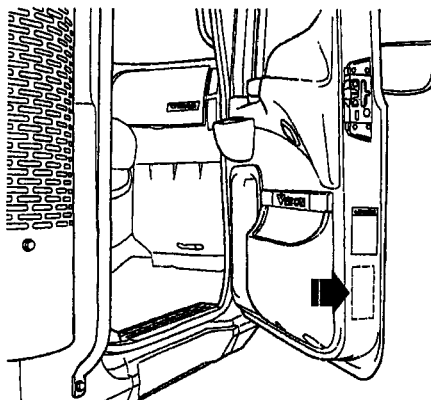
**Figure 5 — Campaign Label Location**

To signify that the campaign has been completed, use a permanent-type marker (such as a Sharpie®) to write the campaign number (SC289) and completion date in the spaces provided on the Campaign Completion label located on the lower edge (below the door latch) of the passenger-side door. If a label is not already affixed to the door, apply a label (part No. TS897) and supply the information as required. Campaign Completion labels are available in packs of 50 and can be ordered by faxing a completed BR313 to Pacesetters Business Services at 610-264-9465.
