# BMW Motorrad

### Service Information Bulletin

**Subject:** Recall 04V-576 Rear brake line adapter.

**Models:** R 1200 GS models in the VIN range noted below.

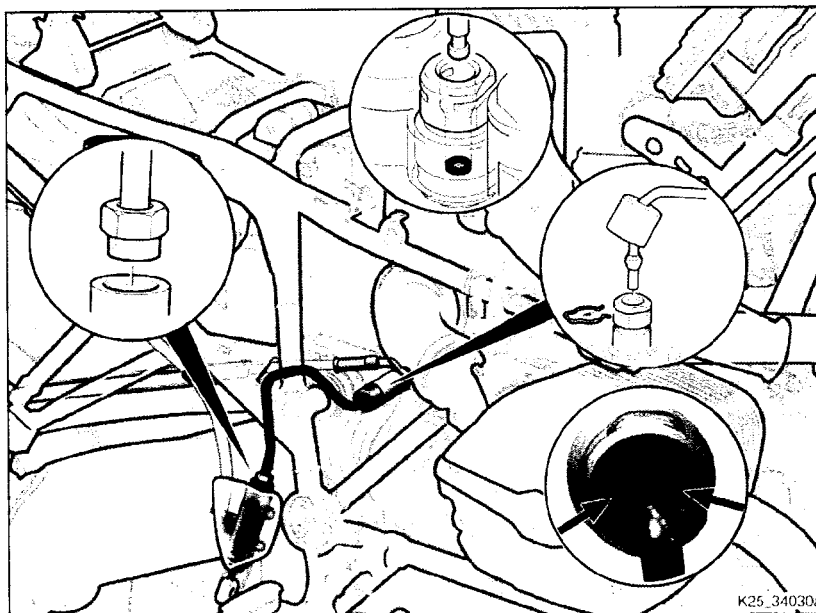
Photo 2

2) If the **GREEN SPOT** is not present check the rear brake pipe as illustrated in **photo 2**. Slide the rubber boot back. The rear brake pipe is securely connected if the spring clip is seated against the brake pipe on both sides. This connection is confirmed by a visual inspection. **In this inspection both sides of the spring clip must be visible.** Please refer to the example in the lower right hand corner of **photo 2**, in **photo 3** and **photo 4** below.

If the spring clip is seated against the brake pipe on one side only, or is not seated against the brake pipe on either side, the entire adapter (P/N 34 32 7 673 768) must be replaced.

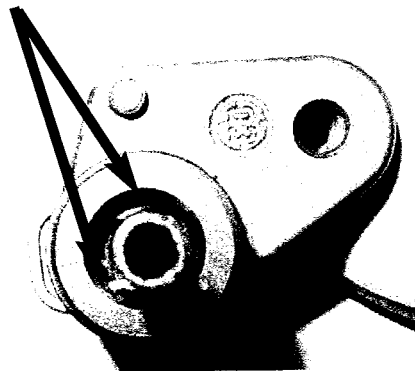
Photo 3 Engagement OK

The spring clip is clearly visible on both sides of the brake pipe.

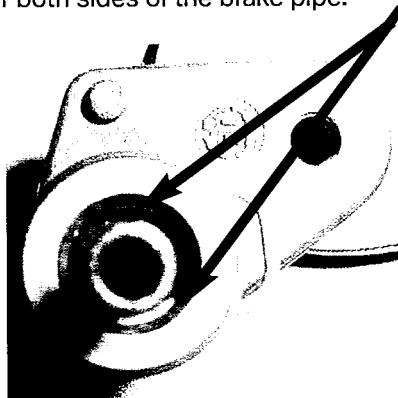
Photo 4 Engagement not OK

The spring clip is not 100% on one or both sides of the brake pipe.
