OWNER'S RENOTIFICATION LETTER

Re.: NHTSA Safety Recall Program-Campaign number **04V - 424**
Van Hool coaches types T2145 - C2045 : **Power Steering Lines.**
Vin # (45992)

SERVICE BULLETIN No.1153

COACH MODEL	: T2145 and C2045
BULLETIN TYPE	: Safety Recall Program – NHTSA campaign number 04V-424
MANUAL & SECTION	: Maintenance Manual: Chapter 7 - Steering Spare Parts Manual: Section 651209 Steering – hydraulic system
PARTS BOOK REVISION	: No
DATE	: December 3, 2004
SUBJECT	: Power steering line - inspection
TERMS & CONDITIONS	: Refer to the Warranty Information in this Bulletin.

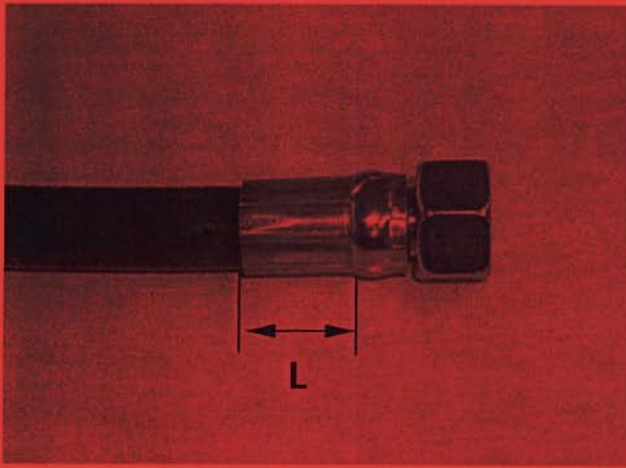
1. the crimp length of the affected hose fittings, which should be at least 0.944 inch (24 mm) as indicated in Figure 2.
2. the crimp diameter of the affected hose fittings, which should be 0.893 inch (22.7 mm) maximum as indicated in Figure 3.

Figure 2: Fitting crimp length L should be at least 0.944 inch

1. a fitting with a crimp length *less* than the above-mentioned value (see Figure 4) should be put out of service.
2. a fitting with a crimp diameter *higher* than the above-mentioned value should be put out of service.

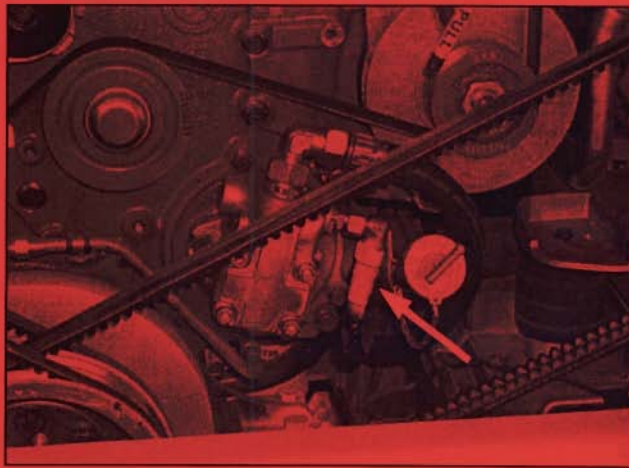
Figure 5: Behind rear engine compartment door - C2045 and T2145 w/ Detroit Diesel engine - pressure feed line at hydraulic pump. Check one crimp fitting.

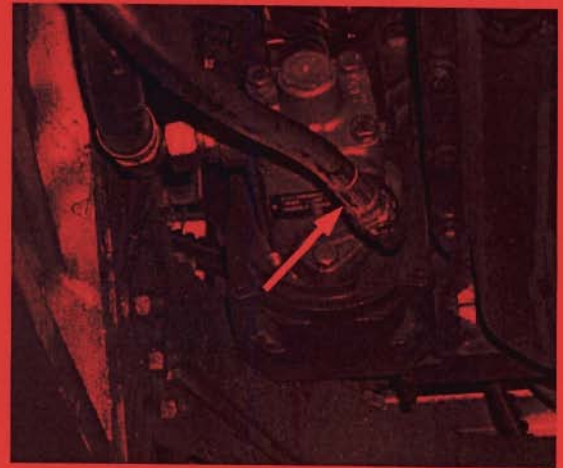
Figure 6: Beneath the coach at the rear - C2045 and T2145 w/ Cummins engine - pressure feed line at hydraulic pump. Check one crimp fitting.

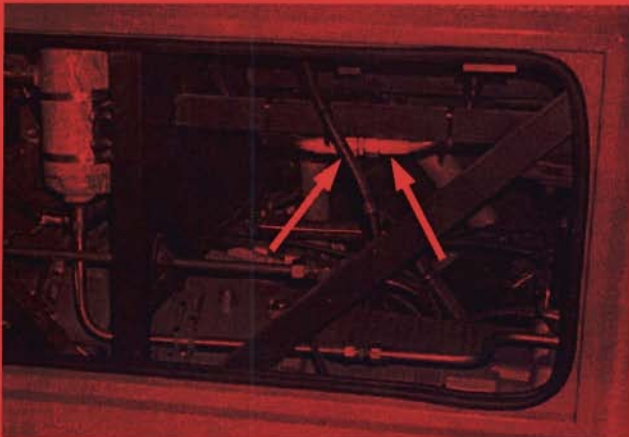
Figure 7: T2145 - Behind the RH engine compartment side door - engine compartment to central tunnel line connection. Check two crimp fittings.

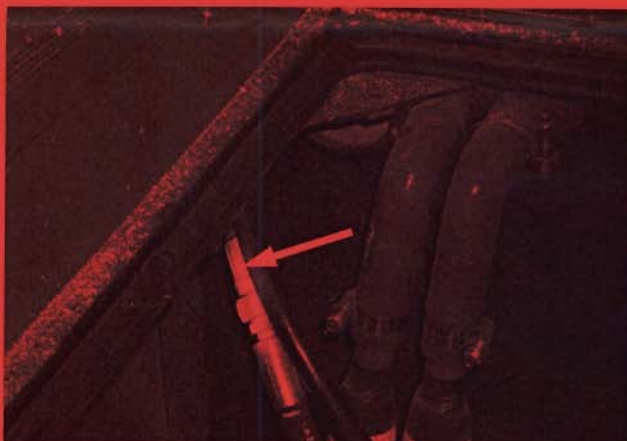
Figure 9: Below the aisle front trap door - T2145 - central tunnel line to steering gearbox line connection. Check one crimp fitting.

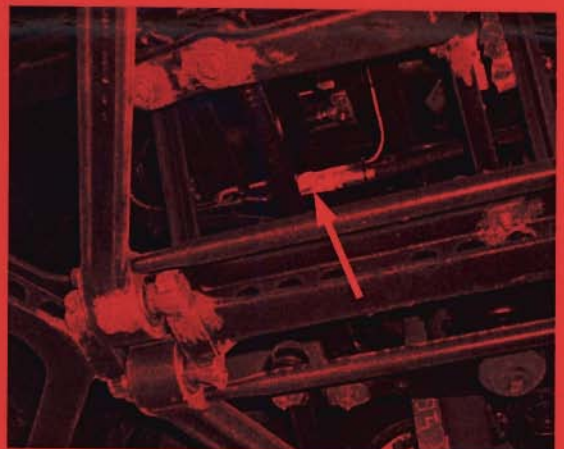
Figure 10: Beneath the coach at the front - C2045 - central tunnel line to steering gearbox line connection. Check one crimp fitting.

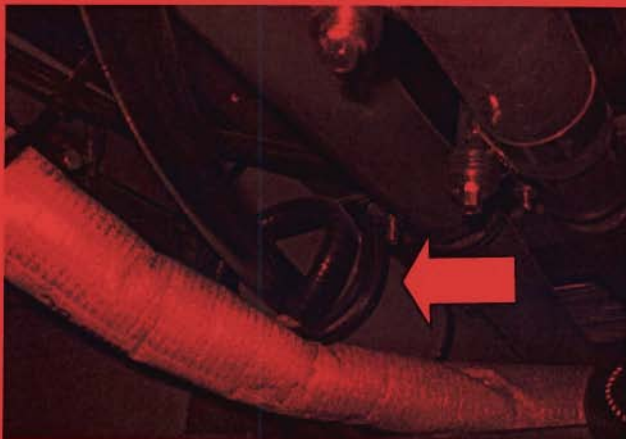
Figure 11: Spare line duct at the front of the coach with new central tunnel line installed

- 1) After disconnecting the old central tunnel line from the engine compartment line at the rear, and the chassis to steering gearbox line at the front, blow it through with compressed air (30 psi maximum) while an assistant catches the fluid inside the line in a suitable container. Cap the line (using the plastic caps VH 637101760, which come with the new hoses) to avoid fluid spillage. Leave the line in place. Do add a label at both ends indicating that this line should not be re-used.
- 2) Run the new hose through the spare line duct above the fuel tank at the front (see Figure 11).
- 3) Next run the new hose along the old central tunnel line in the luggage compartment.
- 4) Finally, run the new hose to the engine compartment via the spare line duct above the drive and tag axles (see Figure 12).

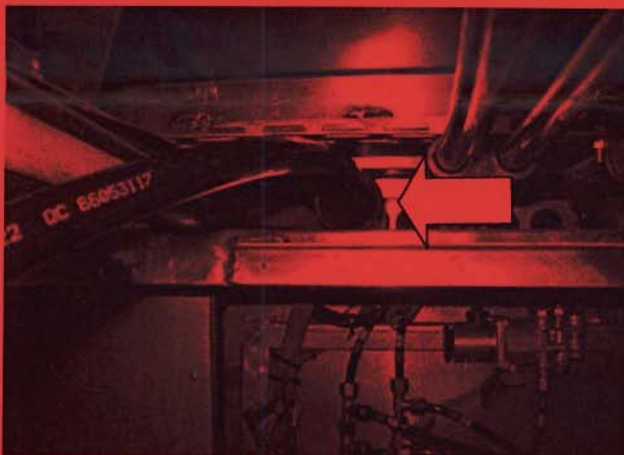
Figure 12: Spare line duct at the rear of the coach with new central tunnel line installed
