PART 573 Defect and Noncompliance Report

Report Date: February 8, 2005

Make:	Vermeer	Model Years Involved:	2002 - 2005	
Model(s):	BC1400			
Production Dates:	Beginning:	01-28-2002	Ending:	12-06-2004
VIN Range:	Beginning:	1VRU1614821000134	Ending:	1VRU1614151001775
Vehicle Type:	Trailer -- Single axle Brush Chipper

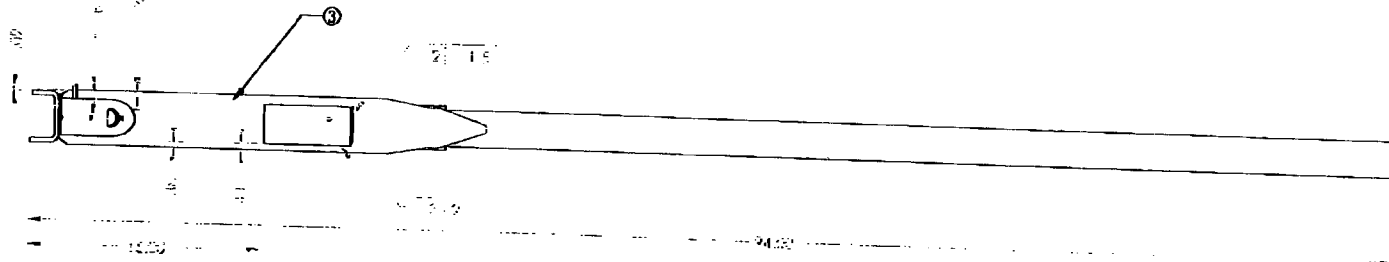
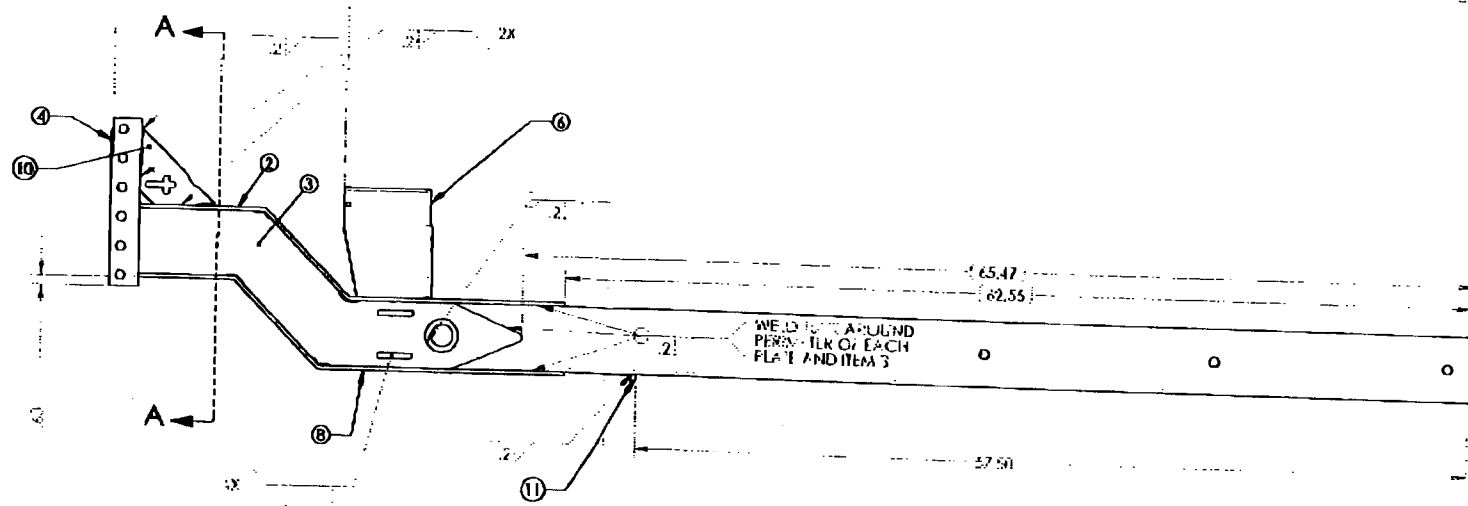
WELDMENT - TONGUE
SECTION CURSIVE NEED
PART NAME 162615001
REVISED 2/21/02

Fatigue cracks can occur in a heat affected zone of the tongue weldment. Recent Finite Element Analysis (FEA) was undertaken after notification of the failure. The analysis indicates that material stresses at the point of failure can result in fatigue fractures (cracks) which can eventually result in complete separation of the tongue.

A copy of a product brochure for Vermeer Model BC1400 is attached. The brochure does not show the curbside feed tongue option, but is shown in the attached Drawing Item Number 162615001, Weldment – Tongue BC1400 Curbside Feed. Also attached are digital photographs of BC1400, VIN 1VRU1614721000366, reference in the chronology below.

Field kit modifications are currently under development. The new tongue design is a bolt-on riser design, which according to the final FE analysis, shows all indications of providing a service life for the riser and its interface with the tongue tube that is equivalent to that of the uninterrupted main forward tube. Confidence in the tube life is based on the test data and presently successful field exposure experienced by the straight tongue model of the BC1400.

WELD TO AROUND PERIMETER OF EACH FLAT AND ITEM 3
