RE: 2005 Mitsubishi Lancer Evolution Turbo Charger Coolant Hose

SUBJECT:		COOLANT HOSE REPLACEMENT — SAFETY RECALL CAMPAIGN		No: SR-05-004
				DATE: August, 2005
				MODEL: 2005 Lancer Evolution
CIRCULATE TO:	<input type="checkbox"/> GENERAL MANAGER	<input checked="" type="checkbox"/> PARTS MANAGER	<input checked="" type="checkbox"/> TECHNICIAN	
<input checked="" type="checkbox"/> SERVICE ADVISOR	<input checked="" type="checkbox"/> SERVICE MANAGER	<input checked="" type="checkbox"/> WARRANTY PROCESSOR	<input type="checkbox"/> SALES MANAGER

2005 Lancer Evolution Water Feed Hose

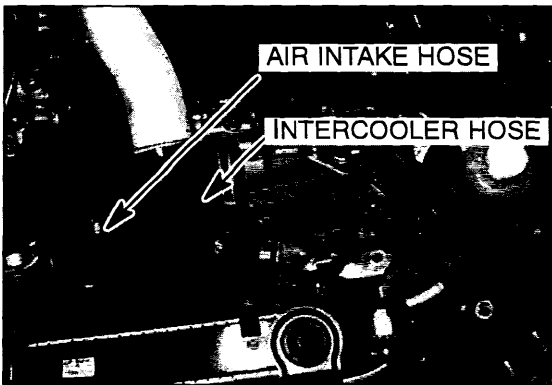
1. Place a metal or plastic receptacle under the vehicle, directly under the water hose area, to collect any spilled coolant.
2. Carefully remove the radiator cap to release system pressure. Then reinstall the cap.
3. Remove the air intake duct and the air cleaner assembly.
4. Remove the air flow sensor connector and its clamp.

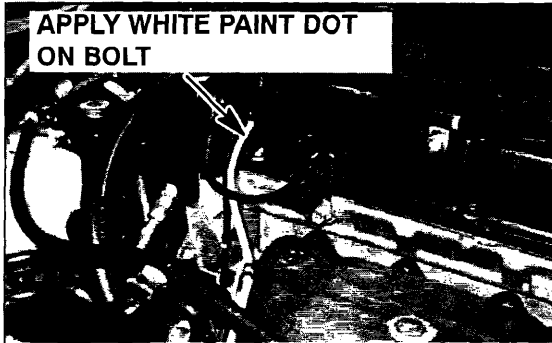
12. Apply a small white paint dot to the rocker cover bolt as shown.
13. Confirm that all hoses, clamps, clips, connections, and bolts are secure.
14. Confirm there are no coolant leaks.
15. Confirm the coolant level is correct.
16. Start the engine and confirm there is no abnormal noise.
