DEFECT INVESTIGATION

SUBJECT: Campaign #96 –Refrigerator Roof Vent Relocation

Instructions to Perform Campaign 96 Refrigerator Roof Vent Relocation

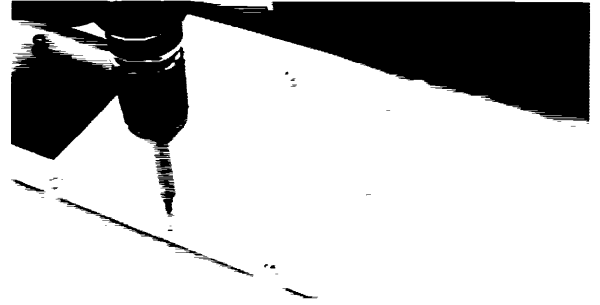
11. Position the cover plate so that the open area is above the refrigerator flue tube, then fasten the "solid" part of the plate to the roof with 5 pan head screws #8 x 3/4" (photo 8). The larger 1/2-inch holes in the cover plate should line up with the existing screw holes in the fiberglass from the original installation.

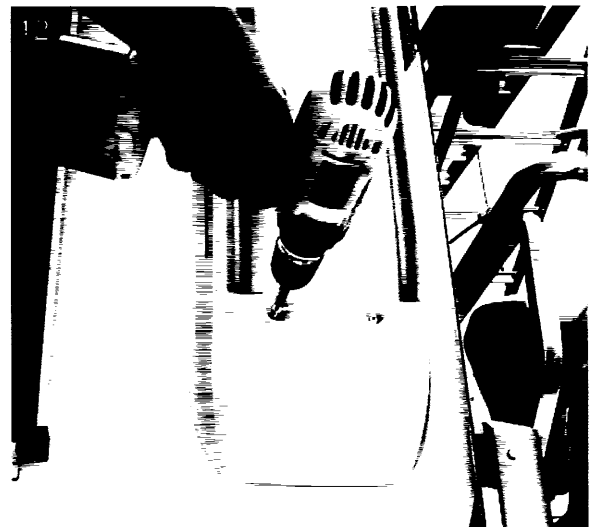
14. Install roof vent cover. (photo12)
