05V-475  
(9 pages)

**SUBJECT: Campaign #97 – Fuel Tank Strap Fastener**

## Instructions to Perform Campaign 97 Fuel Tank Strap Fastener

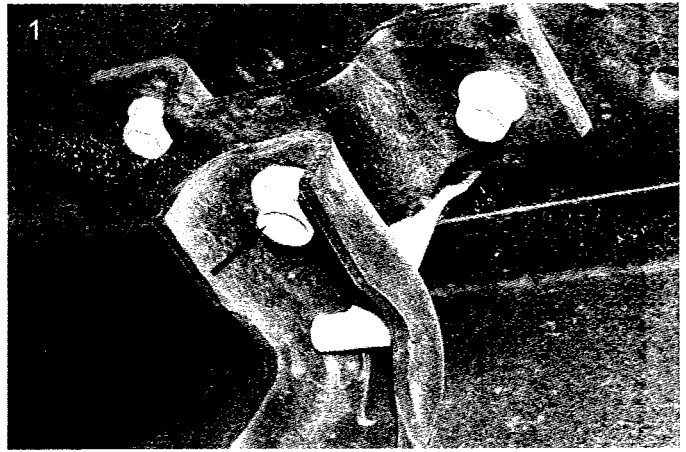
Photo 1  
LH Side Front  
Fuel Tank Strap Mounting Bolts  
Use 15mm deep socket  
Torque 76 ft/lb

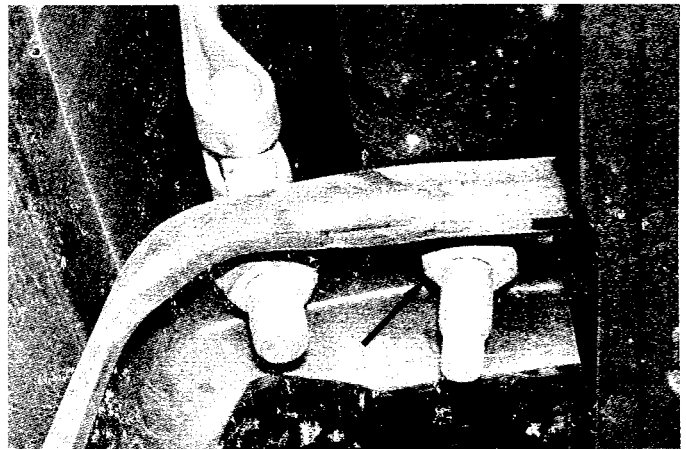
Photo 3  
RH Side  
Fuel Tank Strap Mounting Nuts  
Use 21mm deep socket  
Torque 66 ft/lb
