Service Communication: 2008-003 USA

Subject: Re-issue of recall campaign 05V-506 – replacing male fuel line fitting:

Specific VINs for the 2001 - 2004 Aprilia RST 1000 Futura
Specific VINs for the 2002 - 2003 Aprilia ETV 1000 Caponord

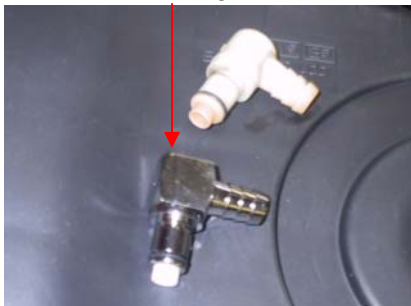
New metal fitting for Futura

Futura: AP8104993 (90 degree male fitting-brass construction)
Caponord: AP8144623 (threaded male fitting-brass construction)

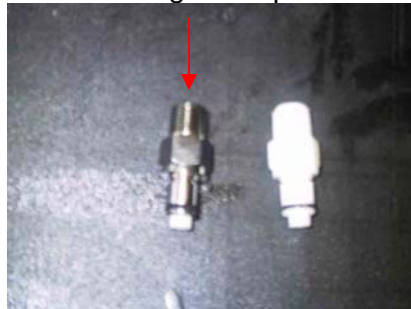
New metal fitting for Caponord
