**Date:** June 20, 2008  
**From:** Aprilia USA  
**To:** All Aprilia Dealers

**Service Communication:** 2008-002 USA

**Subject:** Re-issue of recall 05V-538: 2004 – 2005 RSV 1000 Swing arm replacement

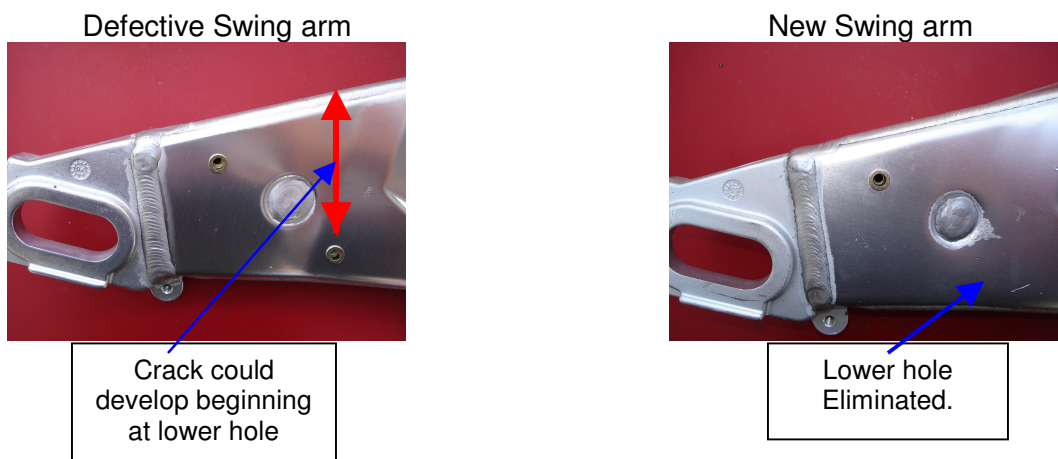
#### Parts Identification:

**Correction:** The replacement swing arm eliminates the nut insert hole used to secure the lower chain guard. A black metal bracket found in the recall kit is now used to secure the lower chain guard to the upper chain guard. In addition, the inside wall thickness was increased from 2.5 mm to 4 mm and to 3 mm for the external wall of the swing arm.

**Part to order:** Order Recall swing arm kit **AP8145030** through the BM ordering system (Kit includes pre-installed bearings & seals, new chain guard bracket and new chain rivet link) This kit is currently available. If this kit becomes unavailable in the future, the normal spare parts swing arm AP8145020 can be used. The necessary seals, bearings, brackets, nut inserts, etc., would have to be ordered separately, as this swing arm comes blank.

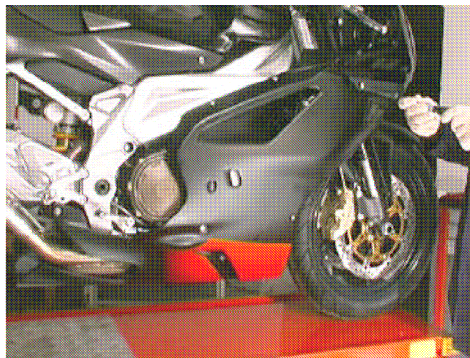
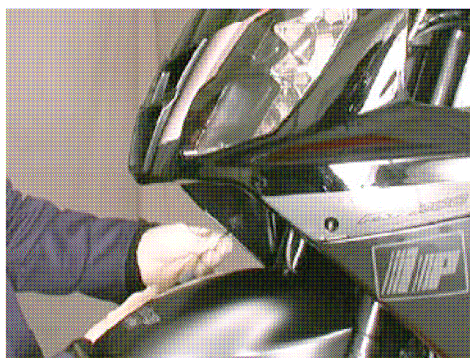
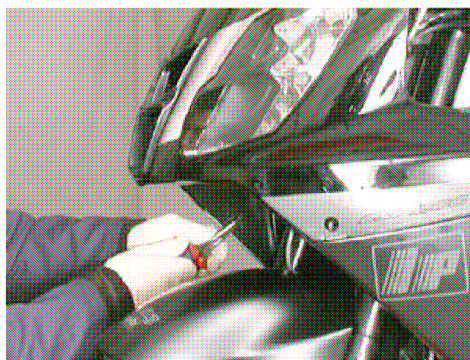
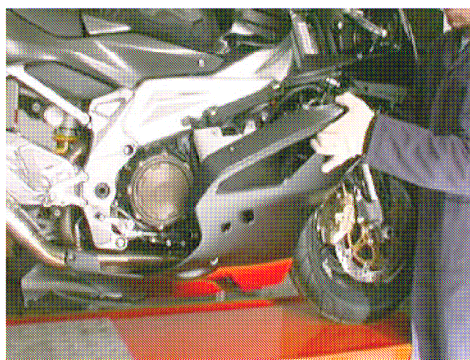
### 1 - REMOVING THE FAIRINGS

- Remove the fairing side retaining screws.
- Release the clips securing the fairing to the headlight fairing, using a screwdriver.
- Remove the clips from their housing using suitable pliers.
- Slide out the fairing from the side, do not damage it.

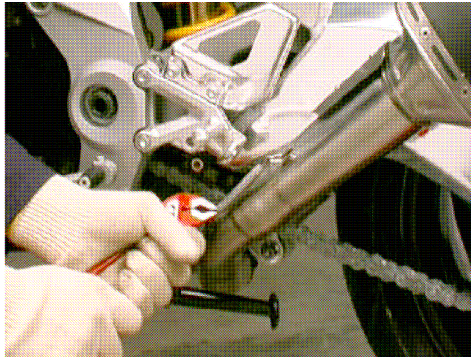
- Release the silencers springs, using a suitable spring puller.

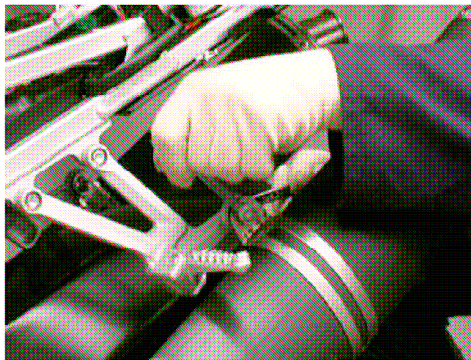
- Loosen the silencer clamp retaining screw.

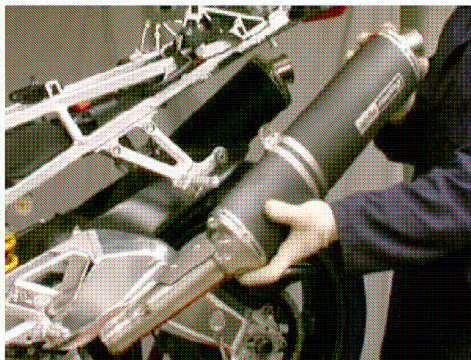
- Remove the silencers.

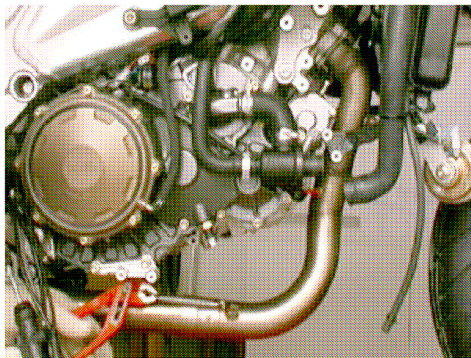
- Release the spring securing the front cylinder manifold to exhaust, using a suitable spring puller.

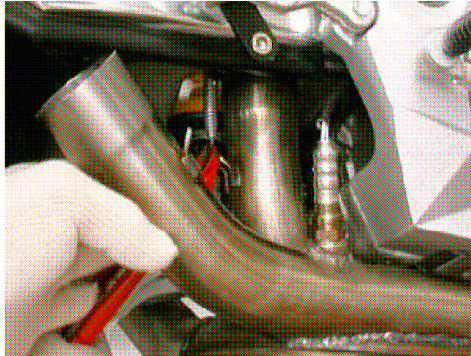
- Release the spring securing the rear manifold to exhaust, using a suitable spring puller.

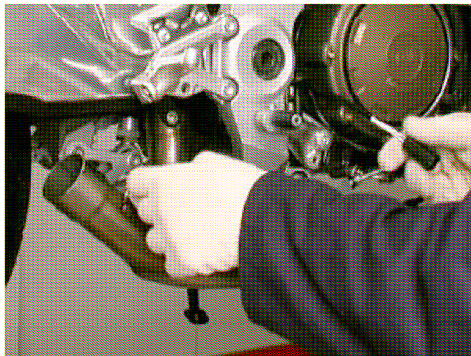
- Slide out the oxygen sensor wiring from the frame.

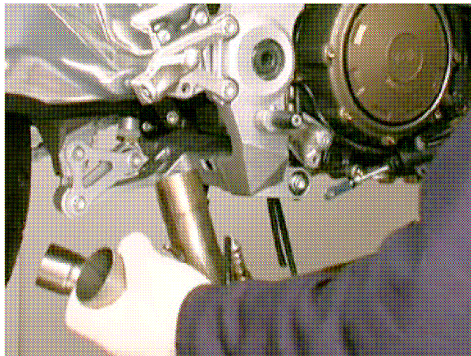
- Remove the exhaust system together with the oxygen sensor.

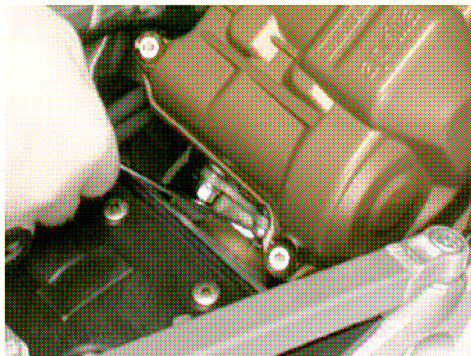
- Loosen the four nuts securing the manifold to the rear cylinder.

NOTE FOR REASSEMBLY  
Lower nuts tightening torque 12 Nm

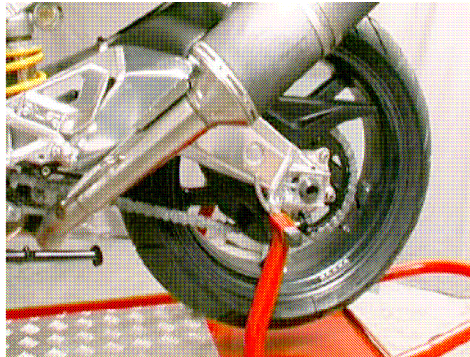
- Position the vehicle on the suitable rear paddock stand.

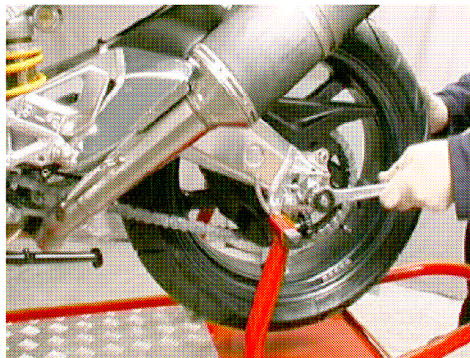
- Loosen and remove the wheel shaft nut.

NOTE FOR REASSEMBLY  
Chain slack: 25 mm  
Tightening torque: 120 Nm

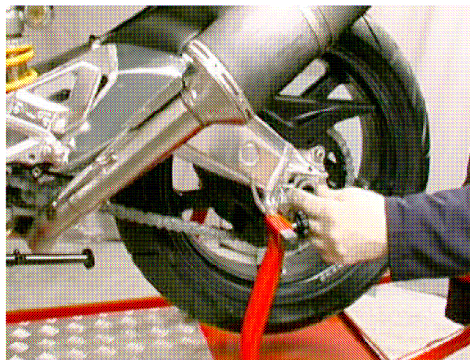
- Collect the washer.

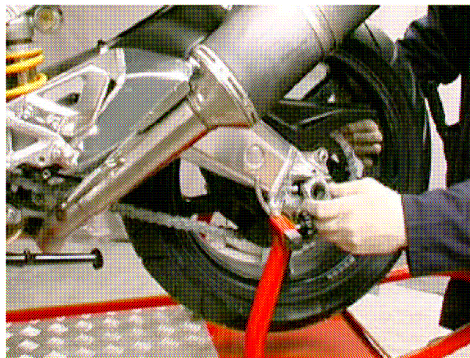
- Collect the left chain slider.

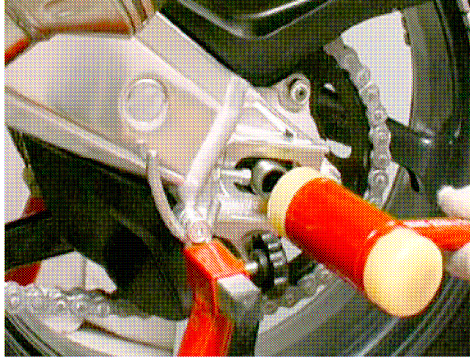
- Lightly tap on the wheel shaft to remove the head from its housing.

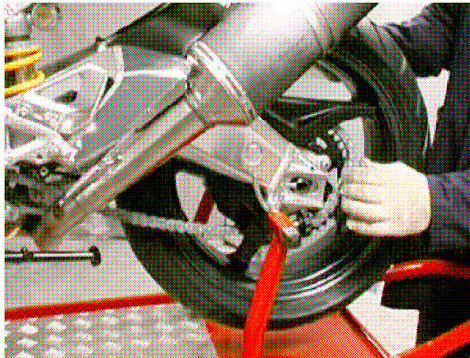
- Move the wheel forward and take the chain off the rear sprocket.

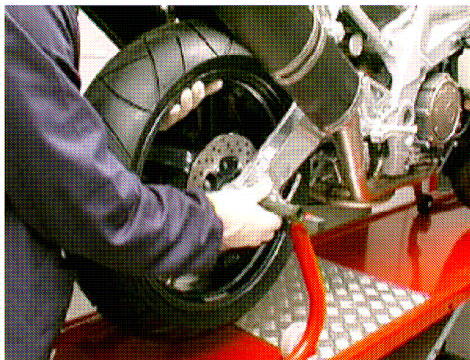
- Slide out the wheel shaft together with the right chain slider.

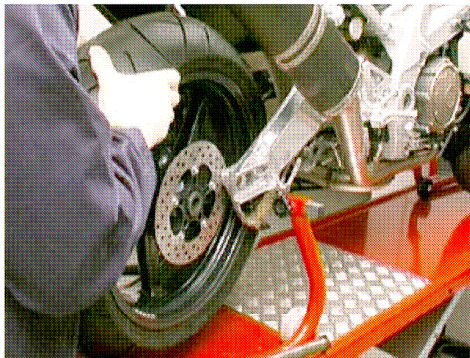
- Remove the complete wheel after moving the brake calliper away from the disc.

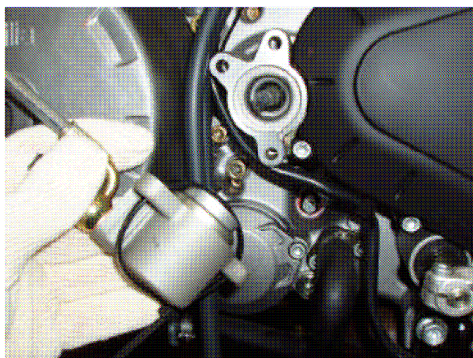
- Remove the clutch slave cylinder.
- Secure with a tie the cylinder piston to its seat to prevent it from popping out.

Do not pull the clutch lever when the clutch slave cylinder is removed or the piston might pop off its seat and cause fluid leakage.

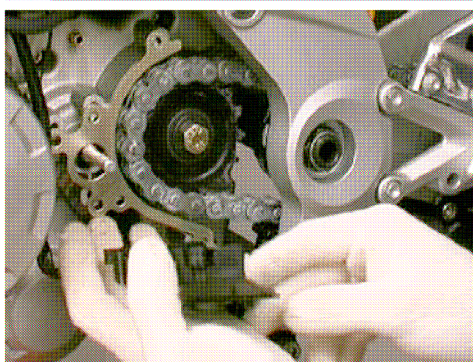
- Remove the sprocket guard and the guide plate from crankcase.

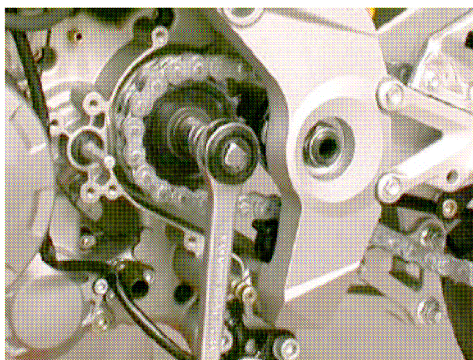
- Loosen the front sprocket bolt and collect the washers.

Smear some LOCTITE 243 on the thread.  
Tightening torque: 50 Nm

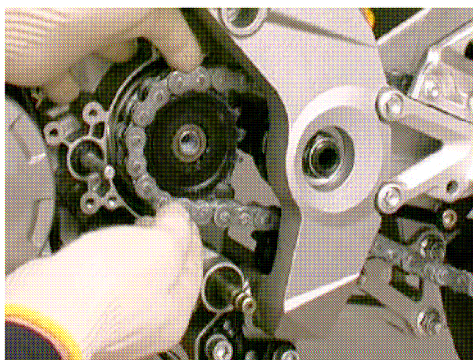
- Remove the front sprocket.

Smear some LOCTITE Anti-Seize on the front sprocket inner teeth.

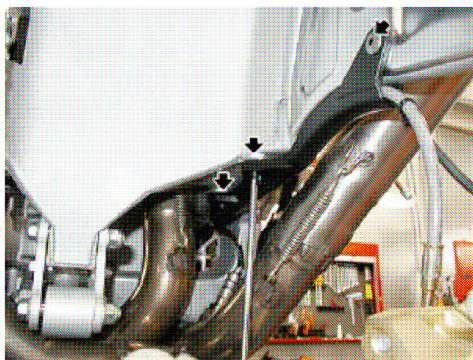
- Remove the exhaust system.
- Loosen and remove the three screws from rear brake line protection and collect the washers.

Tightening torque: 3 Nm

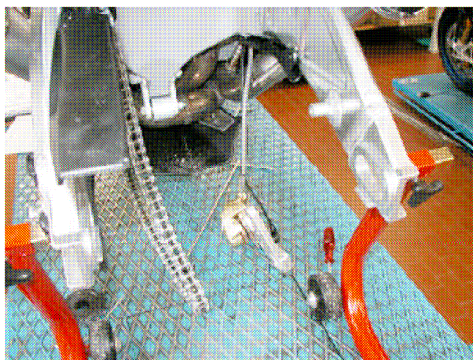
- Take off the support plate from the side and carefully set it on the ground with brake calliper and speed sensor respectively connected to line and cable.

Do not work the rear brake lever when the calliper is removed or the calliper piston might pop off its seat and cause fluid leakage.

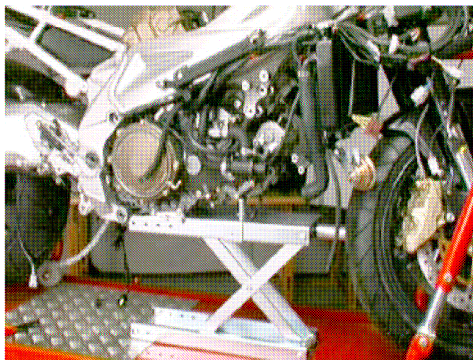
- Support the vehicle using a suitable mobile platform, the centre stand or a hoist.

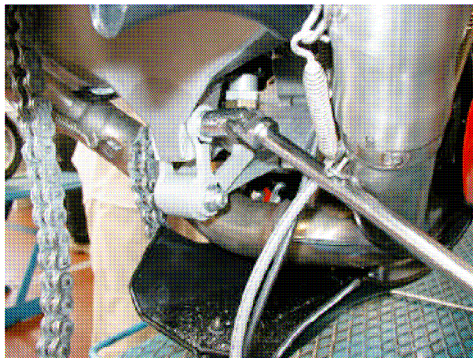
- Working on the right side, loosen and remove the split con-rod/swinging arm nut.
- Remove the screw from the other side.

Tightening torque: 50 Nm

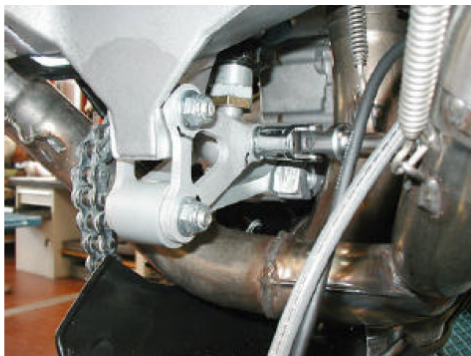
- Working on the right side, loosen and remove the shock absorber lower nut.
- Remove the screw from the other side.

NOTE FOR REASSEMBLY  
Tightening torque: 50 Nm

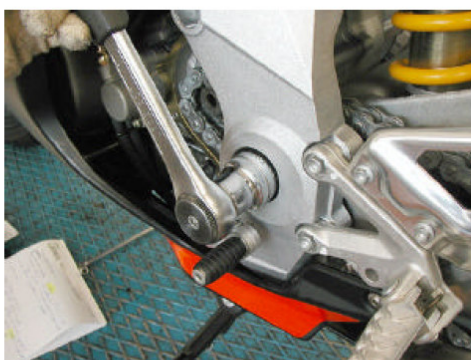
- Loosen and remove the swinging arm shaft nut and collect the washer.

NOTE FOR REASSEMBLY  
Tightening torque: 90 Nm

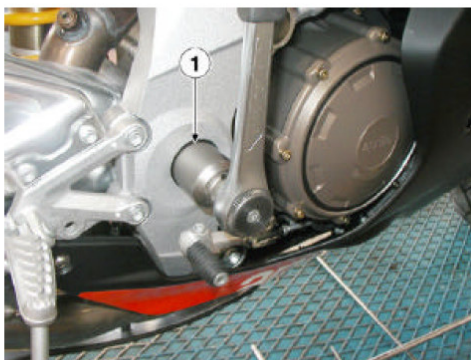
- aprilia part# 8140191 (tool for tightening the swinging arm shaft and engine support).
- Using the suitable box wrench, loosen and remove the ring nut (1) from the vehicle right side.

NOTE FOR REASSEMBLY  
Tightening torque: 60 Nm

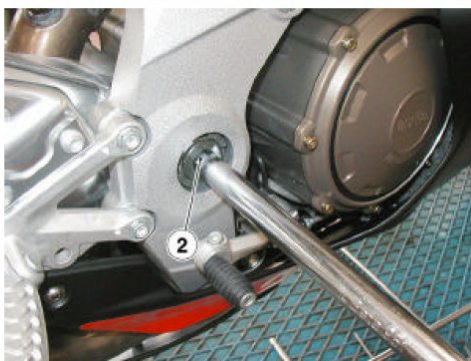
- Turn the swinging arm shaft (2) counter clockwise to loosen the adjuster bush (3).

**Warning**  
The removal procedure shall be performed with utmost care.  
Support the swinging arm at the front to ensure it will not fall.  
Set a wooden support under the swinging arm front end to keep it in place.

NOTE FOR REASSEMBLY  
Tightening torque: 12 Nm

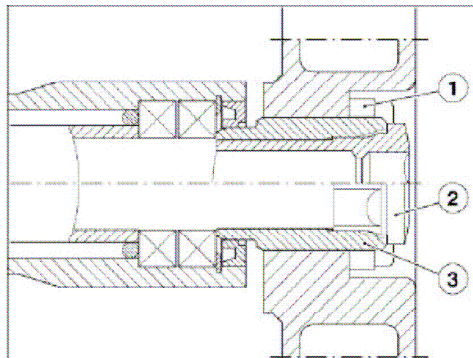
- Set a support under swinging arm front end.
- Support the swinging arm at the front.
- Slide out the swinging arm shaft (2) from the right side.

**NOTE FOR REASSEMBLY**  
Grease the swinging arm shaft

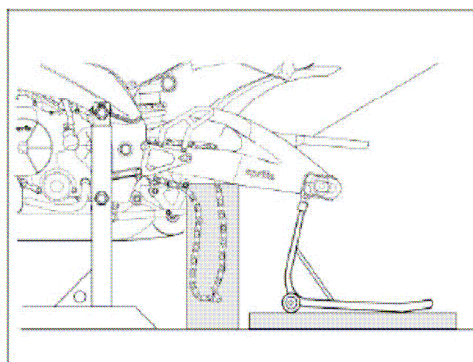
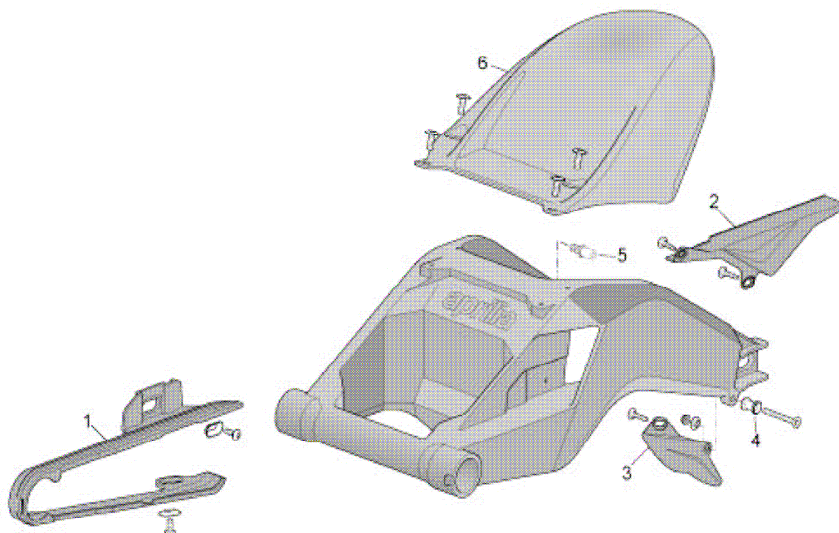
- Support the swinging arm front end and get ready to support it in the following movement.
- Using the rear stand, slide out the swinging arm from the rear until clear of the vehicle.
- Remove the adjuster bush (3) from the swinging arm shaft (2).
- Remove the following parts from the swinging arm:

Chain frame (1),  
chain guard (2),  
chain guide (3),  
stand bushes (4) on either side,  
brake plate pin (5),  
mudguard (6).

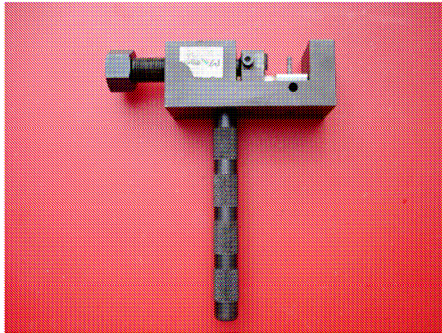
Regina #805187- Connecting link installer-presses plate on to pins  
(aprilia #ap8104516)

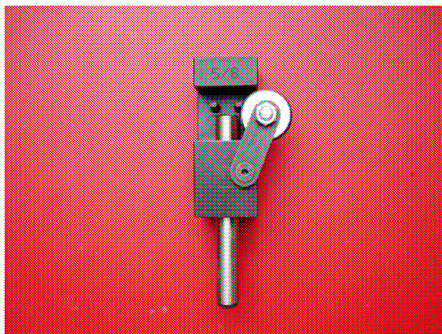
Regina #805188- Chain riveting tool

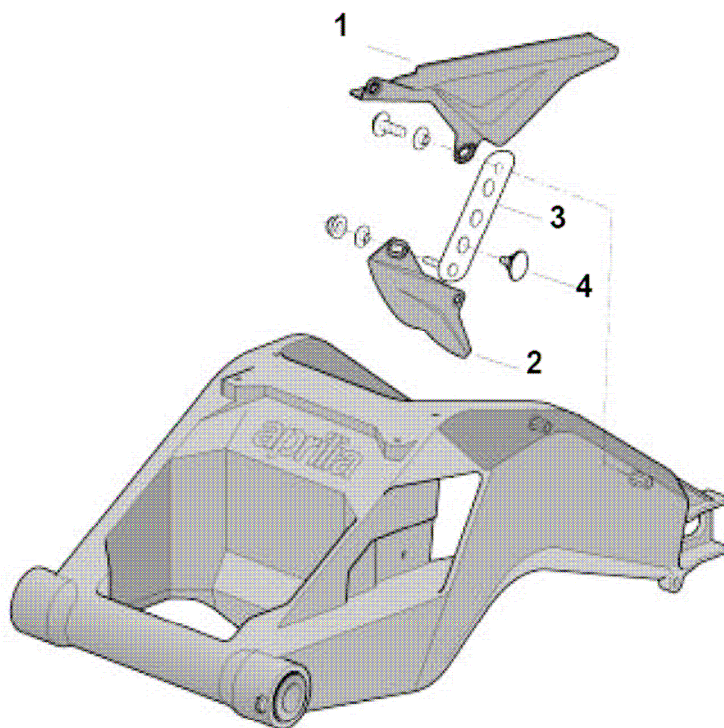
- Refit the following parts to the new swinging arm:

- chain frame,
- chain guard (1) and chain guide (2) with the new bracket (3) and its hardware; fit rubber element (4) to avoid direct contact between swinging arm and bracket,
- stand bushes,
- brake plate pin **smearing LOCTITE 243 on its thread**,
- mudguard.

| Chain frame screw tightening torque: | 3 Nm |
| Chain guard screw tightening torque: | 4 Nm |
| Chain guide screw tightening torque: | 4 Nm |
| Chain guide nut tightening torque: | 4 Nm |
| Stand bushes tightening torque: | 10 Nm |
| Brake plate pin tightening torque: | 50 Nm |
| Mudguard screws tightening torque | 4 Nm (3 Nm for carbon versions) |
