IC Corporation

SAFETY RECALL

SAFETY RECALL 05509

An incorrectly manufactured burner tube in the Webasto heater installed in the bus can fail prematurely.

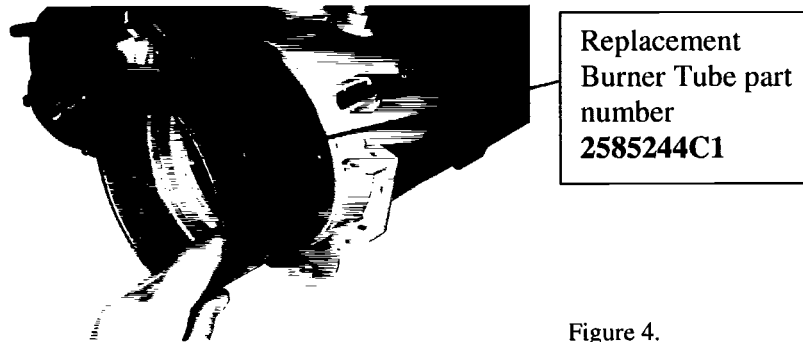
Figure 4.

6. The burner tube can now be carefully pulled out (see figure 4). If burner tube fit is very tight, use two screwdrivers to gently pry it evenly away from the heat exchanger. **Destroy the burner tube NOW so that it cannot be accidentally re-used (hit aluminum section of tube with a hammer- - once it is damaged, the tube is no longer useable).** Do a visual check of the heat exchanger for damages. If necessary, remove carbon deposits with a steel brush. Insert the new burner tube into the heat exchanger until it is fully seated. No further adjustment is necessary.

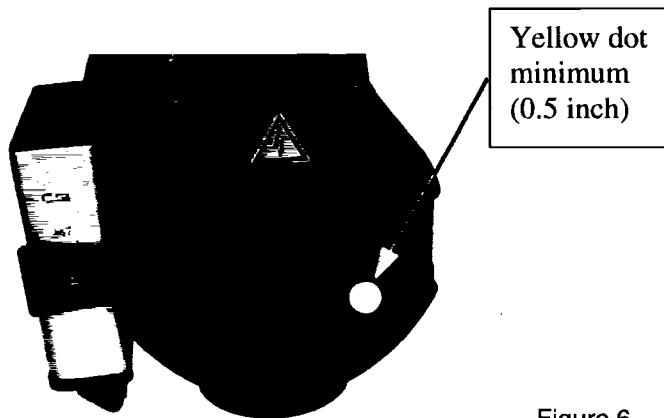
Figure 6.

10. Place a water insoluble (permanent ink or paint) yellow dot, minimum $\text{Ø}10\text{mm}$ (0.5 in.), on the control unit and on the front side of the burner head (see figures 6 & 7) to identify corrected heaters.

1. **Before** starting work, check to see if the heater is already marked. This means the burner tube has been replaced already. Corrected heaters are marked with a yellow dot on the control unit or on the front side of the burner head cover (black plastic) or in both places (see figures 6 & 7).
2. Remove the heater power cable from the vehicle battery or disconnect the heater from other electrical source. Removing the heater from the vehicle is not generally necessary.
3. Inspect the heater for the following serial numbers. Only these serial numbers must have the burner tubes changed. **If the Webasto heater serial number is not on this list, DO NOT change the burner tube.**
