Re: Webasto Heater # DBW 2010 Recall, NHTSA No.: 05E-015
Kenworth Recall No.: 05KW1
Peterbilt Recall No.: 305-A
NHTSA Recall No.: 05V-084

**SUBJECT: SAFETY RECALL #305-A
WEBASTO SCHOLASTIC COOLANT HEATER
EXPIRATION DATE: NONE**

Process Instruction for the Replacement of the Burner Tube

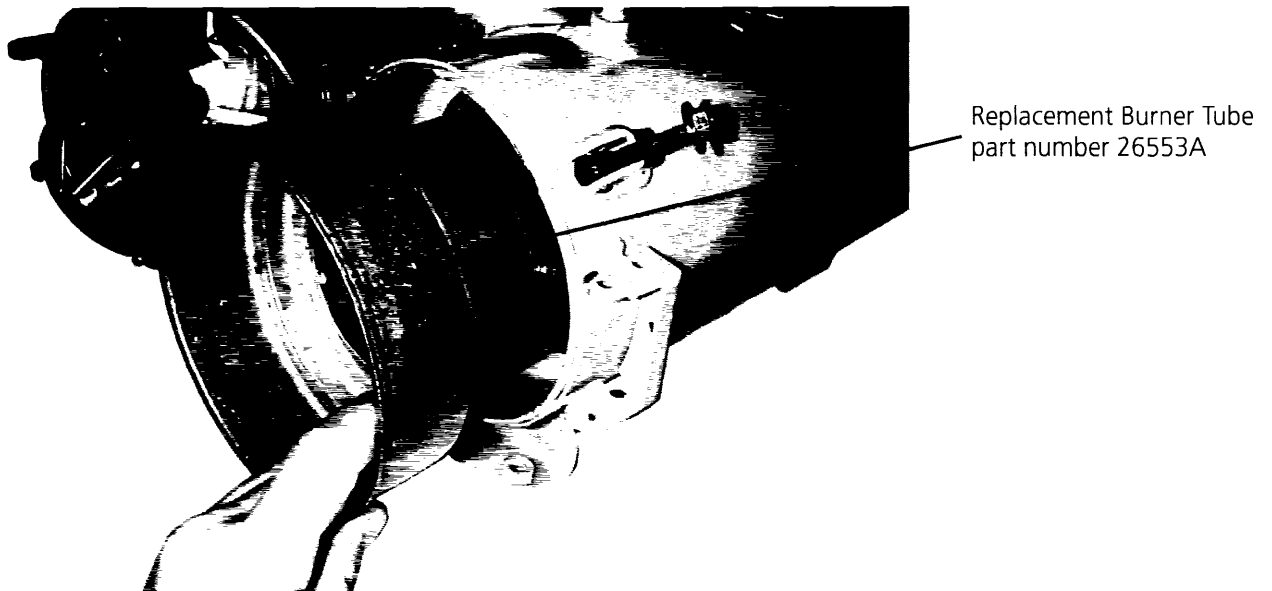
Figure 4.

The burner tube can now be carefully be pulled out (see fig. 4). If burner tube fit is very tight, use two screwdrivers to gently pry it evenly away from the heat exchanger. Mark the exchanged burner tube immediately with a thick red strip and send it to your Webasto branch or your Webasto representative. Do a visual check of the heat exchanger for damages. If necessary remove carbon deposits with a steel brush. Insert the new burner tube into the heat exchanger until it is fully seated. No further adjustment is necessary.
