Campaign No. 2005070007, May 2006

TO: ALL MERCEDES-BENZ CENTERS

SUBJECT: **MODELS 211, 230**
MODEL YEAR 2004
INSPECT SBC HYDRAULIC UNIT, REPLACE AS DIRECTED

This Recall Campaign has been initiated because DCAG has determined that on the affected vehicles (see VIN range below) the SBC brake system may shift to the hydraulic back up mode due to the loosening of the ground wire harness connection over time, or due to premature failure of the hydraulic pump. On Model 211, dealers will install a bracket and replace the ground wire, and if required, replace the hydraulic pump and suction hose. On Model 230, dealers will install a bracket and replace the ground wire, replace the suction hose, and if required replace the hydraulic pump.

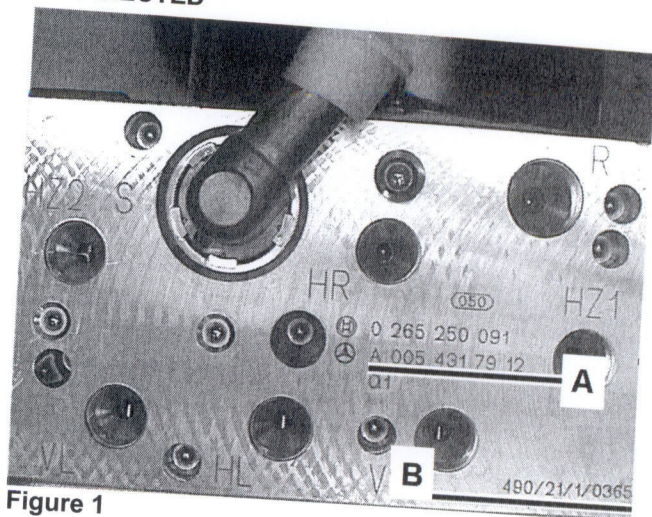
Figure 1

1. Check if part number (A, Figure 1) is listed in the table below:
 - If the part number (A) **is** listed, proceed to step 2.
 - If the part number (A) is **not** listed proceed to step 3.

2. Check (refer to table below) if the production number (B, Figure 1) is within the listed production number range for the relevant part number (A):
 - If the production number (B) is **not** within the production number range proceed to step 3.

- If the production number (B) **is** within the production number range compared to the relevant part number; proceed to Subject **B**, Replacement of SBC Hydraulic unit.
(E.g., for SBC hydraulic unit part number: A 005 431 68 12. The production number 392/08/1/0500 is not within the number range – proceed to step 3. The production number 392/11/1/0700 is within the number range – proceed to Subject B, Replacement of SBC Hydraulic unit).

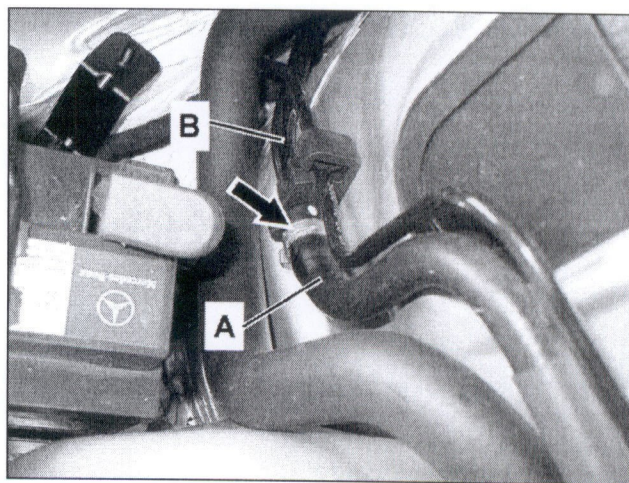
Figure 3

Do not use sharp-edged tools (e.g., screwdriver) to remove suction hose (A, Figure 3) from SBC suction line (B), this may cause damage to the suction line (B) and possible SBC brake system malfunctions.

- Carefully detach suction hose (A, Figure 3) from the suction line (B) using a plastic wedge (Example: Special Tool: W110 589 03 59 00).

- When removing suction hose (A, Figure 3), do not bend suction line.
- To prevent brake fluid from running out and to prevent contamination in the brake system, the suction hose (A, Figure 3) and line (B) are to be plugged using suitable plugs from the stop plug kit (Special Tool: W129 589 00 91 00).
- Discard old suction hose (A) and clamp (arrow) after removal.

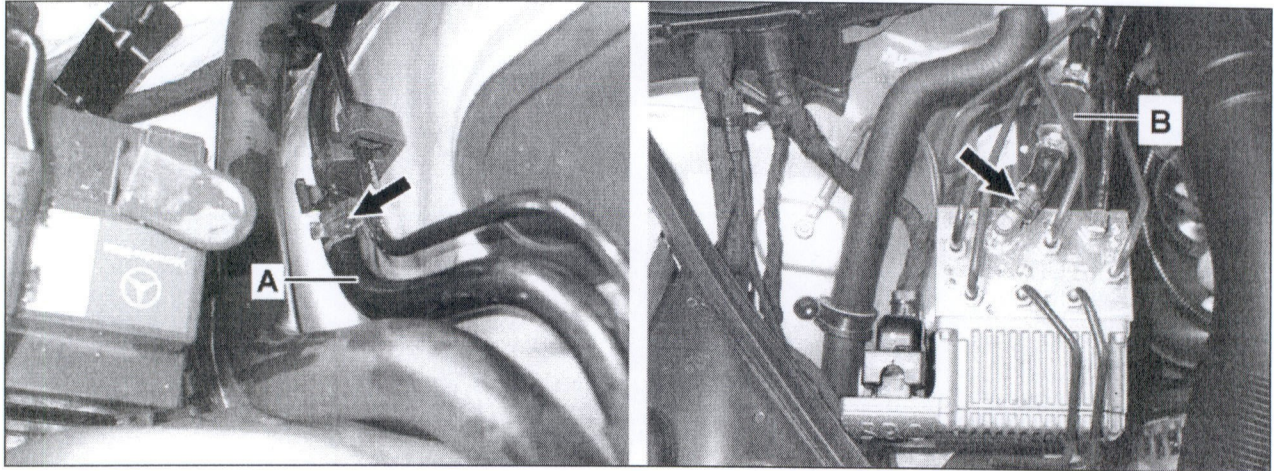
Figure 4

9. Check if a pulsation damper (B, Figure 4) was installed on suction hose:
 - If pulsation damper (B) was **not** installed: Install new standard suction hose (A) to suction line, secure with new hose clamps (arrows).
 - If pulsation damper (B) **was** installed: Install new suction hose (A) with double pulsation damper to suction line, secure with new hose clamps (arrows).
10. Reinstall combination filter housing in reverse order.
11. Remove cable tie (arrow, Figure 5) securing SBC wire harness (A) to SBC connector housing (B).

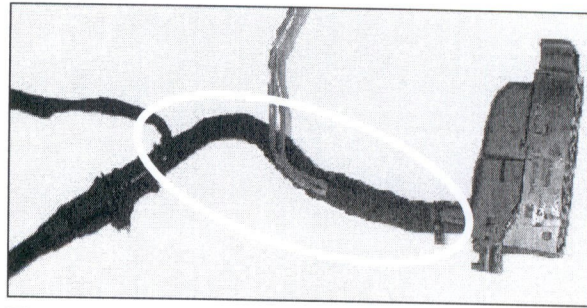
Figure 6

12. Remove fabric tape (circled area, Figure 6) from wire harness up to rubber grommet.

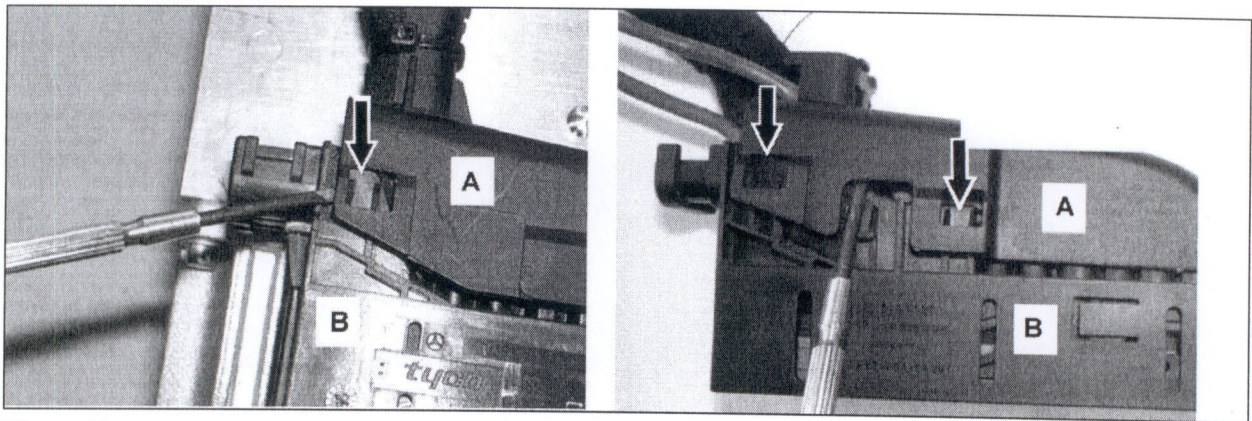
Figure 7

13. Remove SBC connector housing (A, Figure 7) cover:

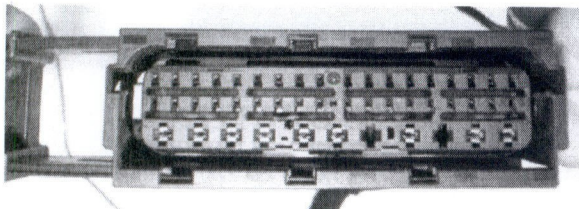
Figure 8a (Connector Type A)

There are two different versions of the SBC wiring harness connector (Figure 8a, b) installed in vehicles involved with this campaign.

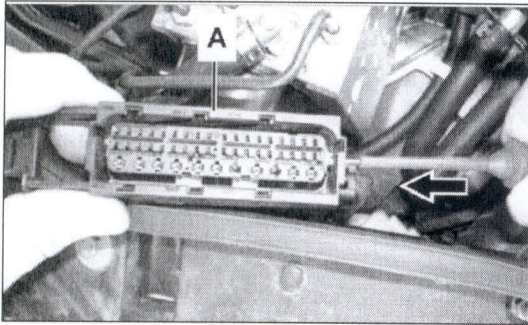
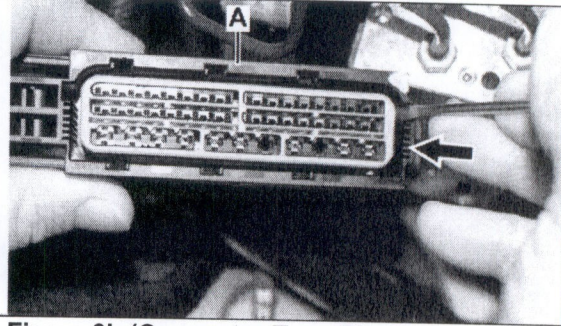
Figure 9a (Connector Type A)

14. Open the (gray) secondary lock in the SBC connector housing (A, Figure 9) by sliding the lock in the direction indicated by the arrows (Figure 9) using a small screwdriver.

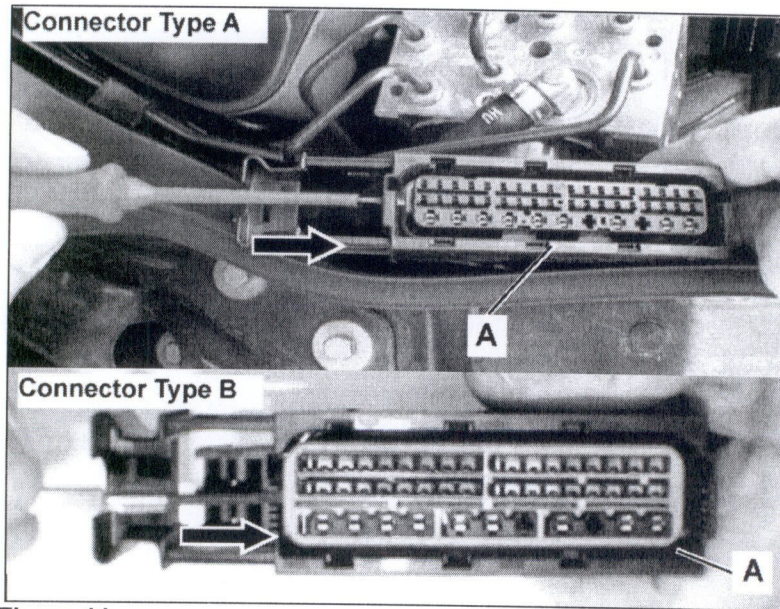
Figure 11

17. Close the (gray) secondary lock of the SBC connector housing (A, Figure 11) by sliding the lock in the direction indicated by the arrows (Figure 11) using a small screwdriver until it locks into place.
18. **Loosely** wrap the exposed SBC wire harness using fabric tape (arrows, Figure 12). **Do not** wrap the ground wiring harness (A) into the SBC wire harness.

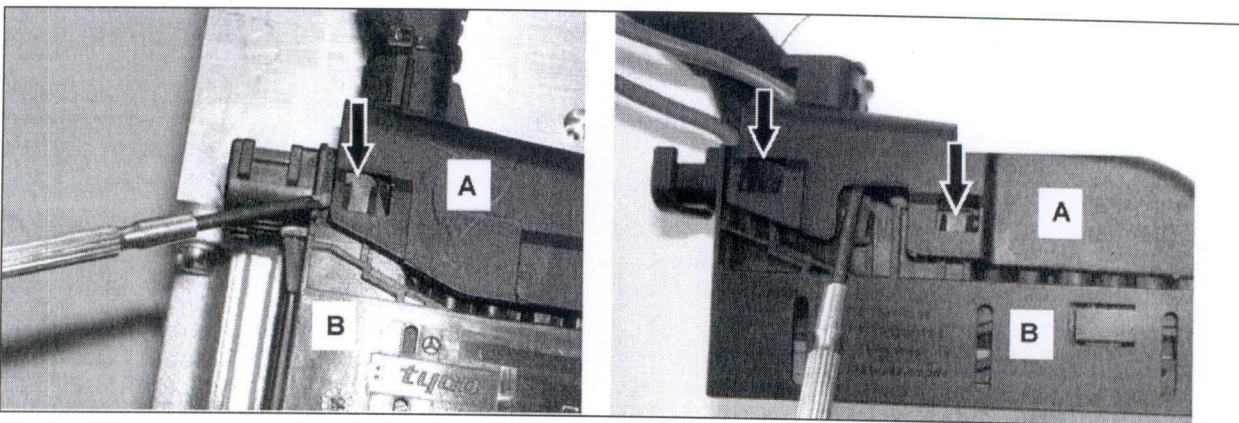
Figure 13

19. Reinstall the SBC wire harness connector cover (A, Figure 13) in reverse order.

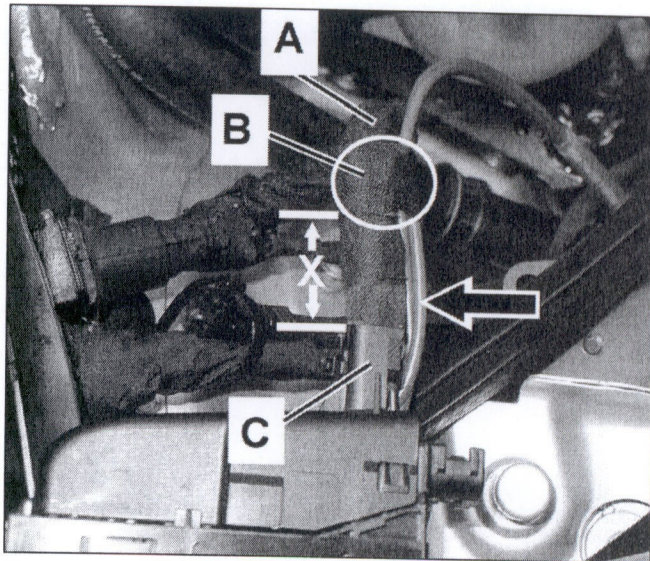
Figure 15

21. Secure ground wiring harness (arrow, Figure 15) to SBC wire harness (A) using two layers of fabric tape (B) in the circled area. Start taping approximately 35 mm (X = 35 mm, Figure 15) from end of connector cover receptacle (C).

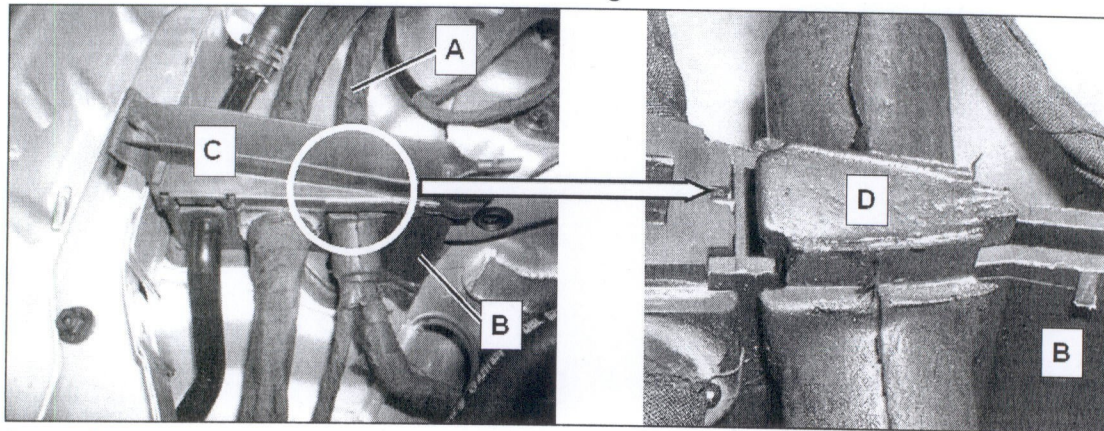
Figure 16

22. Remount the SBC wiring harness (A, Figure 16) in the wire harness guide (B):
- Remove wire harness guide cover (C) and remove SBC wiring harness with grommet (D) from harness guide (B).

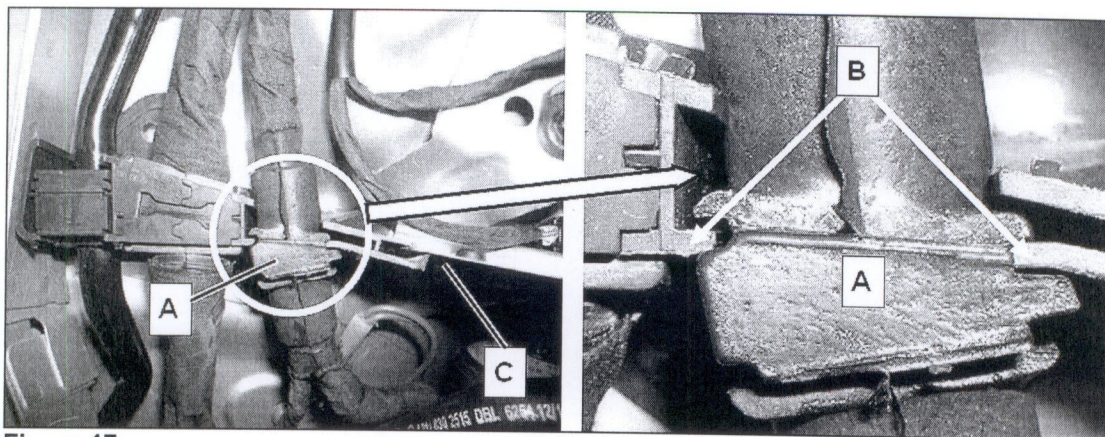
Figure 17

- Reposition SBC wiring harness with grommet (A, Figure 17) into the forward wall opening (B) in the wire harness guide (C).

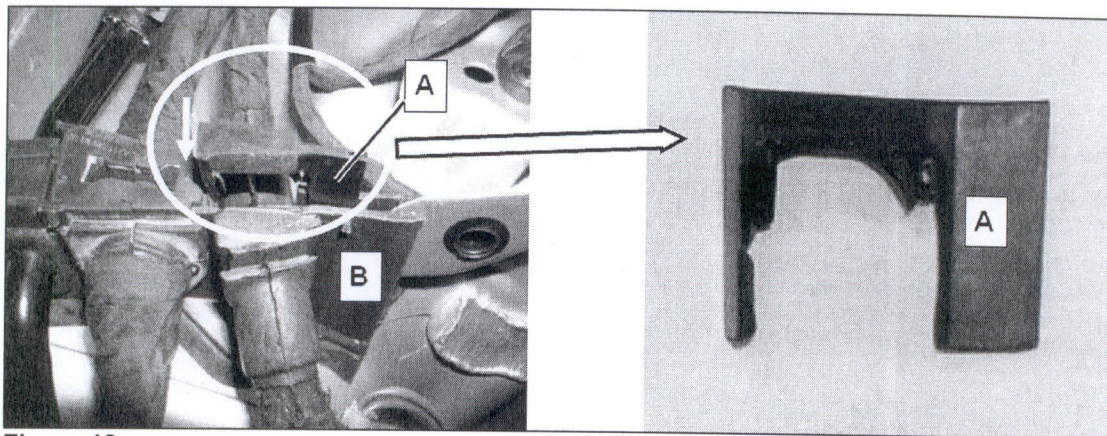
Figure 18

- Insert new routing clip (A, Figure 18) into wire harness guide (B) until top of clip (A) is flush with top of wire harness guide (B).
- Reinstall top of wire harness guide (C, Figure 16).

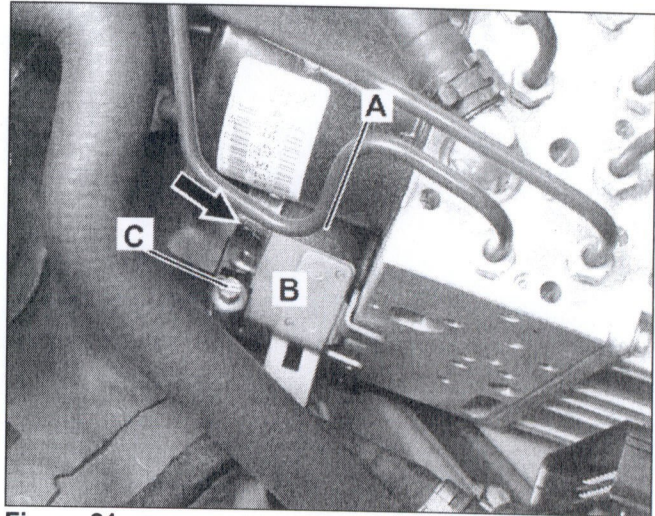
Figure 21

24. Install clamp-on mounting bracket (B, Figure 21) if necessary due to broken self-tapping screw:

Ensure mounting bracket (B) is flush with SBC hydraulic unit (A).

- Torque mounting clamp screw (C) to 5 Nm while pressing bracket (B) onto SBC unit (A) (proceed to step 27).

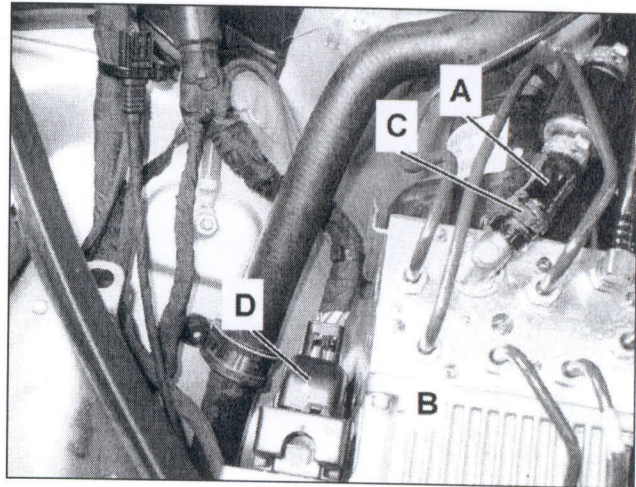
Figure 22

25. Install new SBC hydraulic unit (B, Figure 22) into SBC body mounting grommets.
26. Connect hydraulic lines and SBC suction hose (A, Figure 22) to SBC hydraulic unit (B); refer also to WIS: AR42.46-P-0010R steps 15 - 21.

28. Connect the SBC wire harness connector (D, Figure 22) to the SBC hydraulic unit (B) and secure by engaging locking mechanism.

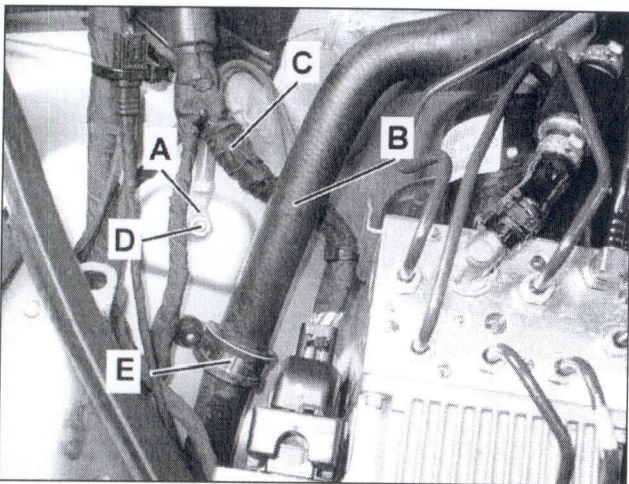
Figure 23

29. Attach hose mounting strap (E, Figure 23) to mounting stud, secure with nut
30. Position ground wiring harness parallel to the vehicle longitudinal axis (X-axis) on the body ground terminal. Torque the M6 nut to 10 Nm.

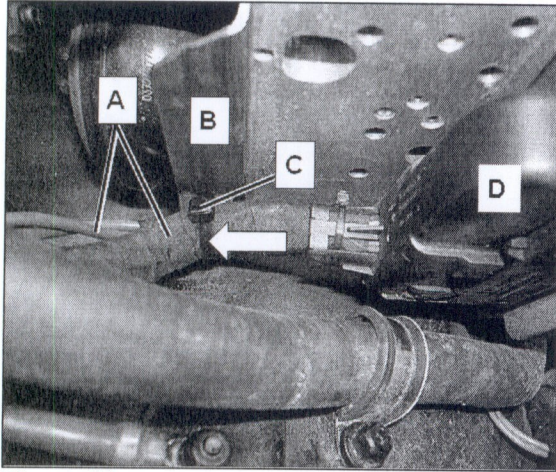
Figure 24

33. Secure ground wiring harness and SBC wiring harness (A, Figure 24) to SBC hydraulic unit bracket (B) with cable tie (arrow). Tighten cable tie (arrow) with Hellermann MK9 cable tie pliers (Special Tool: W 352 589 02 37 00) using **setting 3** on pliers.

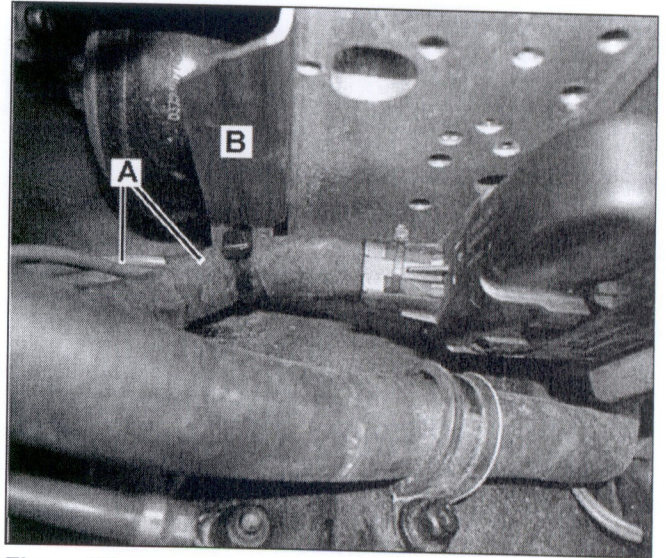
Figure 28

4. Quality measure 4:
- Ensure ground wires (A, Figure 28) are completely wrapped with fabric tape (as performed in step 21) in the area adjacent to the SBC hydraulic unit bracket (B) to ensure that the ground wires do not become chafed. Readjust tape as necessary to prevent chafing.

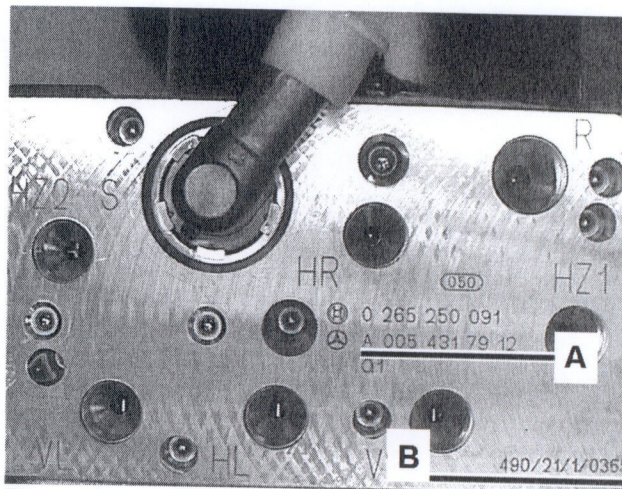
Figure 1

1. Check if SBC hydraulic unit part number (A, Figure 1) is listed in the table below:
 - If the part number (A) **is** listed, proceed to step 2.
 - If the part number (A) is **not** listed, proceed to step 3.

2. Check (refer to table below) if the production number (B, Figure 1) is within the listed production number range for the relevant part number (A):
 - If the production number (B) is **not** within the production number range, proceed to step 3.

- If the production number (B) **is** within the production number range compared to the relevant part number; proceed to Subject B, Replacement of SBC Hydraulic unit.
(E.g., for SBC hydraulic unit part number: A 005 431 68 12. The production number 392/08/1/0500 is **not** within the number range – proceed to step 3. The production number 392/11/1/0700 **is** within the number range – proceed to Subject B, Replacement of SBC Hydraulic unit).

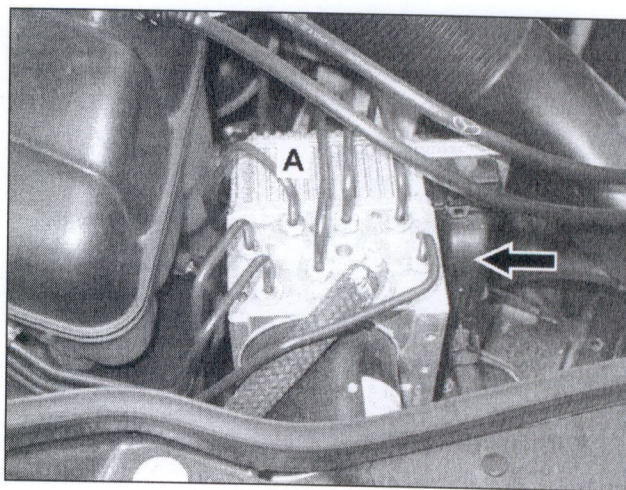
Figure 2a

3. Disconnect SBC hydraulic unit harness connector (arrow, Figure 2a) from SBC hydraulic unit (A) and remove cable tie (B, Figure 3).

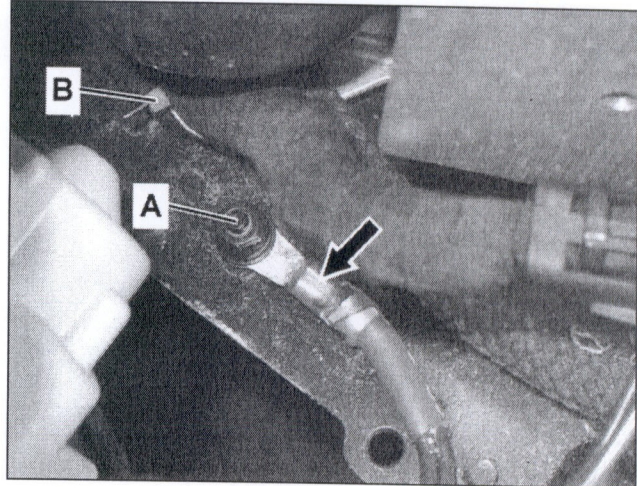
Figure 3

4. Detach the SBC hydraulic unit ground wire harness (arrow, Figure 3) at ground terminal stud (A).
5. Position SBC harness connector (arrow, Figure 2a) away from SBC hydraulic lines to prevent brake fluid from dripping on SBC harness connector and SBC wiring harness.

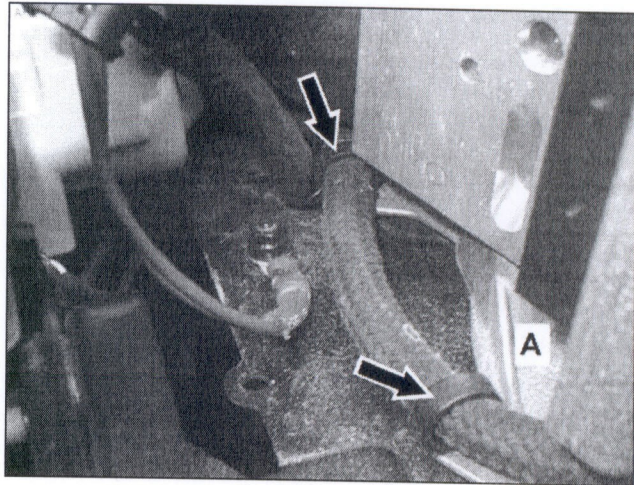
Figure 4

6. Remove omega (arrows, Figure 4) hose clips from SBC hydraulic unit bracket (A).
7. Remove SBC hydraulic unit refer to WIS: AR42.46-P-0010R steps 1 - 3, 5 - 14.

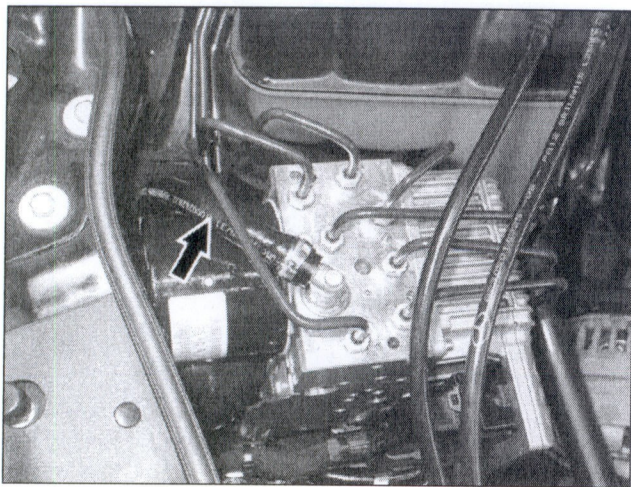
Figure 5

8. Inspect which version of the suction hose is installed on the SBC hydraulic pump:
- If new version (rubber) hose (arrow, Figure 5) is installed, skip ahead to step 10.
 - If previous version (braided) hose (arrow, Figure 6) is installed, proceed to step 9 to replace the suction hose.

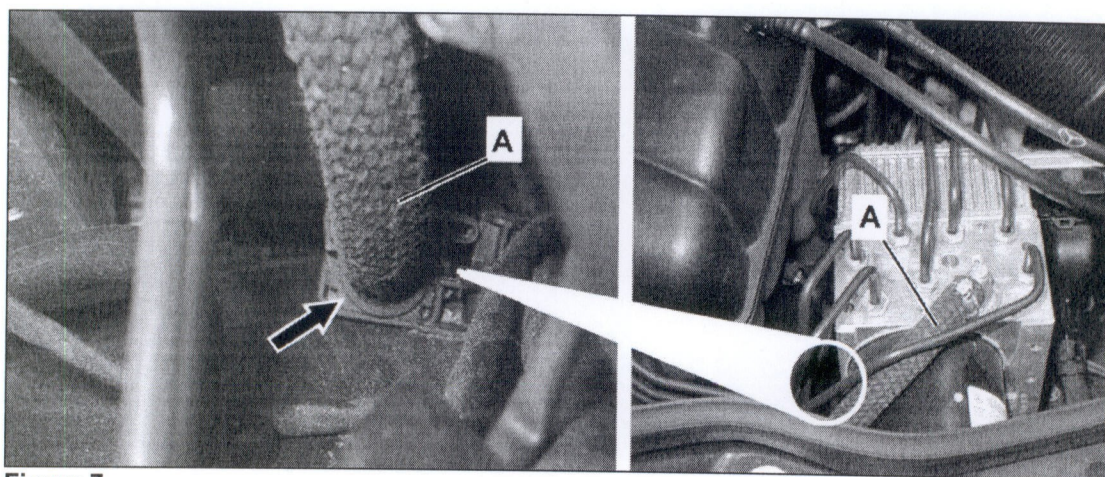
Figure 7

9. Replace suction hose (A, Figure 7):
- Open the suction hose mounting clip (arrow) and remove suction hose (A) from bracket.
 - Remove mounting clip (arrow) from threaded stud and discard.

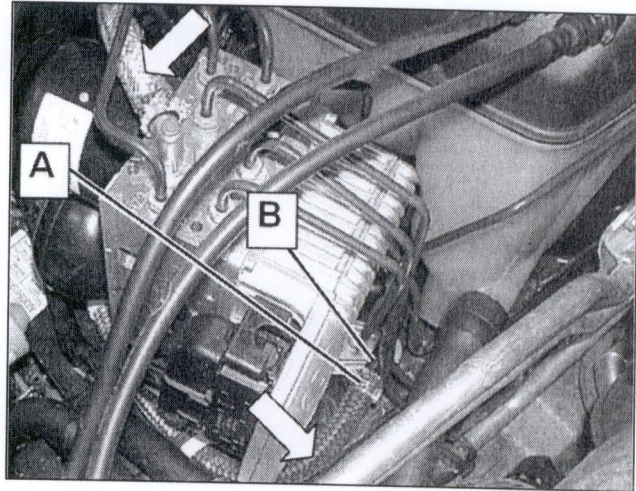
Figure 8

- Do not use sharp-edged tools (e.g., screwdriver) to remove suction hose (arrows, Figure 8) from suction line (B), as this may cause damage to the SBC brake system.

- When removing suction hose (arrow), do not bend suction line (B).
- To prevent brake fluid from running out and to prevent contamination in the brake system, the suction hose (arrows, Figure 8) and line (B) are to be plugged using suitable plugs from the stop plug kit (Special Tool: W129 589 00 91 00).
- Discard old suction hose (arrow) and clamp (A) after removal.

(Shown with SBC hydraulic unit installed)

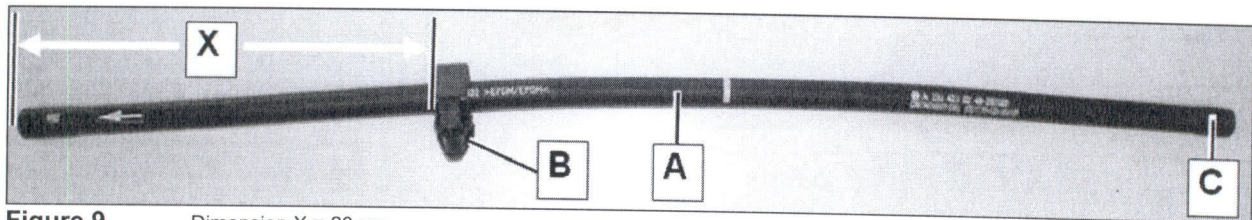
Figure 9

Dimension X = 20 cm

- Verify that the dimension X (Figure 9) on the **new** SBC suction hose (A) equals 20 cm. Adjust (if necessary) by repositioning the mounting clip (B) on the SBC suction hose (A).
- Place new hose clamp onto unmarked side of suction hose (C, Figure 9).
- Connect the unmarked end of the suction hose (C, Figure 9) onto the suction line (A, Figure 10) and secure hose with a **new** hose clamp (arrow, Figure 10).

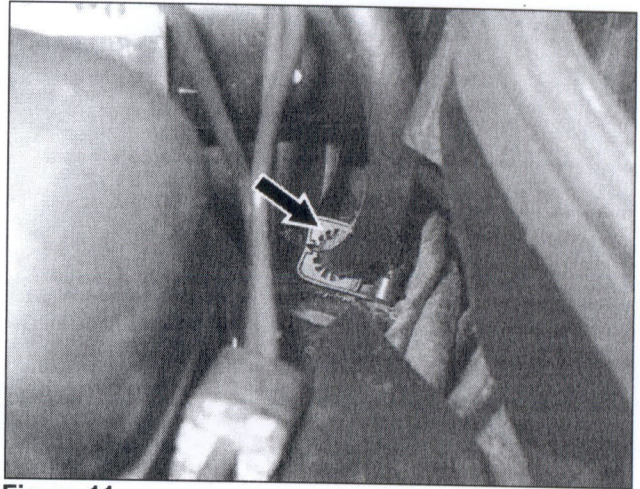
Figure 11

- Install the new SBC suction hose mounting clip (arrow, Figure 11) onto the mounting stud.

To gain better access to mounting clip (during installation); remove the plastic cover over the right head lamp; then tap the clip into place using a socket extension and plastic mallet.

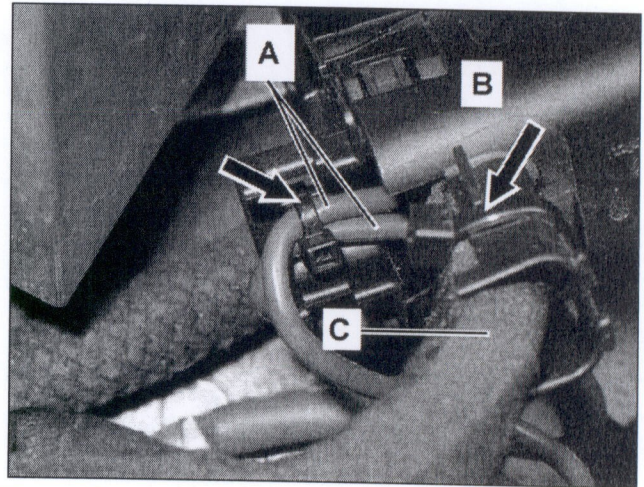
Figure 12

10. Remove cable tie (left arrow, Figure 12) securing ground wires (A) to SBC connector housing (B).
11. Remove cable tie (right arrow, Figure 12) securing SBC wire harness (C) to SBC connector housing (B).

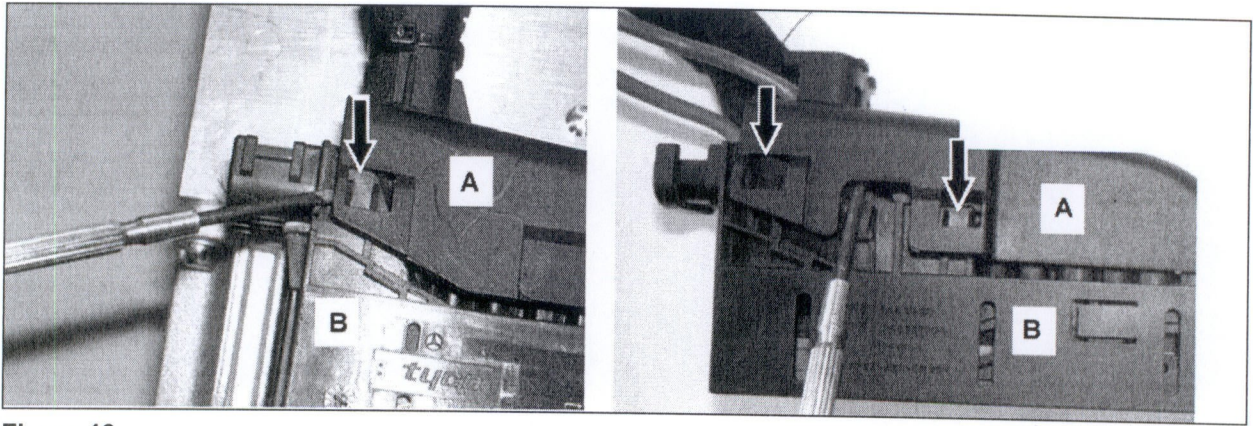
Figure 13

12. Remove SBC connector housing cover (A, Figure 13):

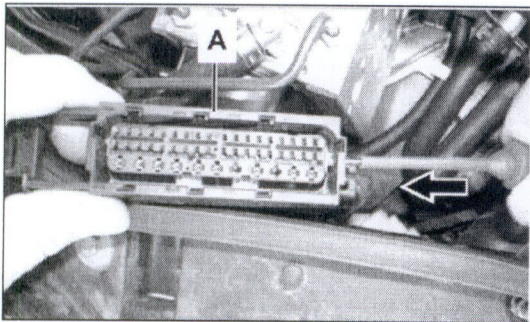
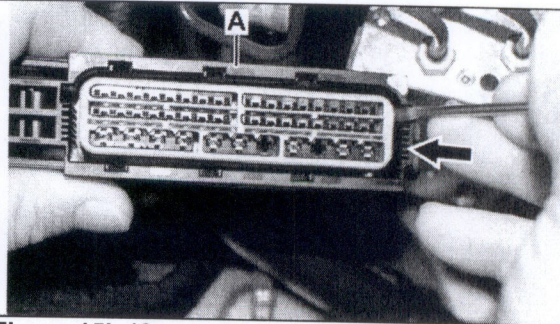
Figure 15a (Connector Type A)

13. Open the (gray) secondary lock in the SBC connector housing (A, Figure 15) by sliding the lock in the direction indicated by the arrows (Figure 15) using a small screwdriver.

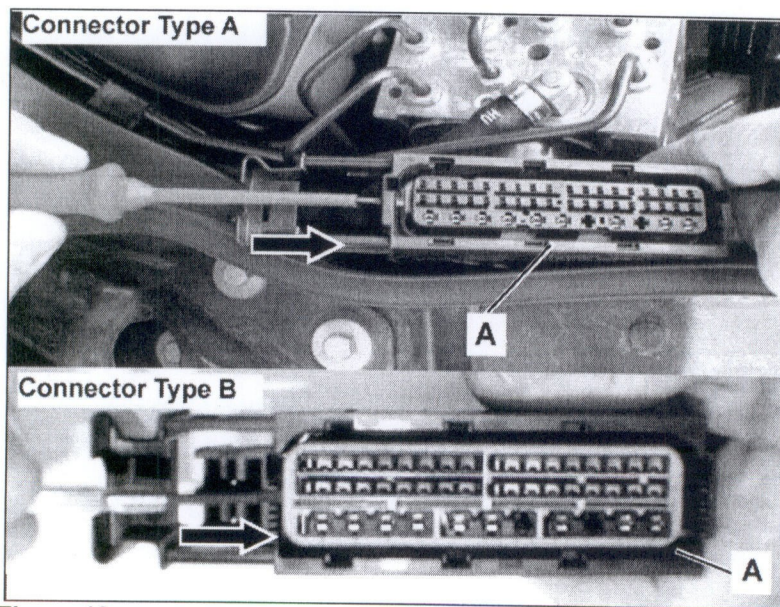
Figure 18

16. Close the (gray) secondary lock of the SBC connector housing (A, Figure 18) by sliding the lock in the direction indicated by the arrows (Figure 18) using a small screwdriver until it locks into place.
17. Reinstall connector cover (A, Figure 13) in reverse order.

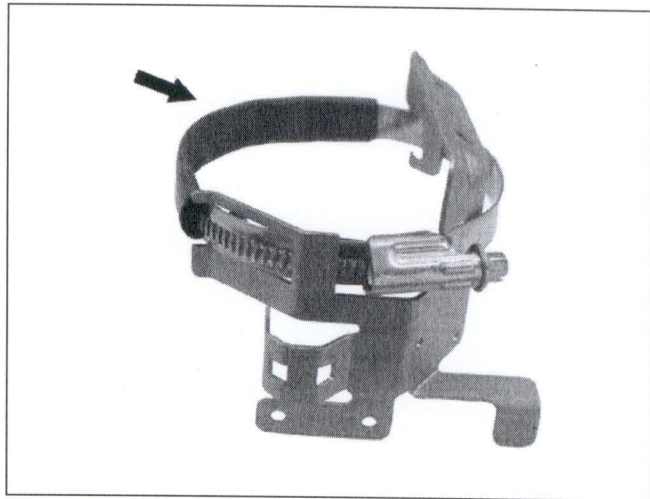
Figure 22

21. Install clamp-on mounting bracket (Figure 22) if necessary due to broken self-tapping screw:

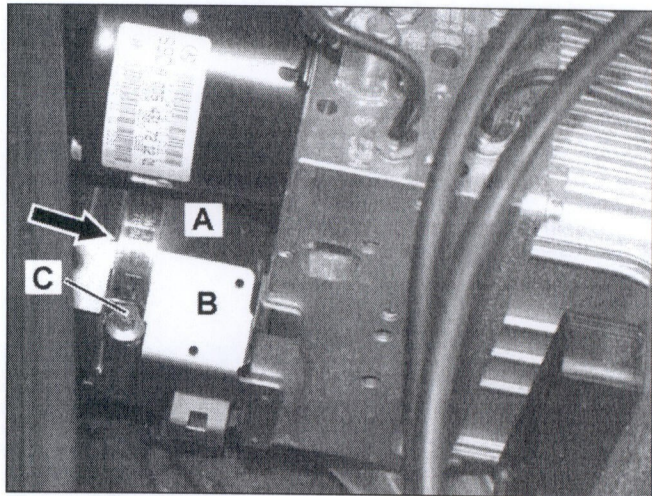
Figure 23

- Position mounting bracket (B) onto SBC hydraulic unit (A) as shown in Figure 23.

- Ensure mounting bracket (B, Figure 23) is flush with SBC hydraulic unit (A).
- Torque mounting clamp screw (C) to 5 Nm while pressing bracket (B) onto SBC unit (A) (Proceed to step 24).

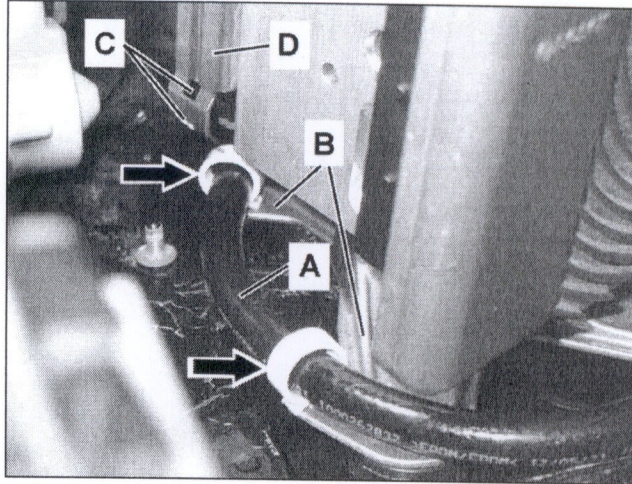
Figure 25

25. Secure new SBC suction hose (A, Figure 25) to SBC hydraulic unit mounting bracket (B) using **new** ("omega" type) mounting clips (arrows).
