Re: Update - SBC Hydraulic Pump - Recall Campaign 2005070007

Campaign No. 2005070007, December 2005

SUBJECT: **MODELS 211, 230**
MODEL YEAR 2004
INSPECT SBC HYDRAULIC UNIT, REPLACE AS DIRECTED

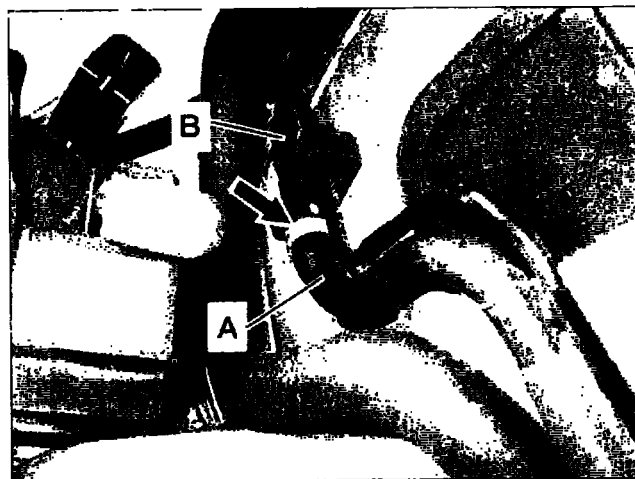
Figure 3

Do not use sharp-edged tools (e.g., screwdriver) to remove suction hose (A, Figure 3) from SBC suction line (B), this may cause damage to the suction line (B) and possible SBC brake system malfunctions.

- Carefully detach suction hose (A, Figure 3) from the suction line (B) using a plastic wedge (Example: Special Tool: W110 589 03 59 00).

- When removing suction hose (A, Figure 3), do not bend suction line.
- To prevent brake fluid from running out and to prevent contamination in the brake system, the suction hose (A, Figure 3) and line (B) are to be plugged using suitable plugs from the stop plug kit (Special Tool: W129 589 00 91 00).
- Discard old suction hose (A) and clamp (arrow) after removal.

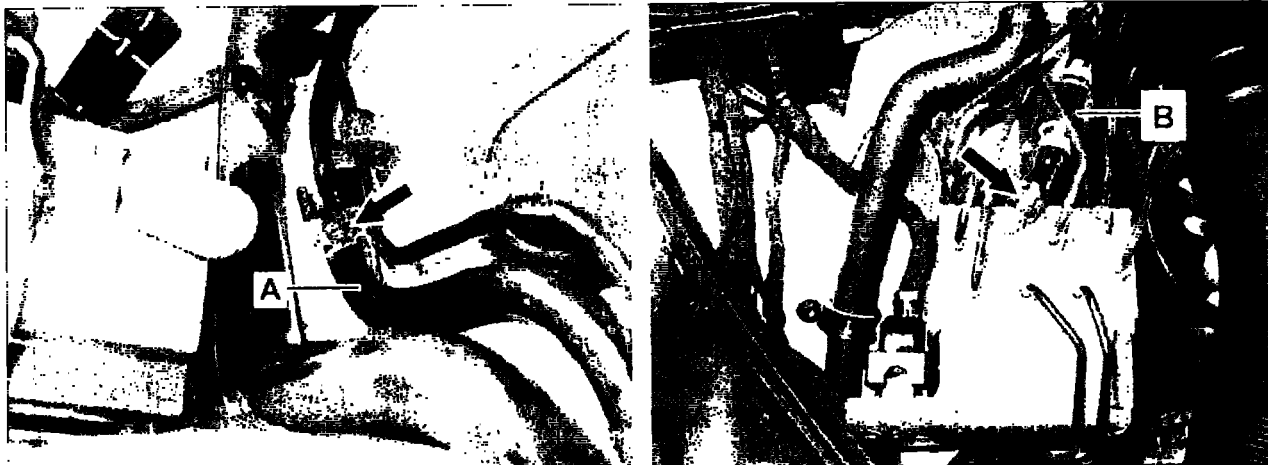
Figure 4

9. Check if a pulsation damper (B, Figure 4) was installed on suction hose:

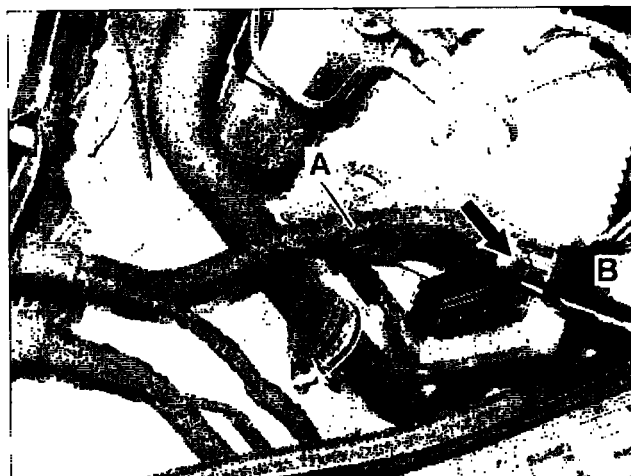
Figure 5

11. Remove cable tie (arrow, Figure 5) securing SBC wire harness (A) to SBC connector housing (B).

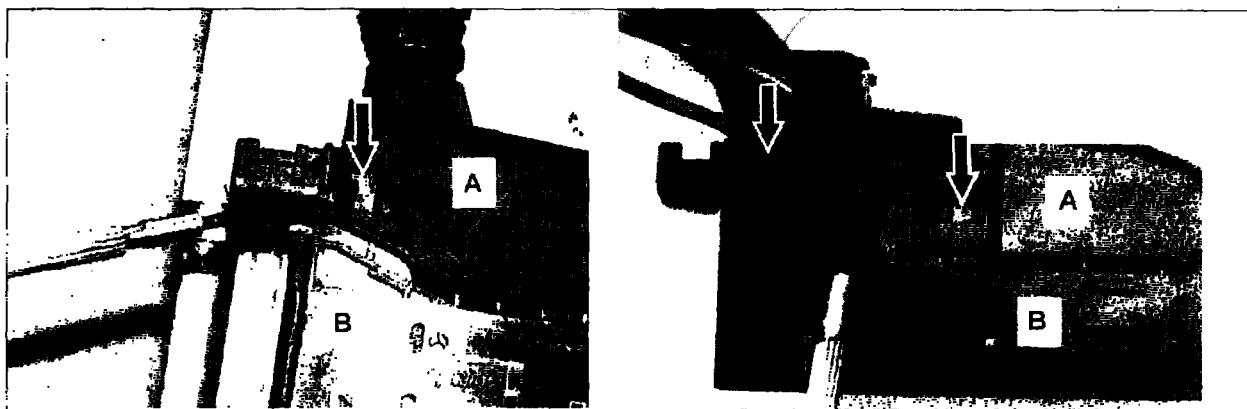
Figure 7

13. Remove SBC connector housing (A, Figure 7) cover:
- Using a small screwdriver, carefully pry cover (A) away from locking lugs (arrow) until it disengages.
 - Repeat the process on opposite side.
 - Remove the cover (A) from the housing (B).

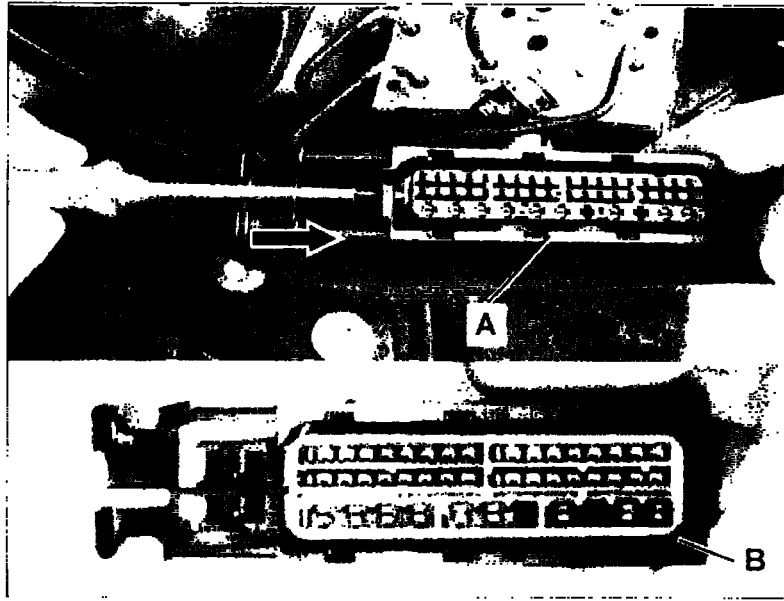
Figure 11

17. Close the (gray) secondary lock of the SBC connector housing (A, B, Figure 11):
- **Connector Type A** (Figure 11):
Slide the gray secondary lock in the direction indicated by the arrow (Figure 11), using a small screw driver until it locks into place.
 - **Connector Type B** (Figure 11):
Place secondary lock on top of connector and snap back into place by pushing downwards.
18. **Loosely** wrap the exposed SBC wire harness using fabric tape (arrows, Figure 12). **Do not** wrap the ground wiring harness (A) into the SBC wire harness.

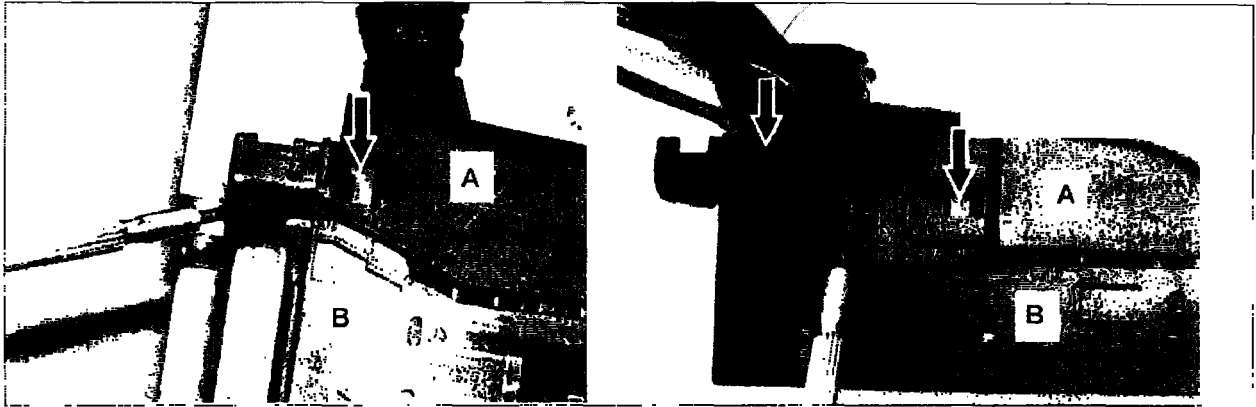
Figure 13

19. Reinstall the SBC wire harness connector cover (A, Figure 13) in reverse order.

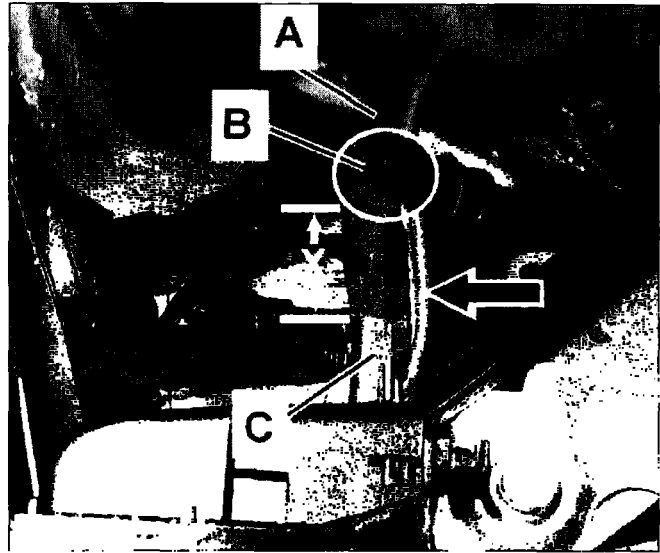
Figure 15

21. Secure ground wiring harness (arrow, Figure 15) to SBC wire harness (A) using two layers of fabric tape (B) in the circled area. Start taping approximately 35 mm (X = 35 mm, Figure 15) from end of connector cover receptacle (C).

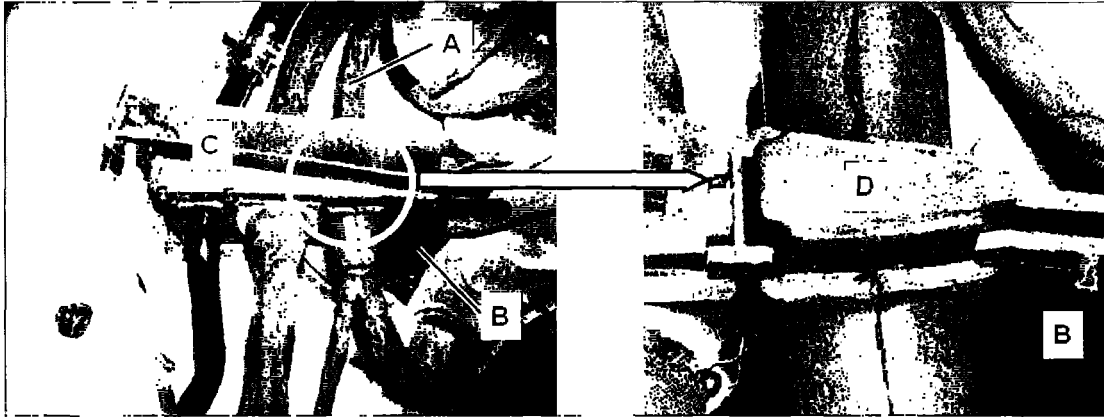
Figure 16

22. Remount the SBC wiring harness (A, Figure 16) in the wire harness guide (B):

- Remove wire harness guide cover (C) and remove SBC wiring harness with grommet (D) from harness guide (B).

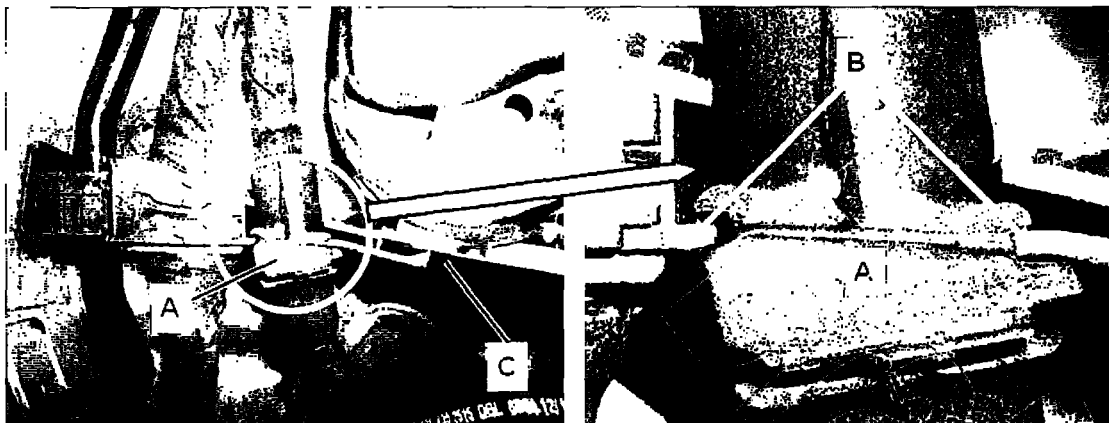
Figure 17

- Reposition SBC wiring harness with grommet (A, Figure 17) into the forward wall opening (B) in the wire harness guide (C).

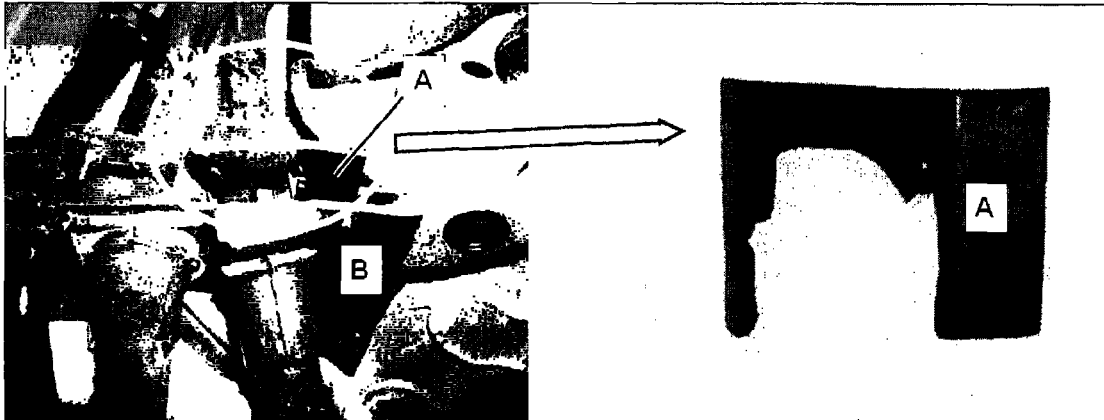
Figure 18

- Insert new routing clip (A, Figure 18) into wire harness guide (B) until top of clip (A) is flush with top of wire harness guide (B).
- Reinstall top of wire harness guide (C, Figure 16).

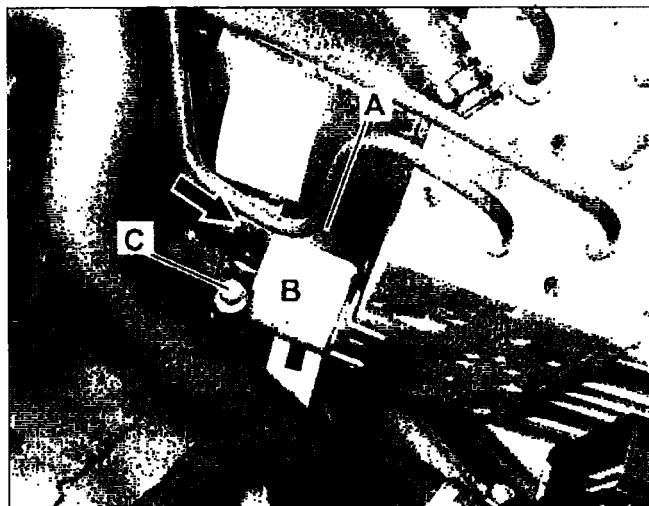
Figure 21

24. Install clamp-on mounting bracket (B, Figure 21) if necessary due to broken self-tapping screw:

- Torque mounting clamp screw (C) to 5 Nm while pressing bracket (B) onto SBC unit (A) (proceed to step 27).

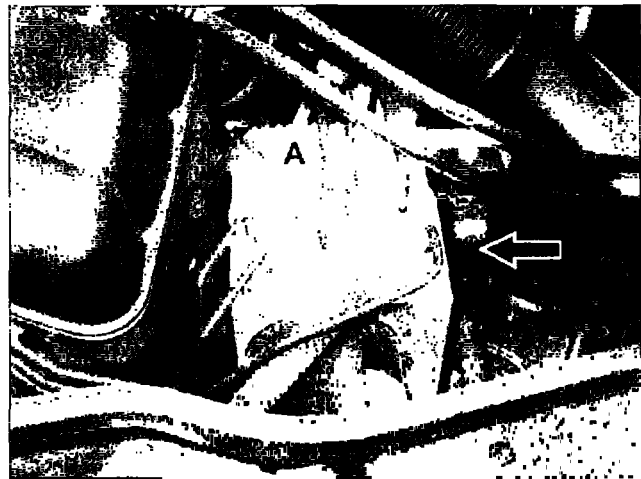
Figure 2a

3. Disconnect SBC hydraulic unit harness connector (arrow, Figure 2a) from SBC hydraulic unit (A) and remove cable tie (B, Figure 3).

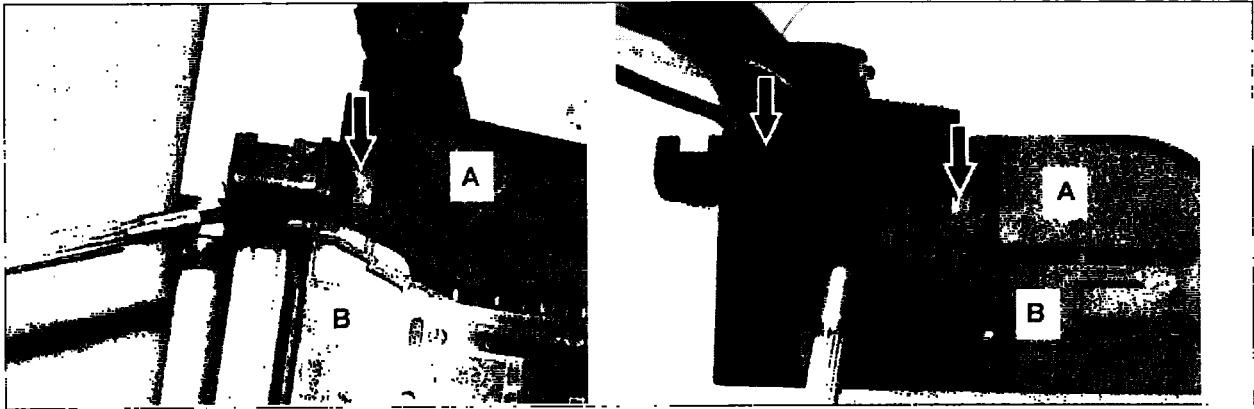
Figure 13

12. Remove SBC connector housing cover (A, Figure 13):

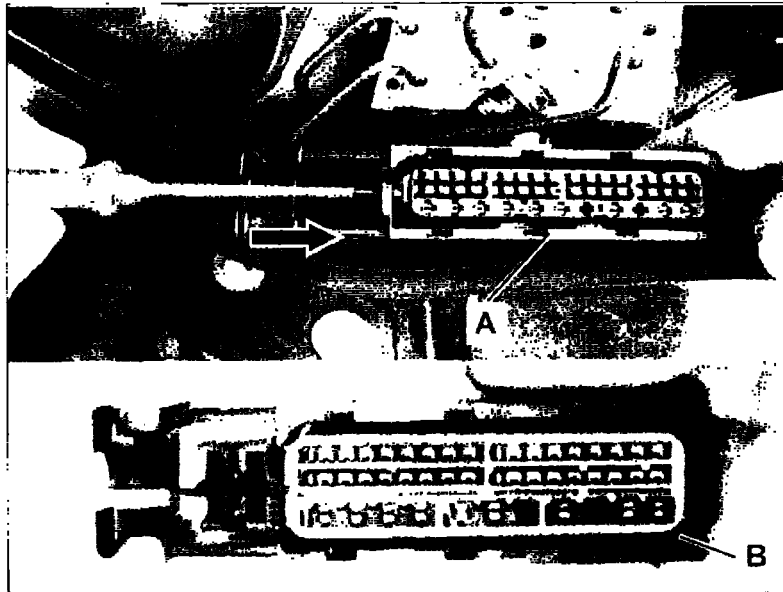
Figure 18

16. Close the (gray) secondary lock of the SBC connector housing (A, B, Figure 18):

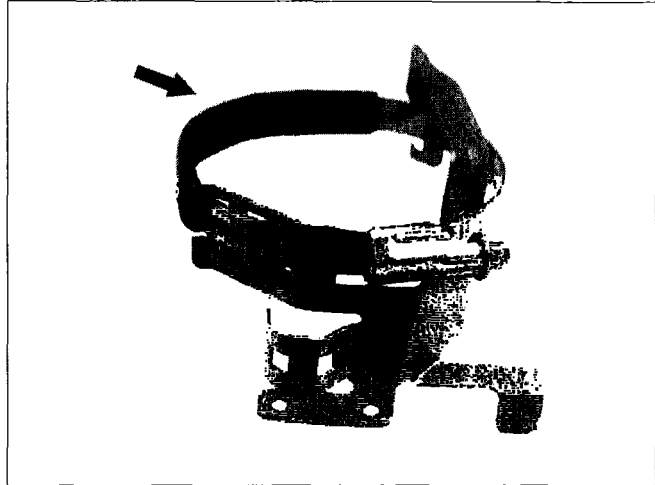
Figure 22

21. Install clamp-on mounting bracket (Figure 22) if necessary due to broken self-tapping screw:

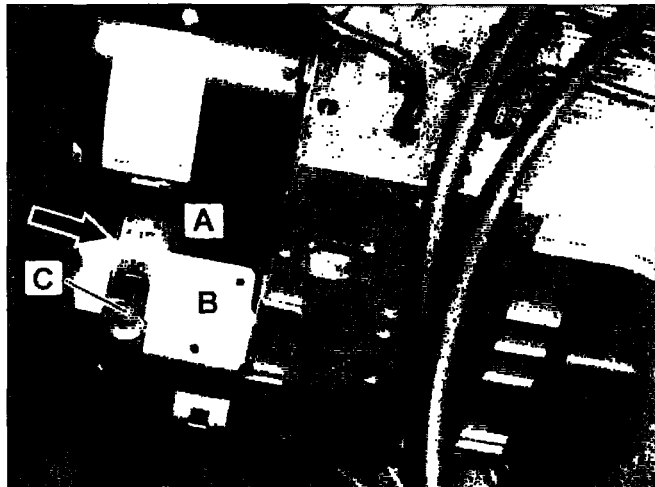
Figure 23

- Position mounting bracket (B) onto SBC hydraulic unit (A) as shown in Figure 23.

- Ensure mounting bracket (B, Figure 23) is flush with SBC hydraulic unit (A).
- Torque mounting clamp screw (C) to 5 Nm while pressing bracket (B) onto SBC unit (A) (Proceed to step 24).

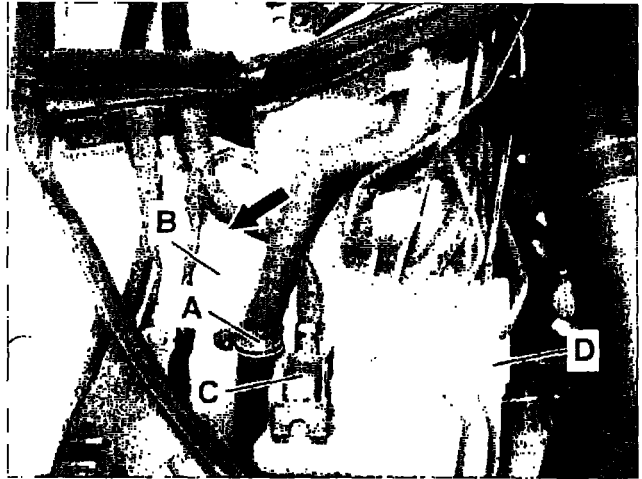
**Figure 3**

1. Lock the vehicle globally and then wait for 30 seconds for the SBC control module to power-down.
2. Loosen hose mounting strap (A, Figure 3) and reposition hose and strap (A) to create more working space.
3. Disconnect harness connector (C, Figure 3) from the SBC hydraulic unit (D).
4. Detach the SBC hydraulic unit ground wire (arrow, Figure 3) at ground terminal (B).
5. Remove cable tie (arrow, Figure 4) securing SBC wire harness (A) to SBC connector housing (B)

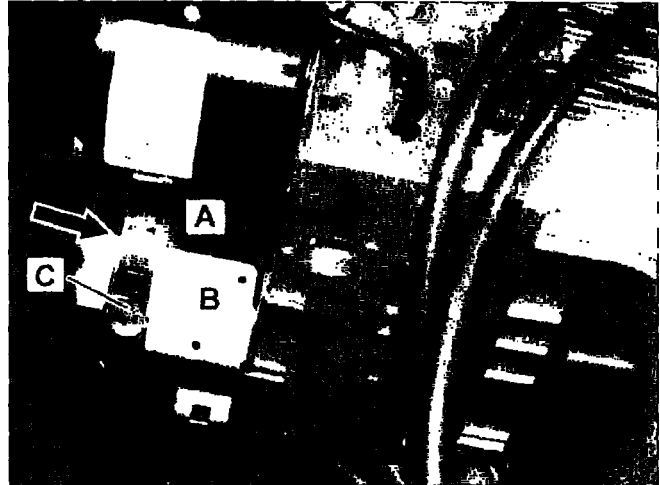
Figure 18

- Position mounting bracket (B) onto SBC hydraulic unit (A) as shown in Figure 18.

- Ensure mounting bracket (B, Figure 18) is flush with SBC hydraulic unit (A).
- Torque mounting clamp screw (C) to 5 Nm while pressing bracket (B) onto SBC unit (A).
