Re: 49 CFR Part 573; Recall of Mercedes-Benz E, SL-Class, and CLS-Class

Installation of Ground Wires and Bracket to SBC Wiring Harness - Recall Campaign 2005110001

- **Installation of Ground Wires and Bracket to SBC Wiring Harness Model 211, 230 MY 2003 - 2005 and Model 219 MY 2006- Recall Campaign 2005110001 - Phase III**

This Recall Campaign has been initiated because DCAG has determined that on the affected vehicles (see VIN range on the following page) the SBC brake system may shift to the hydraulic back up mode due to the loosening of the ground wire harness connection over time. Dealers will install a bracket and replace the ground wire.

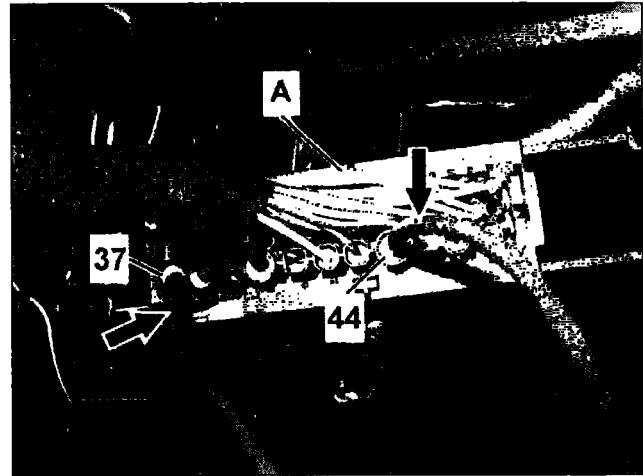
Figure 9

9. Remove SBC ground wires (arrows, Figure 9) from SBC harness connector (A):
 - Unpin ground wire connectors (position 37 and 44) using cable release tool and remove from SBC connector housing (A) (special tool nos.: W 000 589 13 99 30 and W 220 589 01 99 50).
 - Discard old ground wiring harness; it is no longer needed.

10. Insert the new ground wire harness (arrows Figure 9) into the SBC connector housing (A):
 - Insert **longer** ground wire into position 44.
 - Insert **shorter** ground wire into position 37.

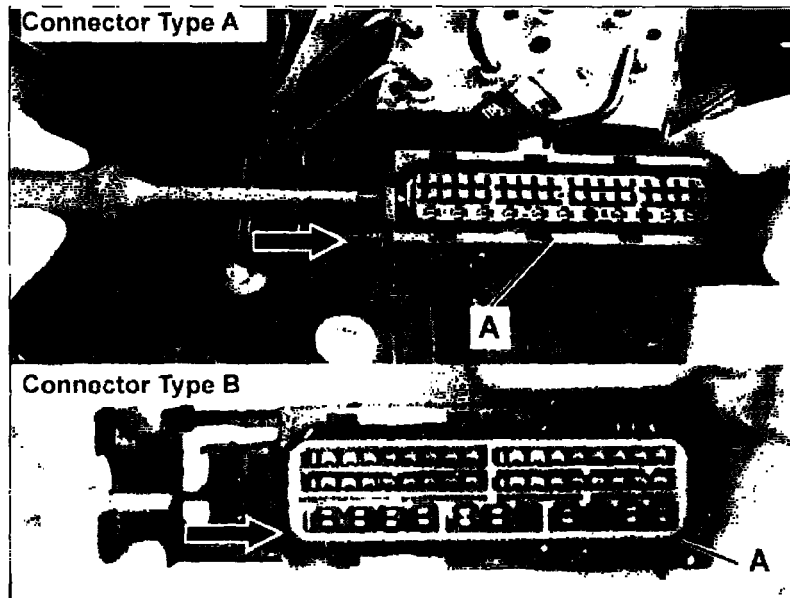
Figure 10

11. Close the (gray) secondary lock of the SBC connector housing (A, Figure 10) by sliding the lock in the direction indicated by the arrows (Figure 10) using a small screwdriver until it locks into place.

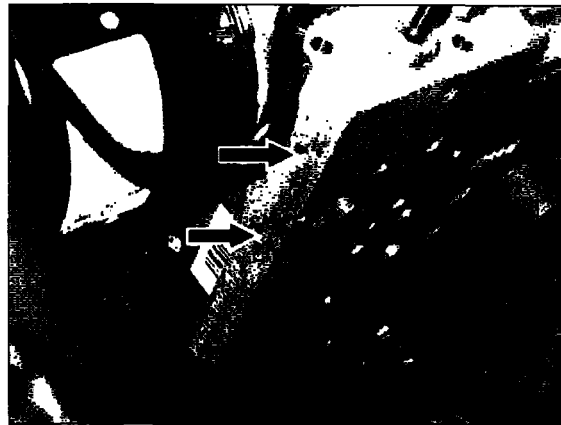
Figure 18

If mounting bores (arrows, Figure 18) are **not** present in hydraulic unit proceed to step 18, if bores are present continue with this step.

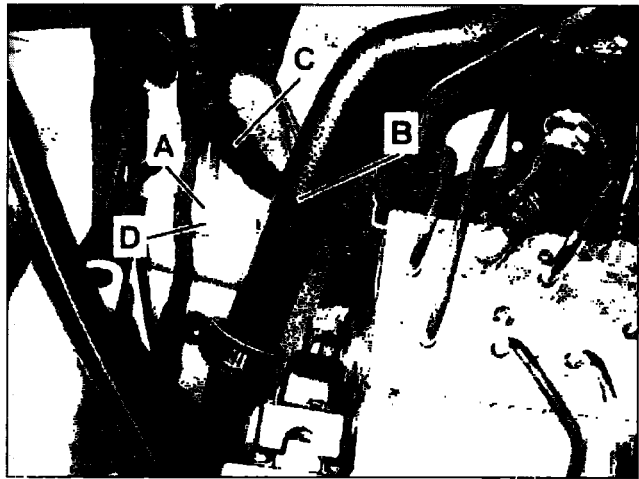
Figure 21

- Ring connector (A, Figure 21) **must** be positioned as shown to avoid contact with water hose (B) and chafing the wire harness (C).
- This ground terminal (D) is to be used **only** for mounting the SBC ground wire.

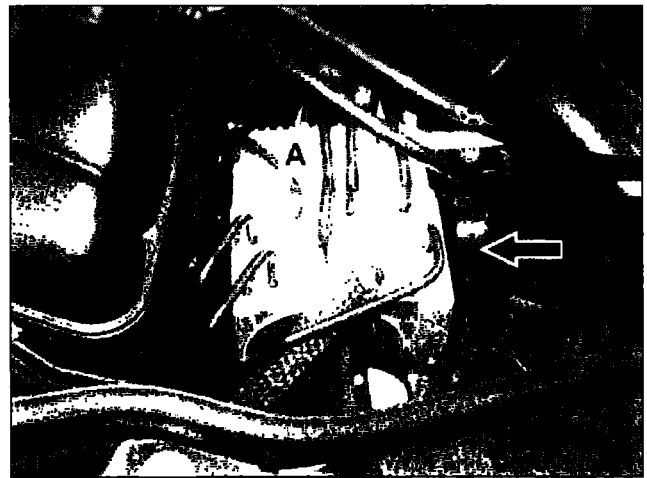
Figure 4

3. Disconnect SBC hydraulic unit harness connector (arrow, Figure 4) from SBC hydraulic unit (A) and remove cable tie (B, Figure 5).

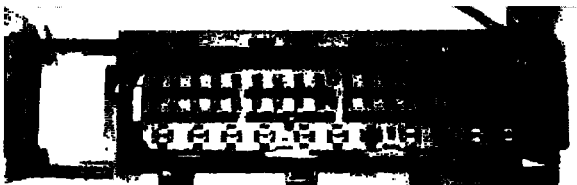
Figure 8a (Connector Type A)

There are two different versions of the SBC wiring harness connector (Figure 8a, b) installed in vehicles involved with this campaign.

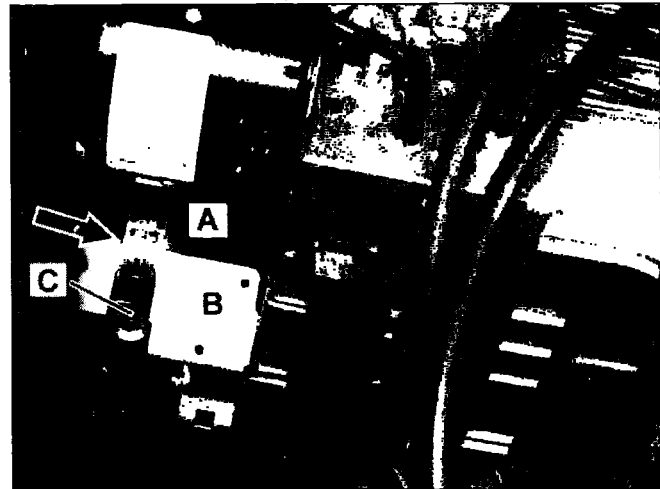
Figure 18

- Position mounting bracket (B) onto SBC hydraulic unit (A) as shown in Figure 18.

- Ensure mounting bracket (B, Figure 18) is flush with SBC hydraulic unit (A).
- Torque mounting clamp screw (C) to 5 Nm while pressing bracket (B) onto SBC unit (A).

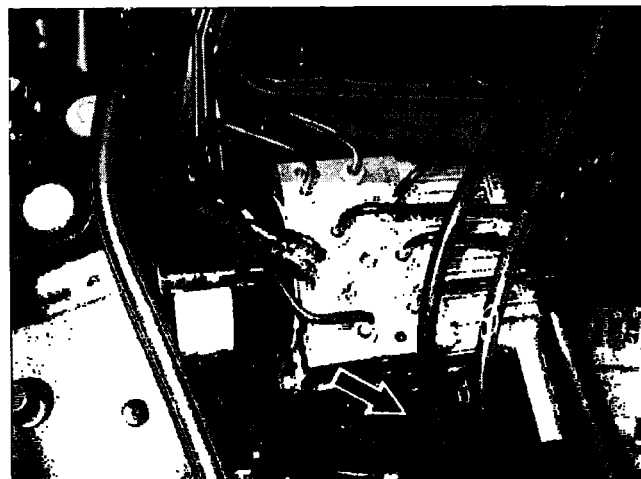
Figure 19

18. Connect the SBC wire harness connector (Arrow, Figure 19) to the SBC hydraulic unit and secure with connector locking mechanism.

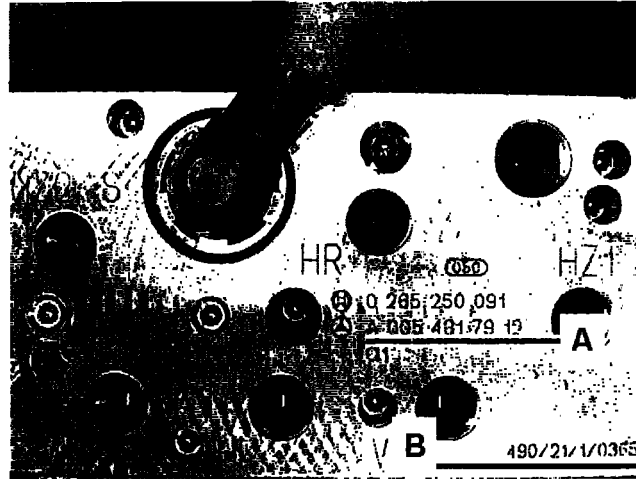
Figure 1

1. Check if part number (A, Figure 1) is listed in the table below:
 - If the part number (A) **is** listed, proceed to step 2.
 - If the part number (A) is **not** listed proceed to step 3.

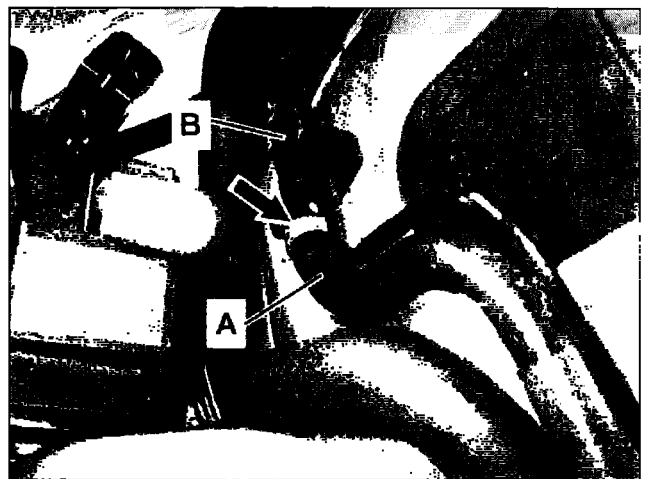
Figure 3

Do not use sharp-edged tools (e.g., screwdriver) to remove suction hose (A, Figure 3) from SBC suction line (B), this may cause damage to the suction line (B) and possible SBC brake system malfunctions.

- When removing suction hose (A, Figure 3), do not bend suction line.
- To prevent brake fluid from running out and to prevent contamination in the brake system, the suction hose (A, Figure 3) and line (B) are to be plugged using suitable plugs from the stop plug kit (Special Tool: W129 589 00 91 00).
- Discard old suction hose (A) and clamp (arrow) after removal.

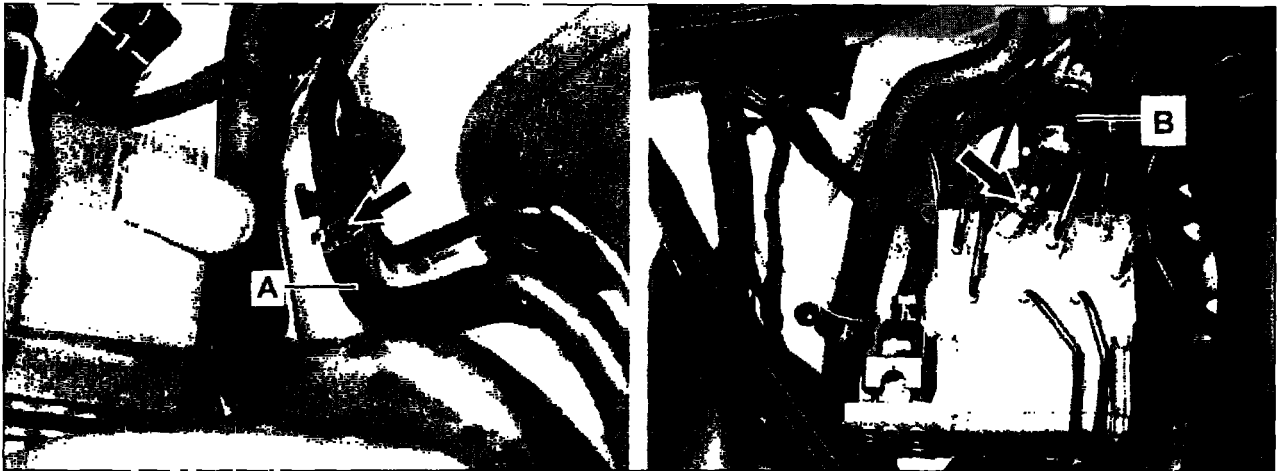
Figure 4

9. Check if a pulsation damper (B, Figure 4) was installed on suction hose:

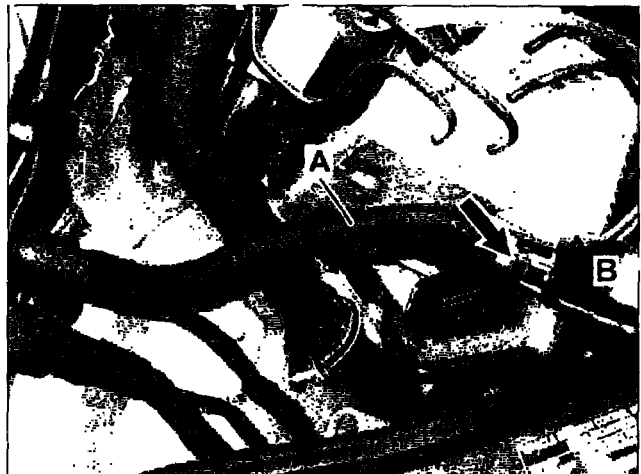
Figure 5

11. Remove cable tie (arrow, Figure 5) securing SBC wire harness (A) to SBC connector housing (B).

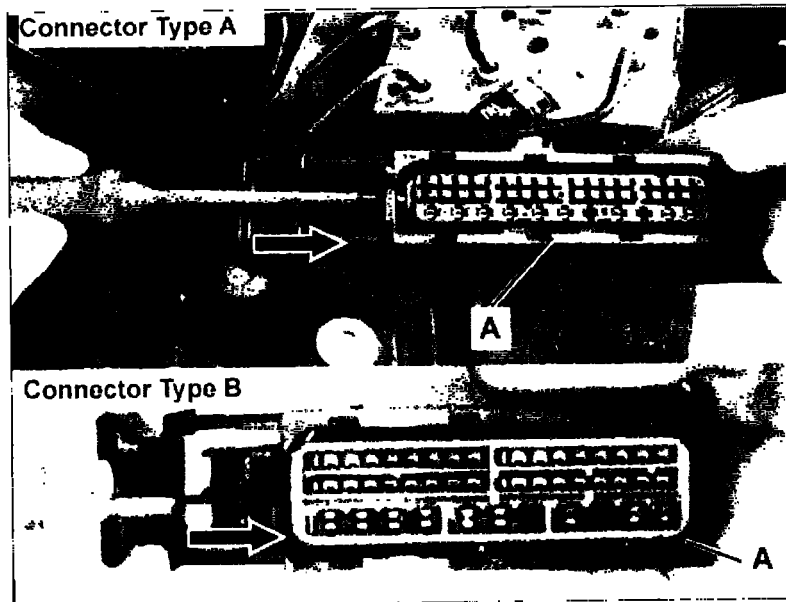
Figure 11

17. Close the (gray) secondary lock of the SBC connector housing (A, Figure 11) by sliding the lock in the direction indicated by the arrows (Figure 11) using a small screwdriver until it locks into place.
18. **Loosely** wrap the exposed SBC wire harness using fabric tape (arrows, Figure 12). **Do not** wrap the ground wiring harness (A) into the SBC wire harness.

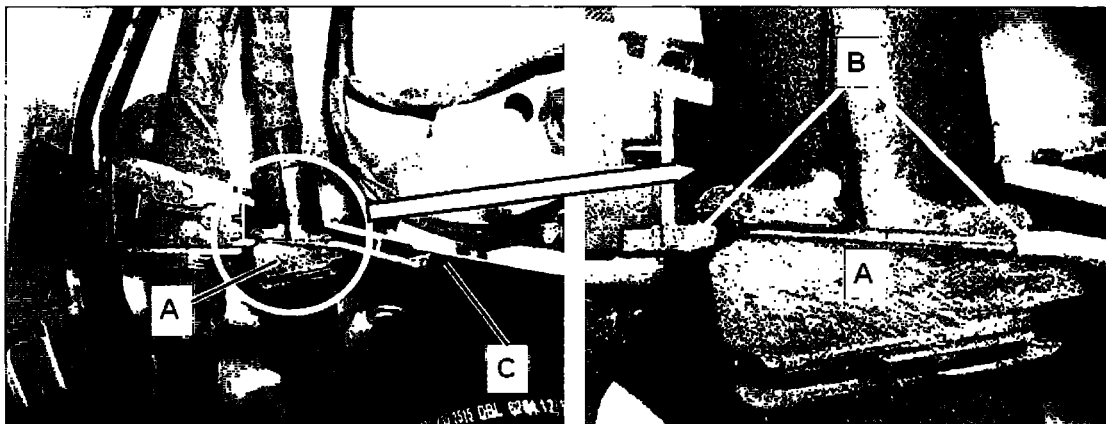
Figure 17

- Reposition SBC wiring harness with grommet (A, Figure 17) into the forward wall opening (B) in the wire harness guide (C).

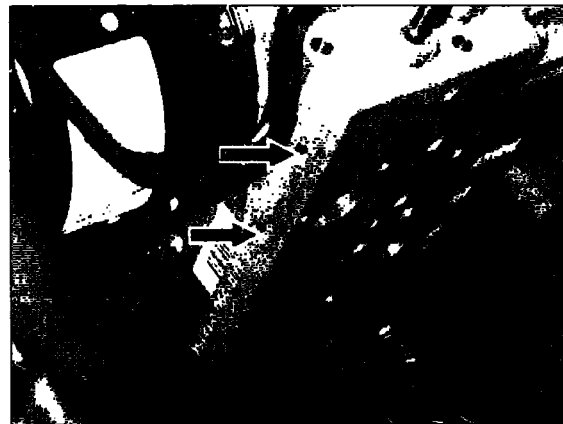
Figure 20

23. Attach SBC harness mounting bracket to the SBC hydraulic unit:

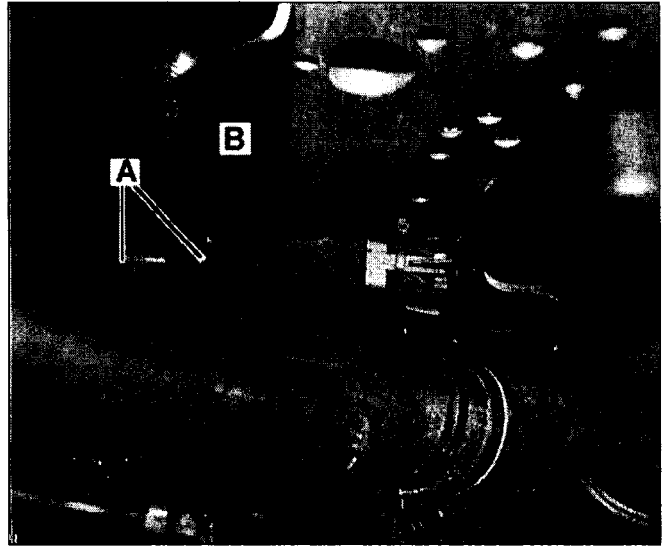
Figure 28

4. Quality measure 4:
- Ensure ground wires (A, Figure 28) are completely wrapped with fabric tape (as performed in step 21) in the area adjacent to the SBC hydraulic unit bracket (B) to ensure that the ground wires do not become chafed. Readjust tape as necessary to prevent chafing.

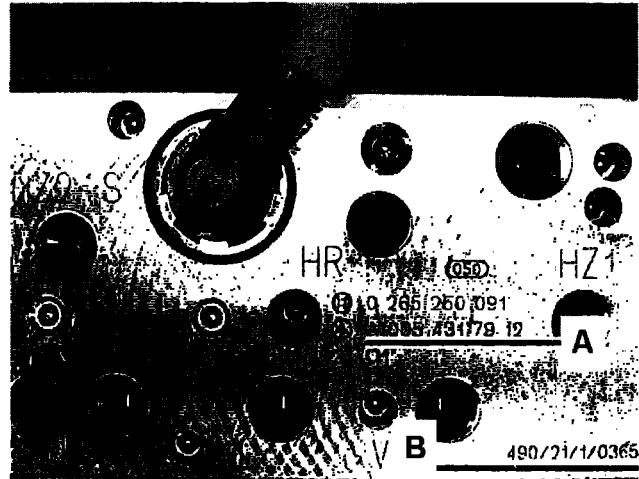
Figure 1

1. Check if SBC hydraulic unit part number (A, Figure 1) is listed in the table below:
 - If the part number (A) **is** listed, proceed to step 2.
 - If the part number (A) is **not** listed, proceed to step 3.

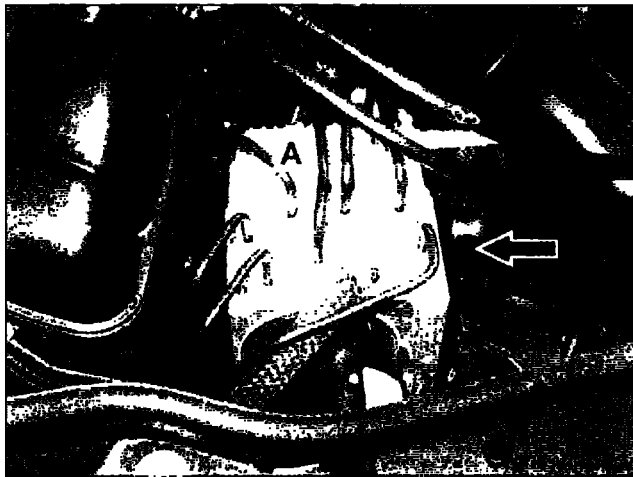
Figure 2a

3. Disconnect SBC hydraulic unit harness connector (arrow, Figure 2a) from SBC hydraulic unit (A) and remove cable tie (B, Figure 3).

4. Detach the SBC hydraulic unit ground wire harness (arrow, Figure 3) at ground terminal stud (A).
5. Position SBC harness connector (arrow, Figure 2a) away from SBC hydraulic lines to prevent brake fluid from dripping on SBC harness connector and SBC wiring harness.

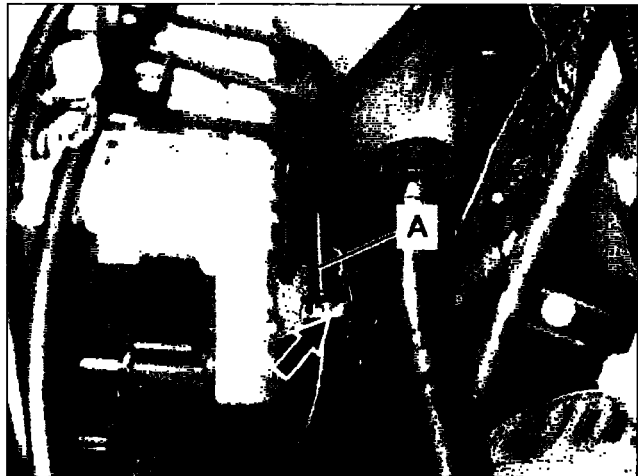
Figure 10

- Verify that the dimension X (Figure 9) on the **new** SBC suction hose (A) equals 20 cm. Adjust (if necessary) by repositioning the mounting clip (B) on the SBC suction hose (A).
- Place new hose clamp onto unmarked side of suction hose (C, Figure 9).
- Connect the unmarked end of the suction hose (C, Figure 9) onto the suction line (A, Figure 10) and secure hose with a **new** hose clamp (arrow, Figure 10).

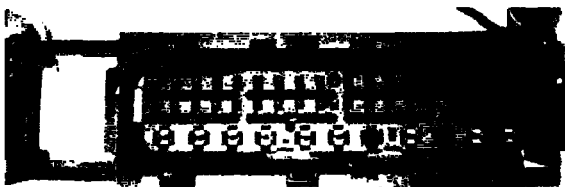
Figure 14a (Connector Type A)

There are two different versions of the SBC wiring harness connector (Figures 14a, b) installed in vehicles involved with this campaign.

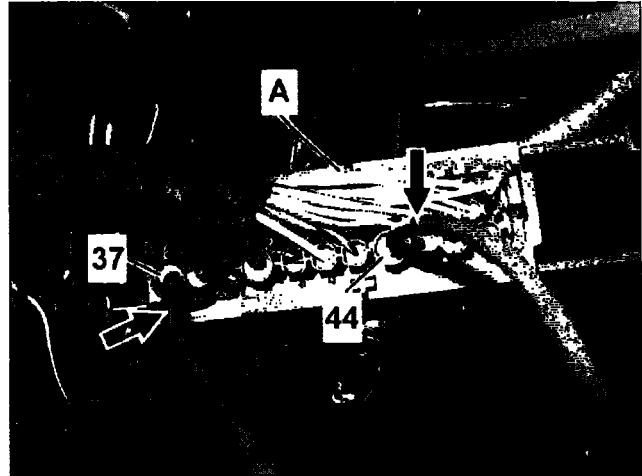
Figure 17

14. Remove SBC ground wires (arrows, Figure 17) from SBC harness connector (A):
 - Unpin SBC ground wire connectors (position 37 and 44) using cable release (Special Tools: W 000 589 13 99 30 and W 220 589 01 99 50) and remove ground wires (arrows) from SBC connector housing (A).
 - Discard old ground wire harness, it is no longer needed.
15. Insert the new ground wire harness (arrows Figure 17) into the SBC connector housing (A):
 - Insert **longer** ground wire into position 44.
 - Insert **shorter** ground wire into position 37.

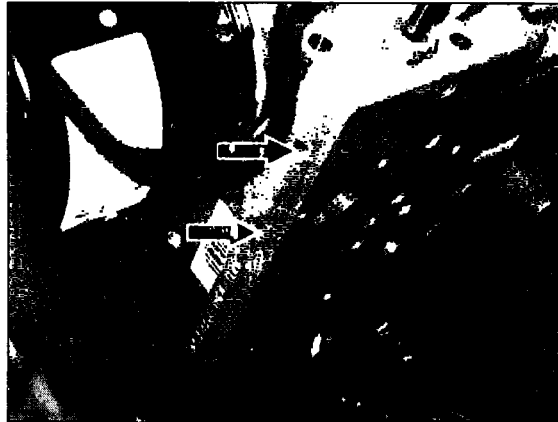
Figure 21

20. Attach SBC harness mounting bracket to the SBC hydraulic unit:

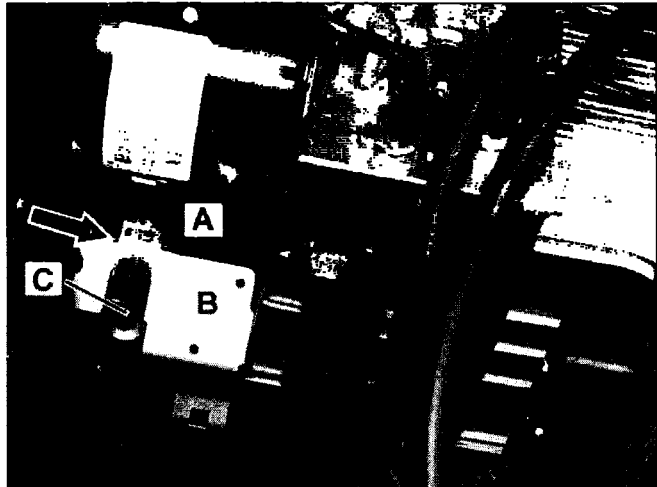
Figure 23

- Position mounting bracket (B) onto SBC hydraulic unit (A) as shown in Figure 23.

- Ensure mounting bracket (B, Figure 23) is flush with SBC hydraulic unit (A).
- Torque mounting clamp screw (C) to 5 Nm while pressing bracket (B) onto SBC unit (A) (Proceed to step 24).
