Recall Campaign Bulletin

Campaign No. 2005110001, December 2005

SUBJECT: **MODEL 211, MODEL YEAR 2003-2006**
MODEL 219, MODEL YEAR 2006
MODEL 230, MODEL YEAR 2003-2005
INSTALLATION OF GROUND WIRES AND BRACKET TO SBC WIRING HARNESS

This Recall Campaign has been initiated because DCAG has determined that on the affected vehicles (see VIN range on the following page) the SBC brake system may shift to the hydraulic back up mode due to the loosening of the ground wire harness connection over time. Dealers will install a bracket and replace the ground wire.

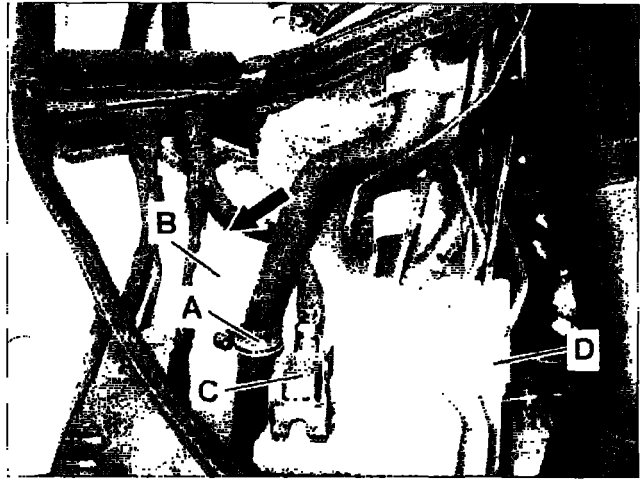
Figure 3

1. Lock the vehicle globally and then wait for 30 seconds for the SBC control module to power-down.
2. Loosen hose mounting strap (A, Figure 3) and reposition hose and strap (A) to create more working space.
3. Disconnect harness connector (C, Figure 3) from the SBC hydraulic unit (D).
4. Detach the SBC hydraulic unit ground wire (arrow, Figure 3) at ground terminal (B).
5. Remove cable tie (arrow, Figure 4) securing SBC wire harness (A) to SBC connector housing (B).
