FILE: SERVICE: GROUP 00 OF SERVICE INFORMATION BINDER  
PARTS: GROUP I OF INFORMATION - PARTS & ACCESSORIES BINDER

Campaign No. 2005110001, April 2006

SUBJECT: **MODEL 211, MODEL YEAR 2003-2006**  
**MODEL 219, MODEL YEAR 2006**  
**MODEL 230, MODEL YEAR 2003-2005**  
**INSTALLATION OF GROUND WIRES AND BRACKET TO SBC WIRING HARNESS**

This Recall Campaign has been initiated because DCAG has determined that on the affected vehicles (see VIN range on the following page) the SBC brake system may shift to the hydraulic back up mode due to the loosening of the ground wire harness connection over time. Dealers will install a bracket and replace the ground wire.

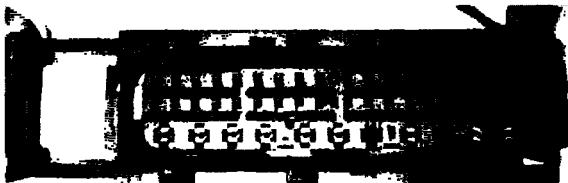
Figure 7a (Connector Type A)

There are two different versions of the SBC wiring harness connector (Figure 7a, b) installed in vehicles involved with this campaign.

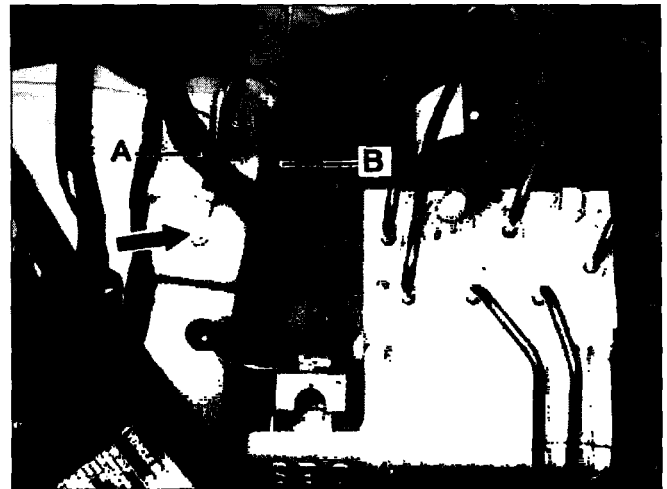
Figure 25

3. Quality measure 3:
  - Ensure tightening torque on ground terminal stud (arrow, Figure 25) is **between 7 and 10 Nm**.
