# RECALL BULLETIN 05V-261 (Rev. A)

DATE: OCTOBER 7, 2005  
 MODEL YEAR: 2002– Certain Early Production 2005 Model Years  
 CHASSIS MODEL: UD1200/UD 1300/UD1400  
 BULLETIN NUMBER: SC-261  
FILE IN THE ELECTRICAL SECTION OF THE TECHNICAL BULLETIN BINDER  
 (Discard previous Recall Bulletin dated September 12, 2005)

**VOLUNTARY SAFETY RECALL CAMPAIGN NUMBER 05V-261:  
 BATTERY CABLE REPLACEMENT**

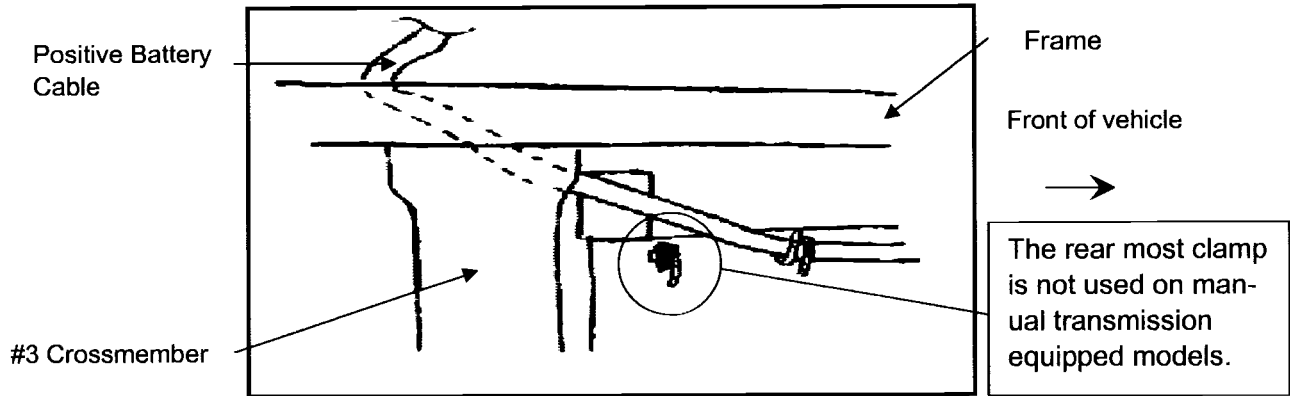
**Figure C**

**On Manual Transmission Models:** Do not use the rear most retaining clip on the transmission shift cover securing the battery cable on manual transmission, see illustration Figure C for details.
