RECALL CAMPAIGN BULLETIN

NTB06-053

VOLUNTARY RECALL CAMPAIGN 2005 MAXIMA; CHILD SEAT ANCHOR BRACKETS

CAMPAIGN I.D. # / NHTSA # R0605 / 05V-338
APPLIED VEHICLES: 2005 Maxima (A34)
APPLIED VINS: 1N4BA41E(*)5C 806853 - 875538

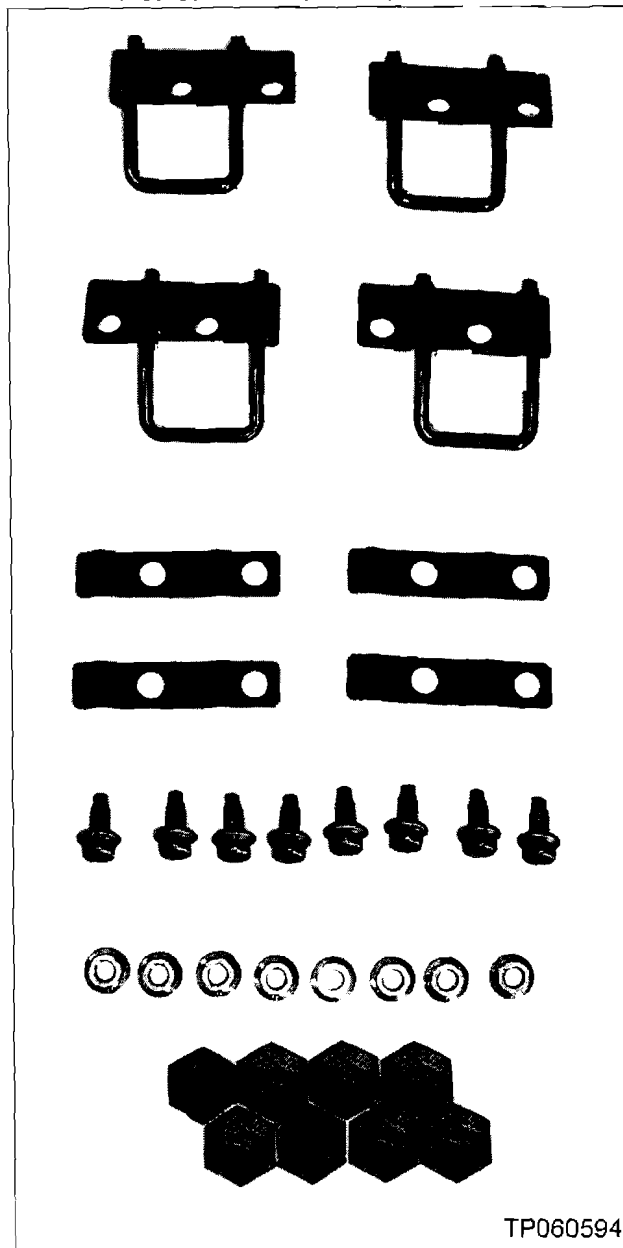
Anchor Bracket Extension Kit

Each Bracket Kit Includes:

4 Upper Child Seat Anchor Bracket Extensions

- 2 right and 2 left

4 Lower Child Seat Anchor Bracket Extensions (all the same).

8 Bolts

8 Nuts

8 Self adhesive foam covers

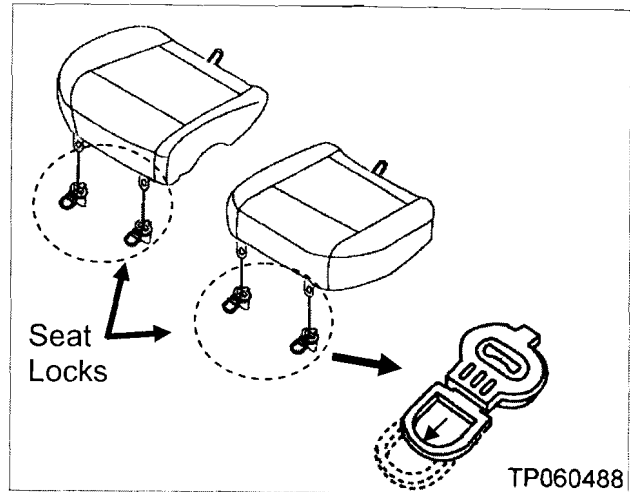
- a. Pull the two seat locks shown in Figure 1 for each cushion.
- b. Pull each seat cushion up/out of the seat locks.
- c. Pull each seat cushion forward and remove it from the vehicle.
 - If equipped with heated seats, disconnect the electrical connector.
- d. Place the cushions in a clean area.

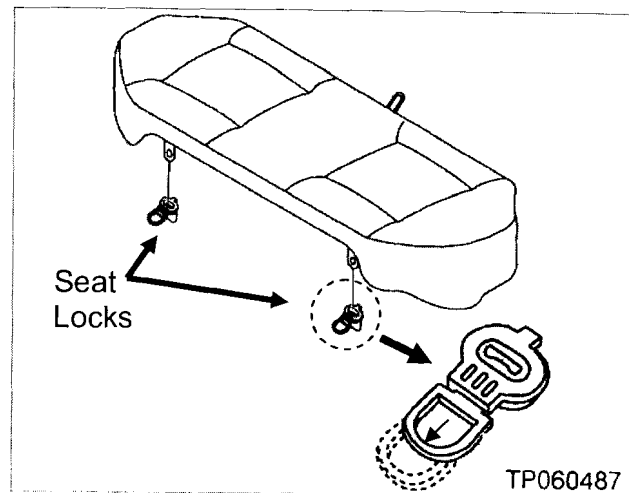
Figure 2

- a. Pull the two seat locks shown in Figure 2.
- b. Pull the seat cushion up/out of the seat locks.
- c. Pull the seat cushion forward and remove it from the vehicle.
- d. Place the cushion in a clean area.

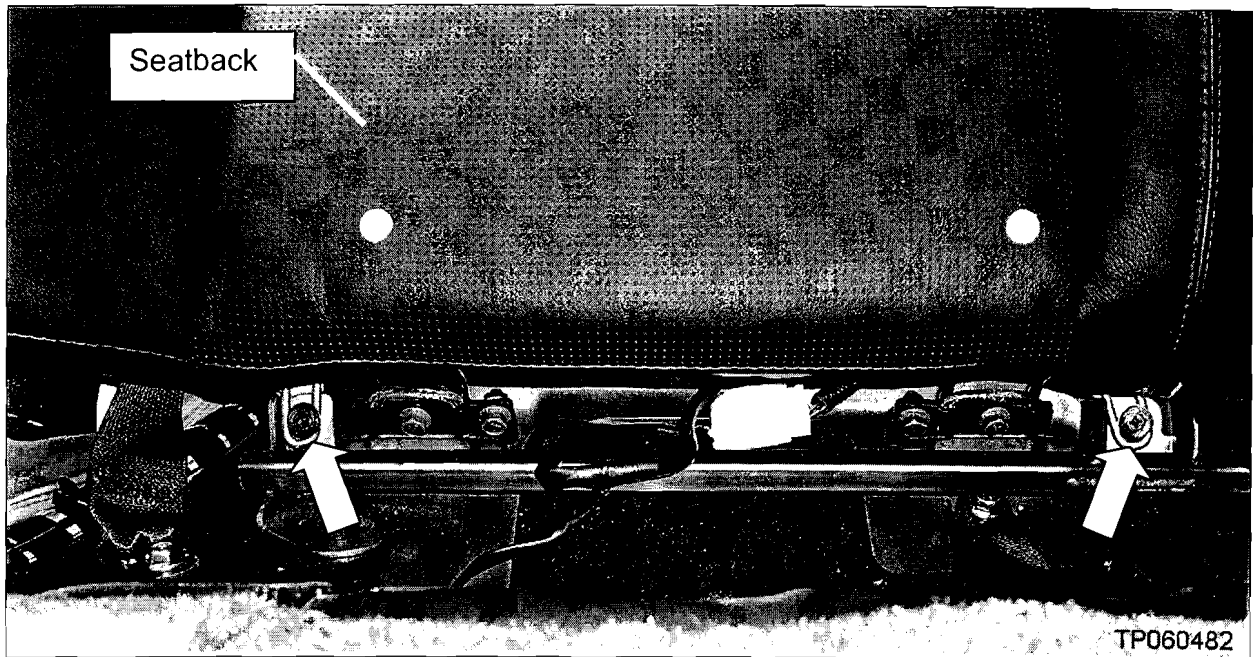
a. Remove the bolts shown in Figure 3 for each seat back (Left and Right).

4 passenger bucket seat: 9.4 N.m (1.0 Kg-m, **7 ft-lb**)

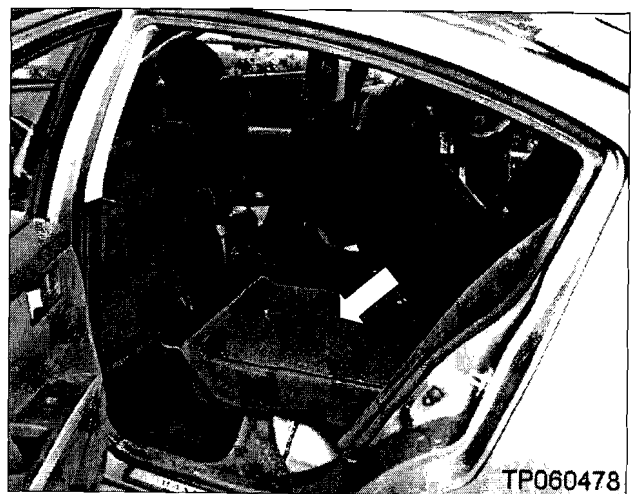
Figure 4

a. Open the trunk and pull the seatback latch release straps.

b. Fold down both seat backs.

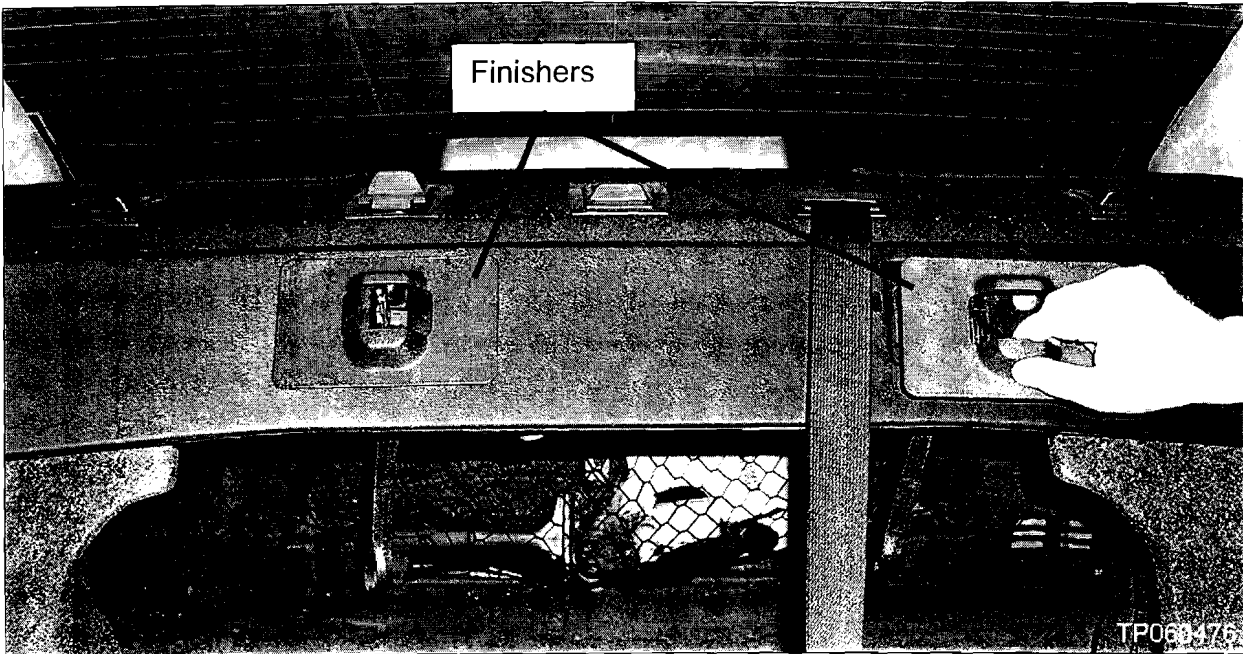
Figure 5

c. Remove the finishers shown in Figure 5.

- Just pull them off.

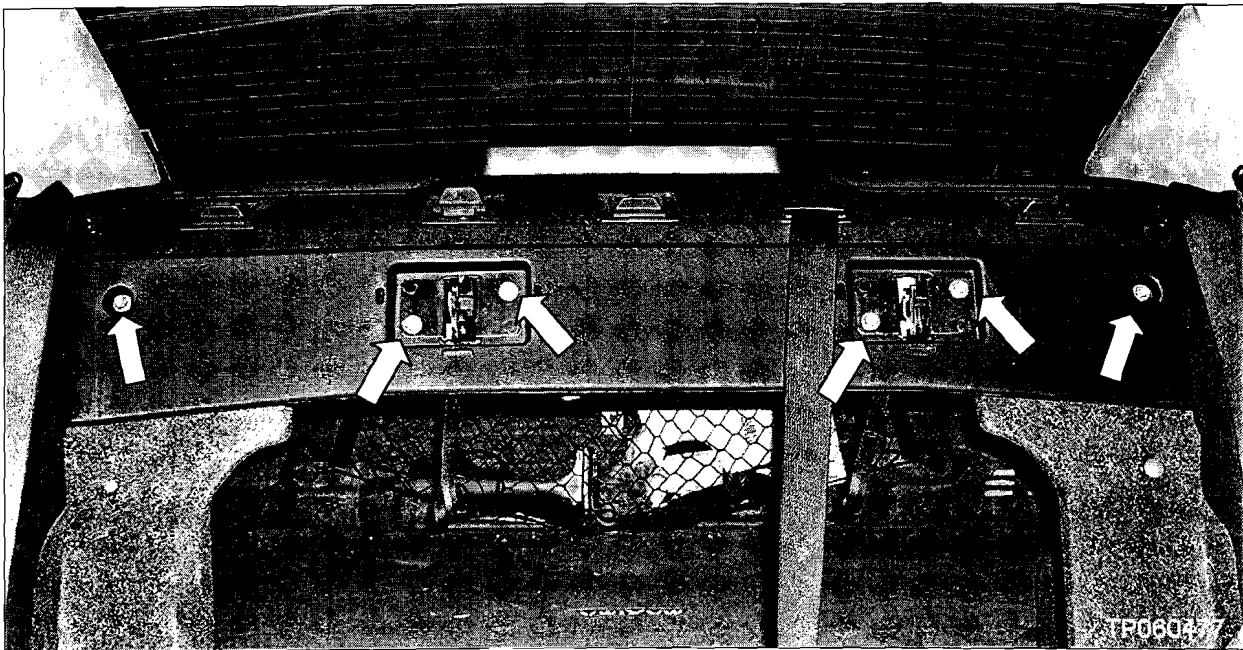
Figure 6

d. Remove the 6 bolts shown in Figure 6.

5 passenger bench seat: 14.9 N.m (1.5 Kg-m, **11 ft-lb**)

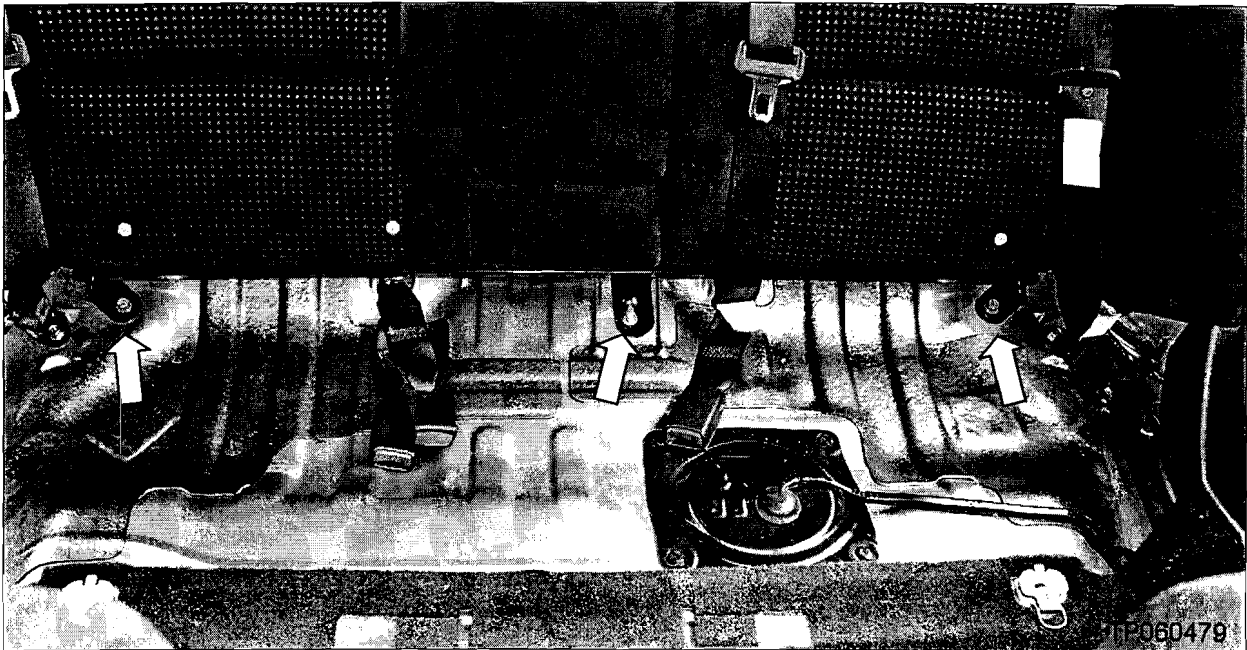
Figure 8

- f. Remove the 2 bolts and the center nut shown in Figure 8.

- g. Carefully lift the seatback off of the center threaded stud.
- h. Use 2 people to **CAREFULLY** remove the seatback from the vehicle.
- Place the seatback in a clean area.

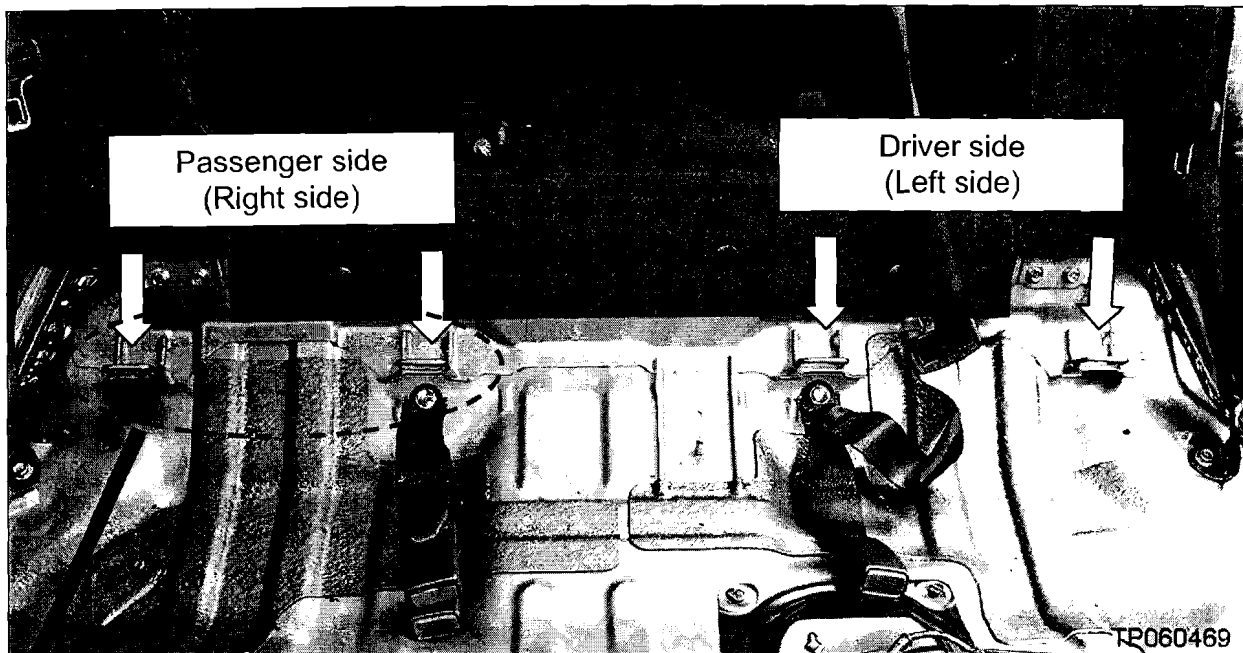
Figure 9

With the seat cushions and the seatbacks removed you can see the 4 child seat anchor brackets (see Figure 9).

You will be installing anchor bracket extensions on each (all four) of the anchor brackets.

There is a left and a right bracket for the passenger side, and a left and right bracket for the driver side.

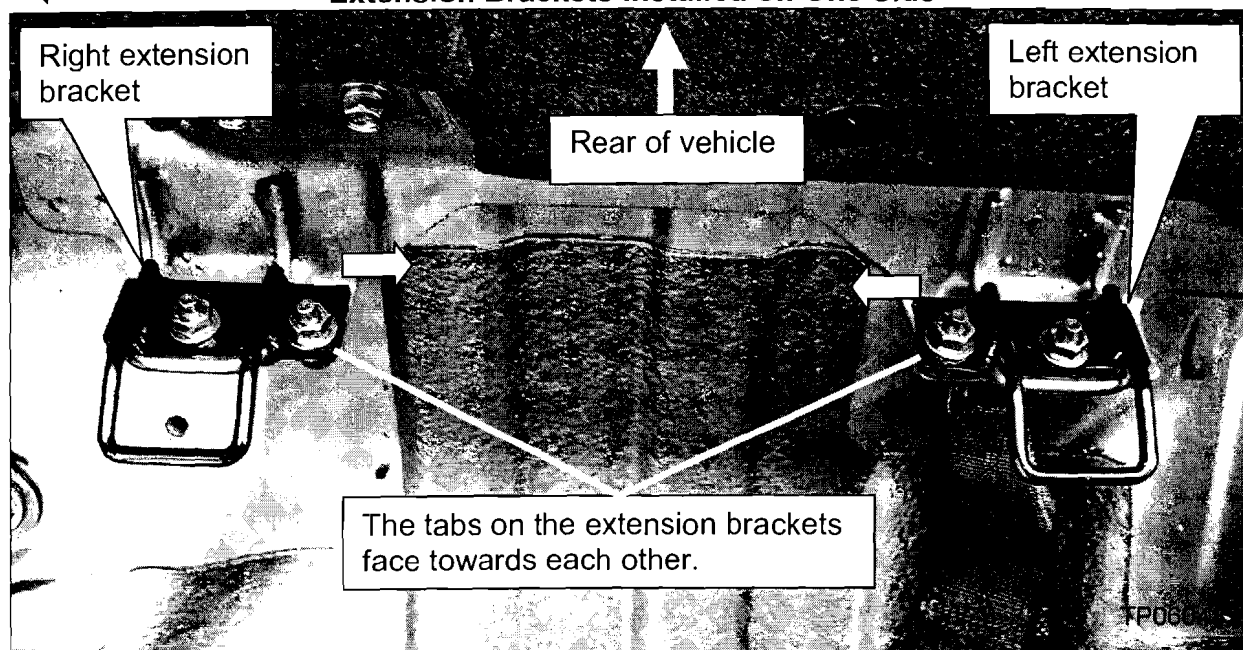
Figure 10

Extension Brackets Installed on One Side

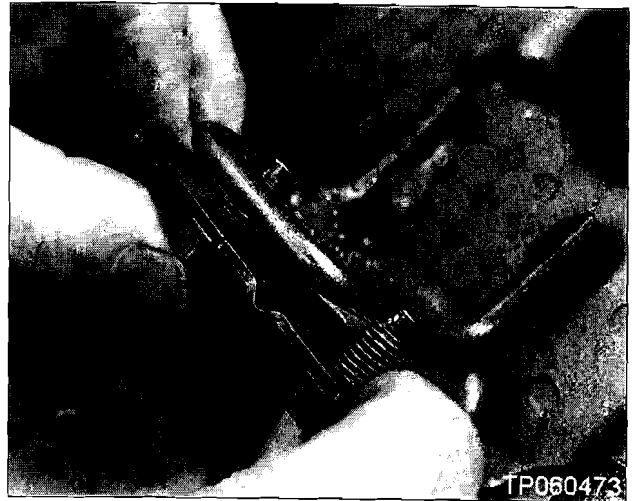
Figure 11

a. Put the bolts in the lower half of the extension bracket.

b. Hold the lower half in place.

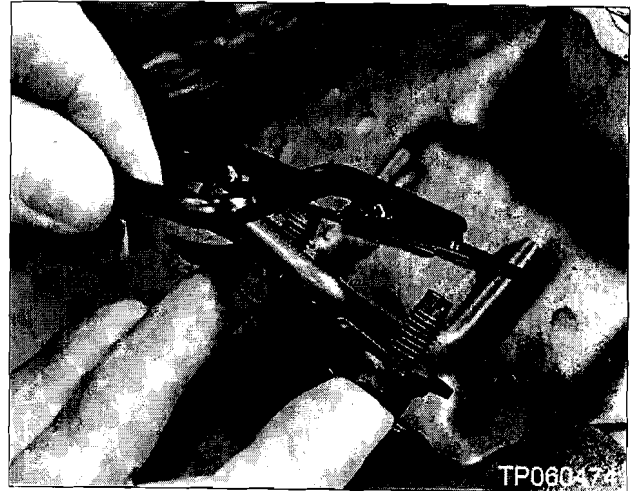
Figure 12

c. Place the upper half over the bolts.

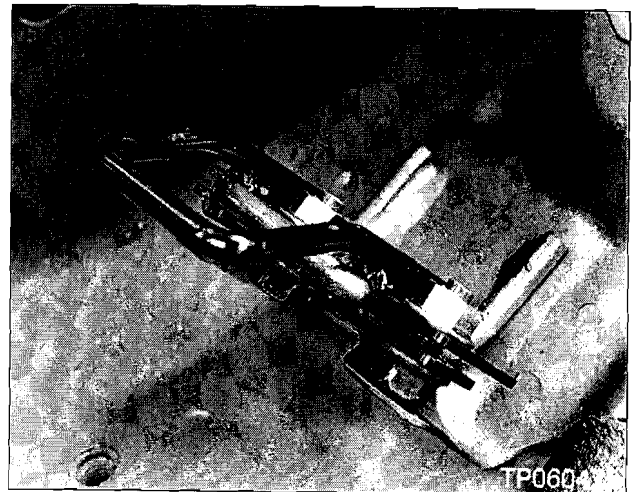
Figure 13

d. Install the nuts finger tight.

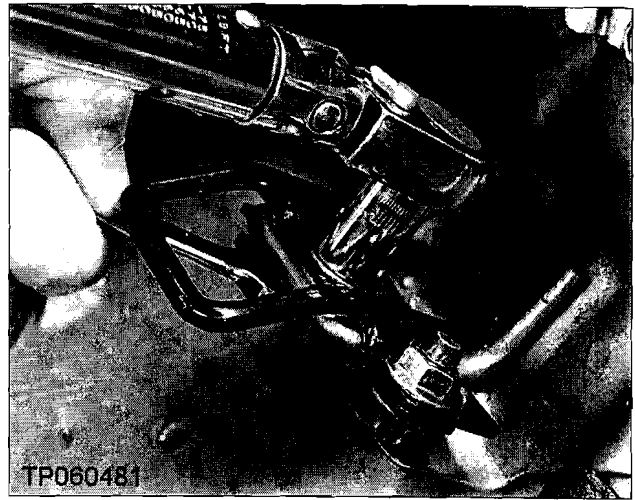
Figure 14

- e. Torque the bolts / nuts to:
35.25 N.m (3.6 Kg-m, **26 ft-lb**)

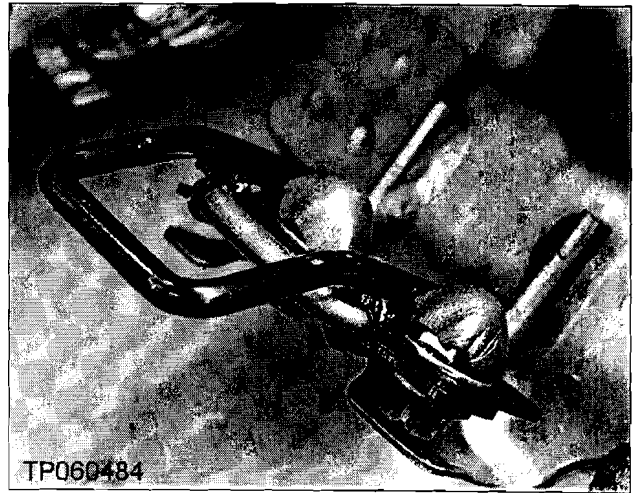
Figure 15

- f. Install the self adhesive foam covers over the nuts.

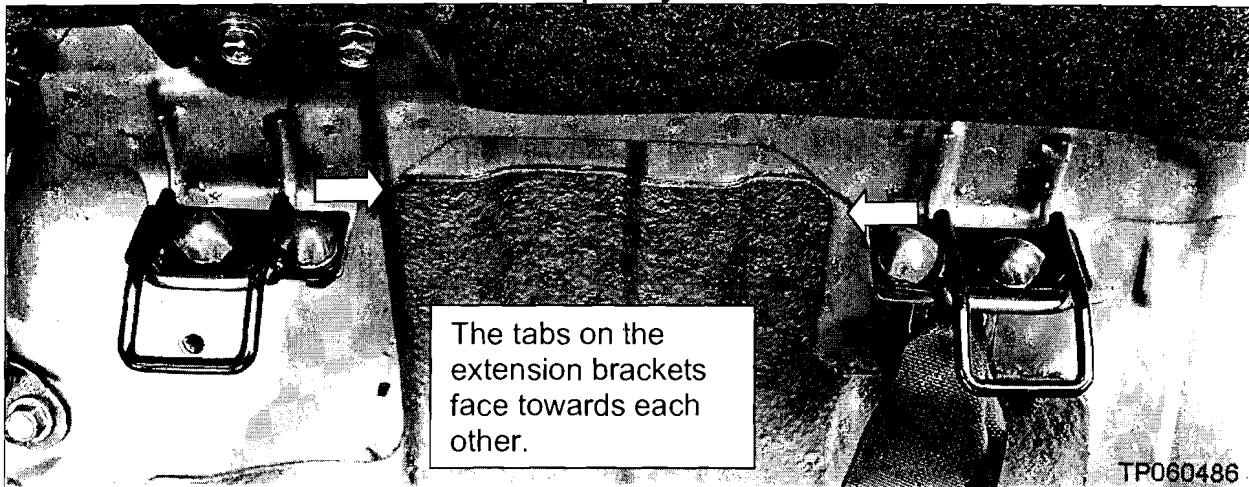
Figure 16

Anchor Brackets Completely Installed for One Side

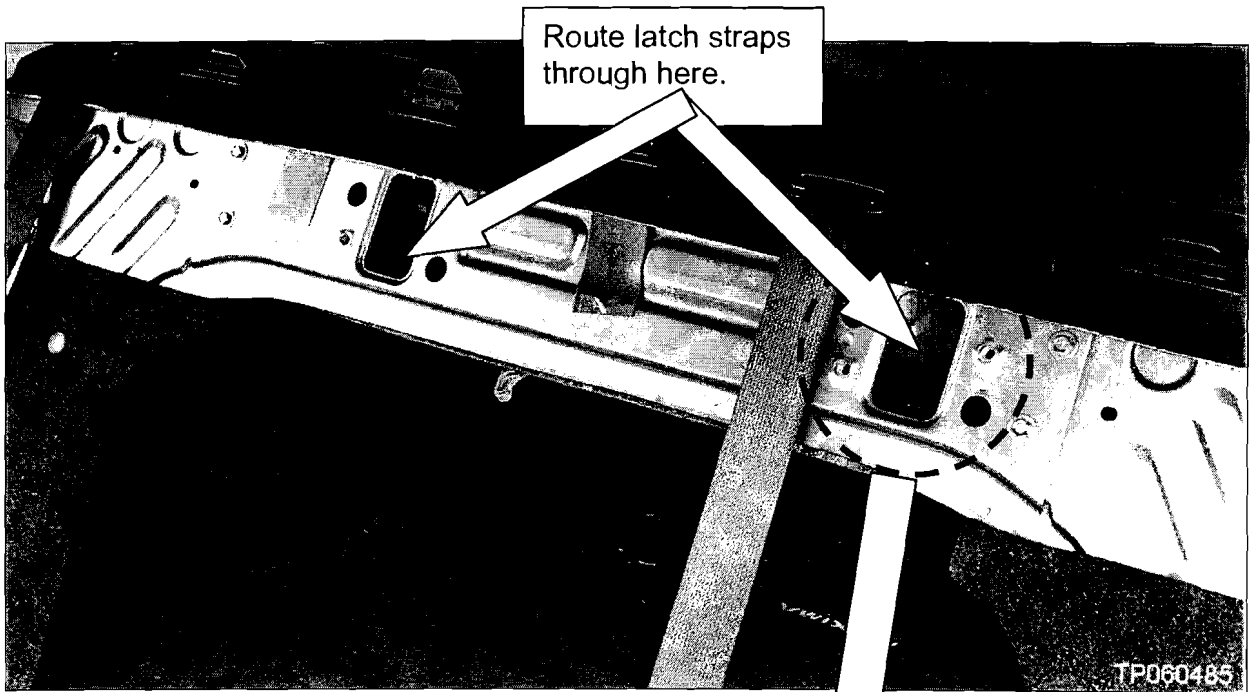
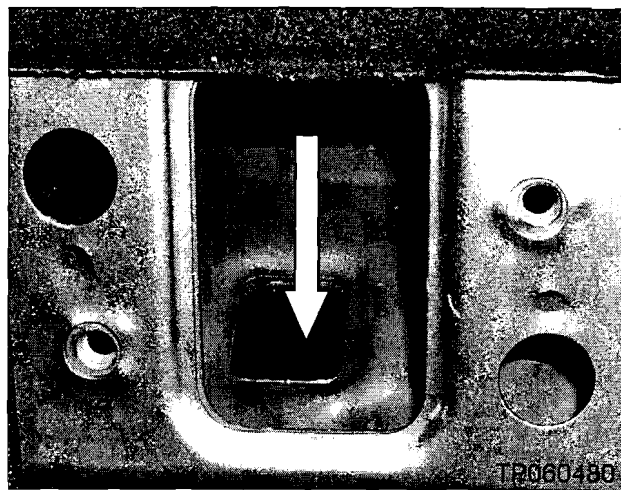
For 5 passenger Maxima (rear bench seat); make sure the seat back latch straps are routed through the holes in the body (see Figure 17 and 18).
