TECHNICAL SERVICE BULLETIN

SUBJECT:
RECALL CAMPAIGN: 2003 SORENTO FUEL LINE REPLACEMENT

This bulletin provides information relating to replacement of fuel lines at the fuel tank assembly. Some 2003MY Sorento vehicles produced between 6/7/02 ~ 8/14/02 may experience a fuel leak near the fuel tank because the fuel line is rubbing against the body and frame. Kia is replacing sections of the fuel lines on all affected vehicles within the production range.

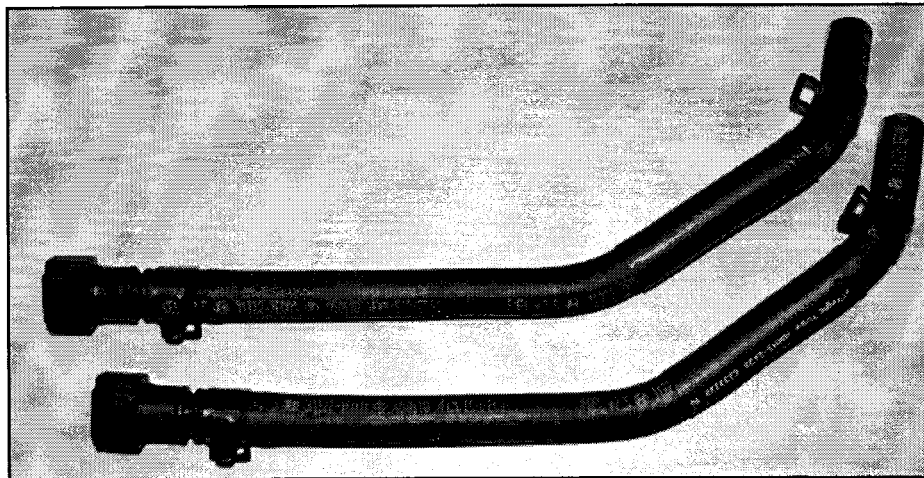
Fuel Hose — (P/N: Q3132 23E000Q Consists of One [1] Fuel Hose) - Two (2) Required Per Vehicle

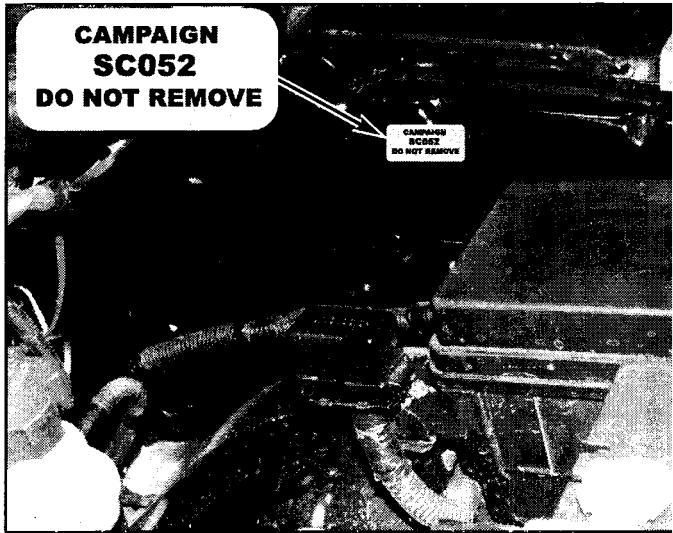
1. Open hood and check for SC052 Campaign Completion Label on inner fender above underhood fuse box.
 - If label exists, Campaign SC052 has been completed - NO FURTHER ACTION IS REQUIRED.
 - If Campaign SC052 label DOES NOT EXIST, continue on to FUEL LINE REPLACEMENT.

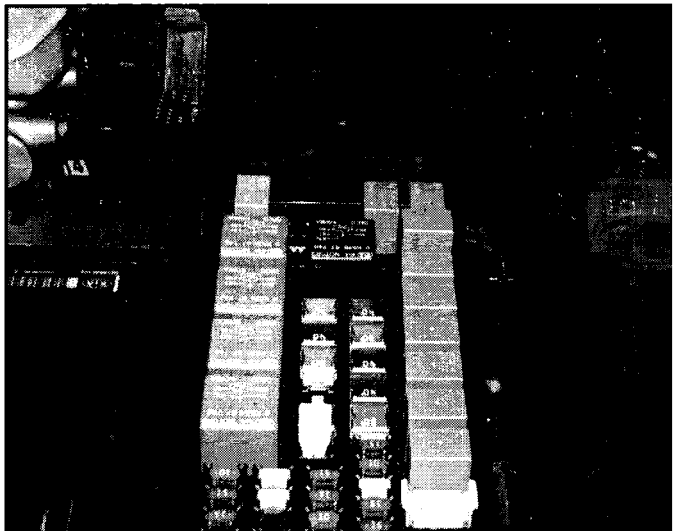
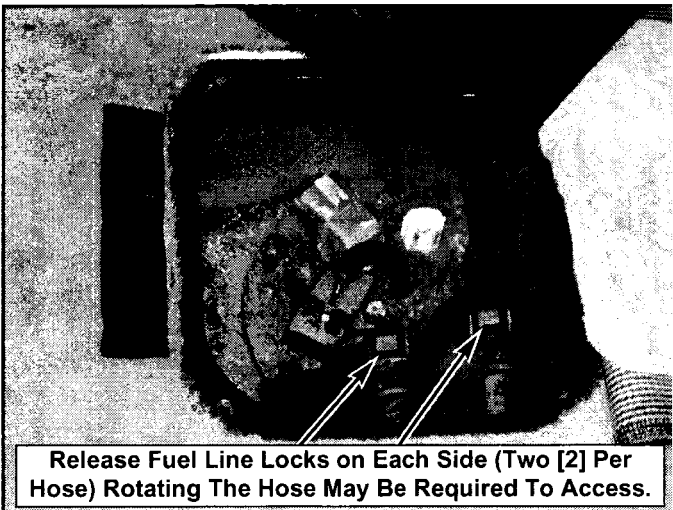
1. Remove the fuel filler cap and pull fuel pump relay from the underhood fuse box, start the engine and allow it to run until the engine stalls. This will decrease the fuel system pressure in the fuel lines for removal. Turn off ignition, replace the fuel pump relay and fuse box cover.
2. Lift the right rear seat bottom to gain access to the fuel pump module. Remove access cover and disconnect the electrical connectors. Place a shop rag under the fuel line connections before removing them to prevent fuel from spilling onto the top of the fuel tank. Depress the fuel line lock and remove the fuel lines from the fuel pump assembly.

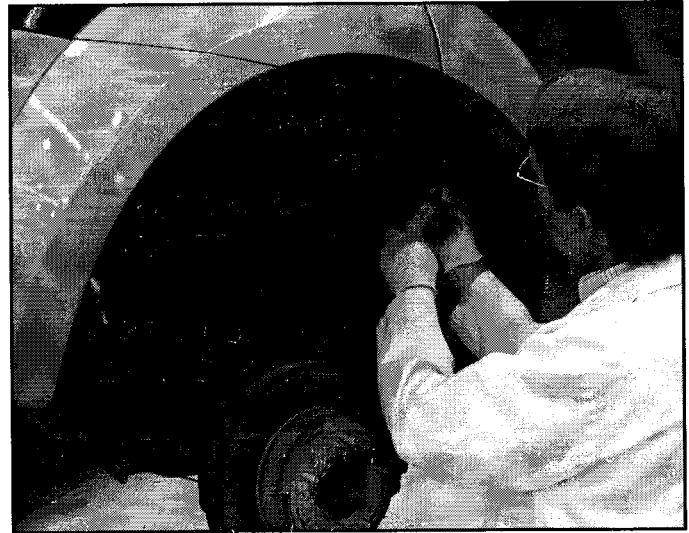
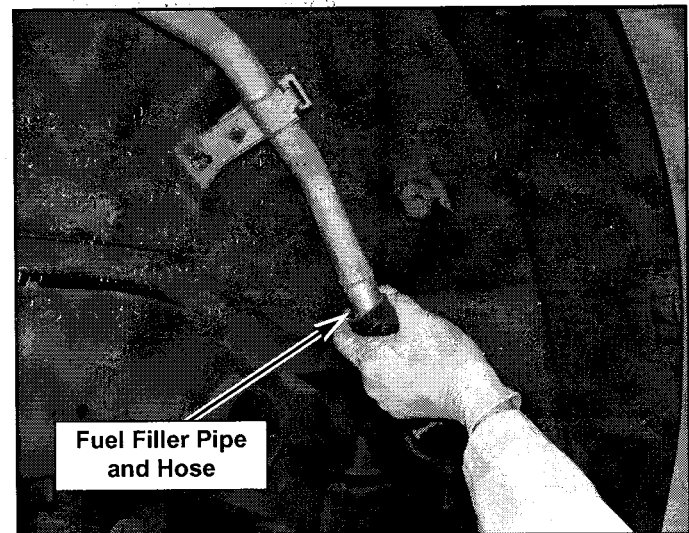
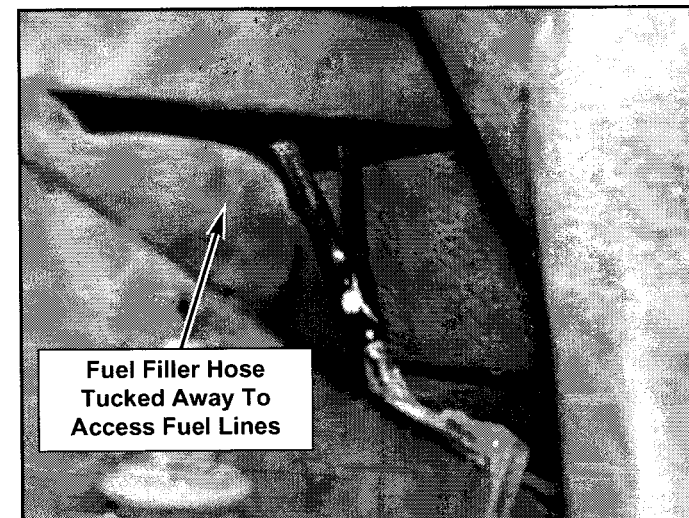
3. Raise and properly support the vehicle as required. Remove right rear wheel and tire assembly.
4. Remove the inner fender well shield from the right rear wheel well to access the fuel lines.
5. Disconnect the fuel filler hose from the fuel filler pipe. Tuck the filler hose into the tank area to gain access to the fuel lines, as shown.

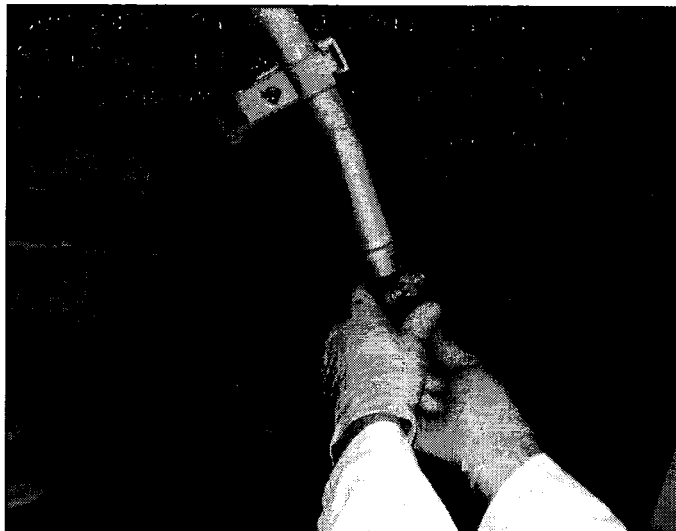
2. Connect the rubber fuel filler hose to the steel filler neck, install and tighten hose clamps.

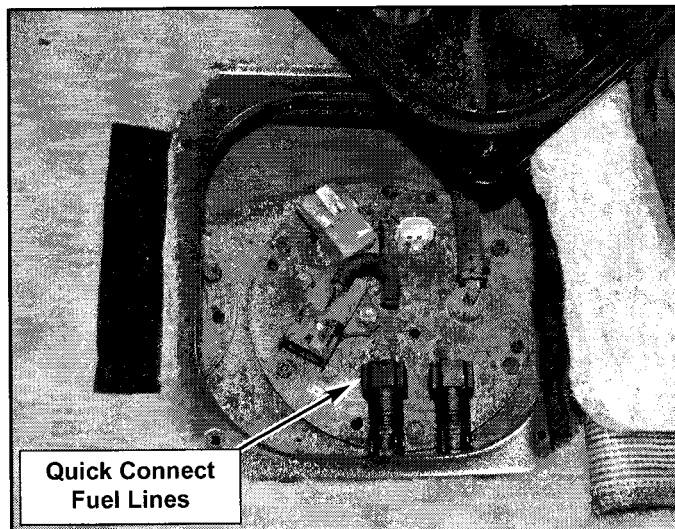
- Lower the vehicle, install the fuel lines to the fuel pump module.

With other end of lines properly installed and not crossed, supply and return lines should be facing the correct connection points on the pump.

Connect the electrical connectors to the fuel pump module.

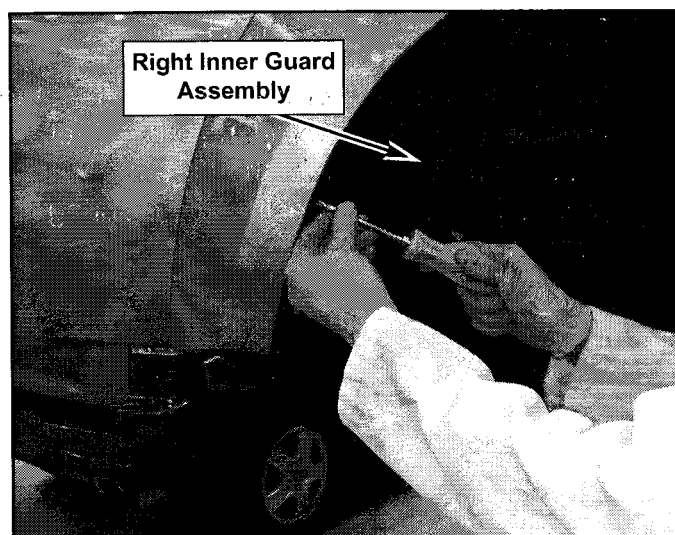
- Start the engine, let it run for 15 seconds and turn the ignition key to the OFF position. Check for fuel leaks, if any are found, repair as necessary.
- Install the fuel pump access cover. Lower the rear seat as required.
- Install the inner wheel guard.

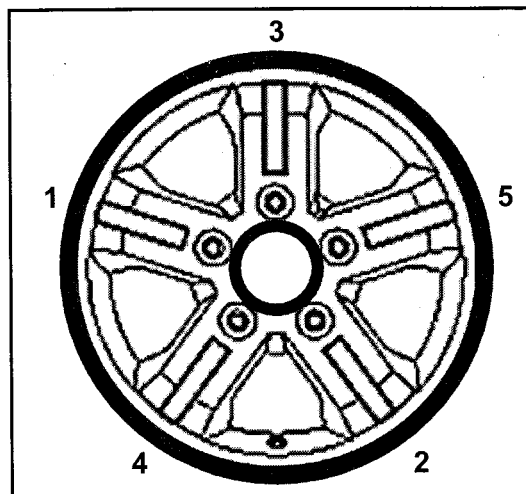
- Install wheel and tire assembly, snug nuts first, then tighten the wheel nuts to 65~86 lb ft. (90~120 Nm) in correct sequence (see illustration).

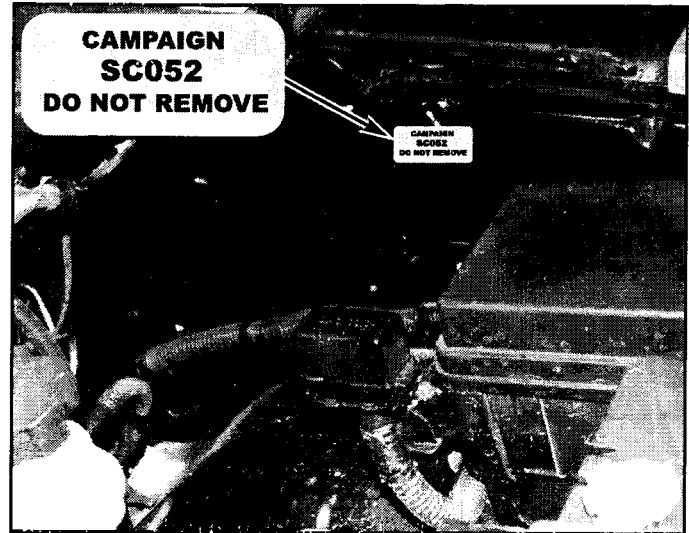
- 8. Install the fuel filler cap and attach the SC052 Campaign Completion Label to the inner fender above underhood fuse box.
