# SERVICE BULLETIN

Bulletin: SRE06-07

**Subject: Recall P001 – Quarantine Notification for Affected Vehicles  
Fuel Tank Replacement**

P001 – Repair Procedure

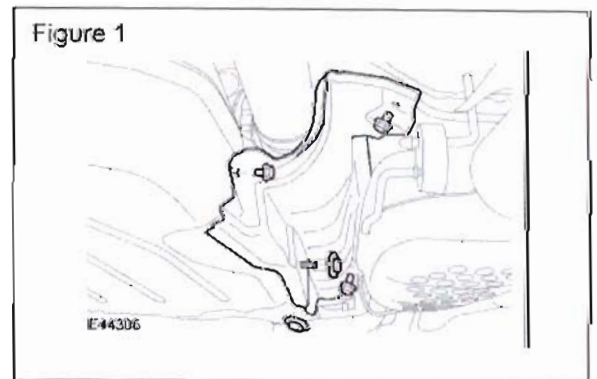
3. Raise and support the vehicle.
4. Remove the three bolts and two nuts securing the fuel tank heat shield (Figure 1).

13. Install the fuel tank heat shield as follows:

- Position the shield to the tank.
- Tighten the bolts to 5 Nm (4 lbf-ft).
- Tighten the nuts to 3 Nm (2 lbf-ft).

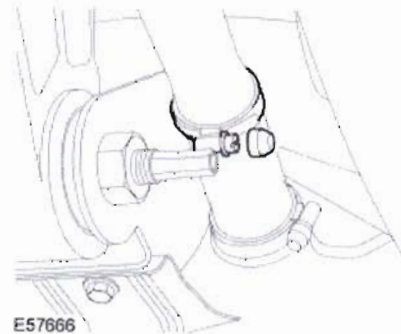
Figure 2

5. Disconnect the fuel filler neck from the filler neck hose:
  - Remove the tamper-proof clamp screw cover if fitted.
  - Remove the hose clamp from the filler connector hose. (Figure 2)
6. Disconnect the fuel supply and purge lines quick release connections at the front of the fuel tank. (Figure 3)
7. Disconnect the fuel tank vent line at the rear of the fuel tank, over the integrated body frame. (Figure 4)
8. Release the fuel tank harness.
9. Release the parking brake emergency release cable and the two emergency release cable clips. (Figure 5)

12. Connect the fuel filler neck as follows:

- Position the removed retaining hose clamp over the tank hose.
- Install the hose over the filler pipe.
- Tighten the hose clamp to 3-4Nm (2-3 lbf-ft).

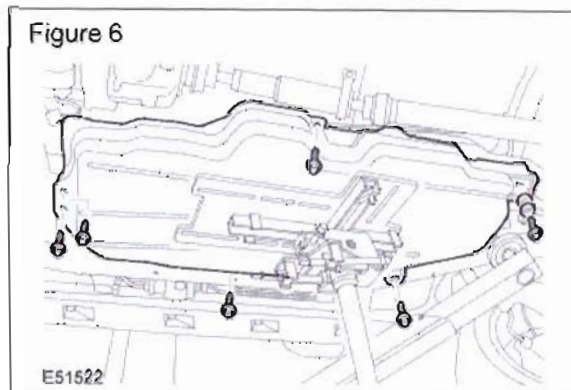
Figure 6

**NOTE:** The rear bolt is fitted with 2 washers.

10. Secure the tank to a suitable transmission jack and remove the six fuel tank retaining bolts. (Figure 6)

**NOTE:** The rear bolt is fitted with 2 washers.

6. Install the fuel tank and tighten the bolts to 45Nm (33 lbf-ft).

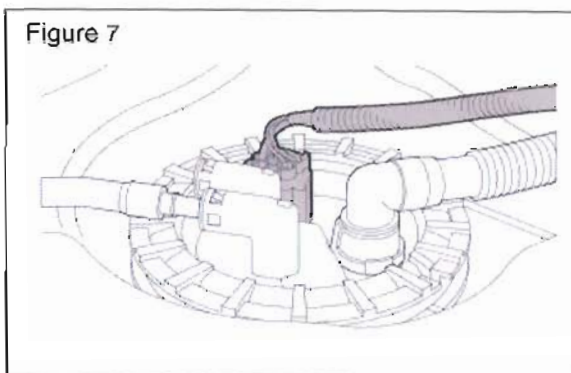
Figure 7

12. Disconnect the fuel pump module electrical connector. (Figure 7)

5. Connect the electrical connector.

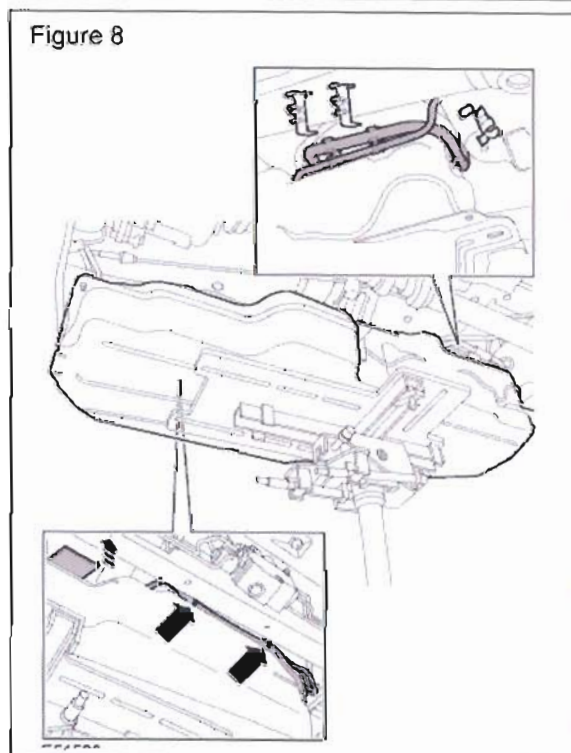
Figure 8

13. Release the purge line from the top of the fuel tank (Figure 8):

- Remove the adhesive pad.
- Release from the five clips.

4. Secure the purge line to the fuel tank:

- Secure with the clips.
- Install the adhesive pad.

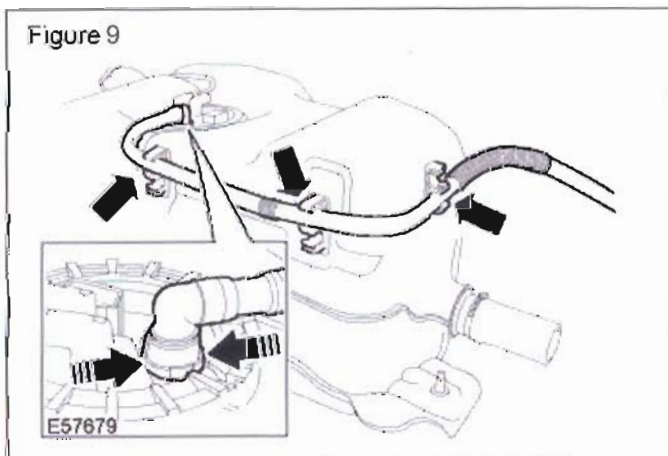
Figure 9

15. Remove the fuel tank vent line (Figure 9):

- Disconnect the quick release connector.
- Remove from the 3 clips

10. Install the vent line as follows:

- Connect the quick release connector.
- Secure into the 3 clips

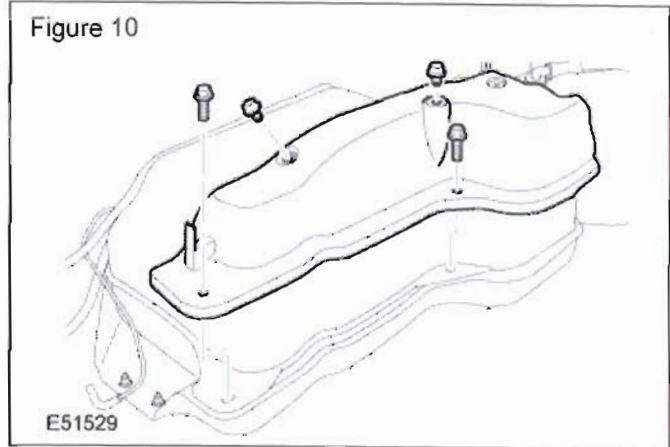
17. Remove the fuel tank bracket (Figure 10):

- Remove the two clips.
- Remove the two bolts.
- Remove the retaining plate.

1. Install the fuel tank bracket on the new tank assembly:

- Install the retaining plate.
- Install the clips.
- Tighten the bolts to 3.5Nm (2.5 lbf-ft)
