BULLETIN NUMBER:
SB06-11-S002

REAR SIDE DOOR CLOSURE PRODUCT SAFETY RECALL 05V-494

2003 Isuzu Ascender (US)

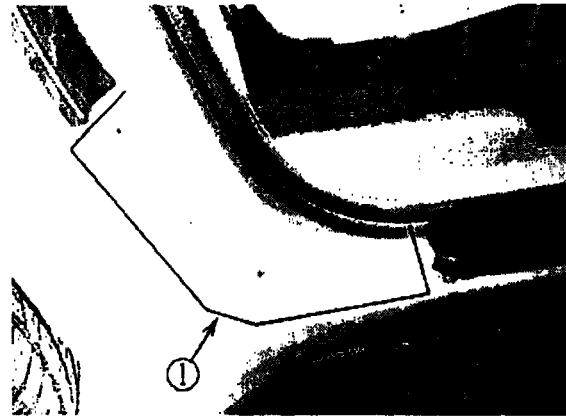
1. Ensure that the rear rocker panel in the tape contact area (1) is clean and dry. Use a non-oil based cleaner, preferably isopropyl alcohol.

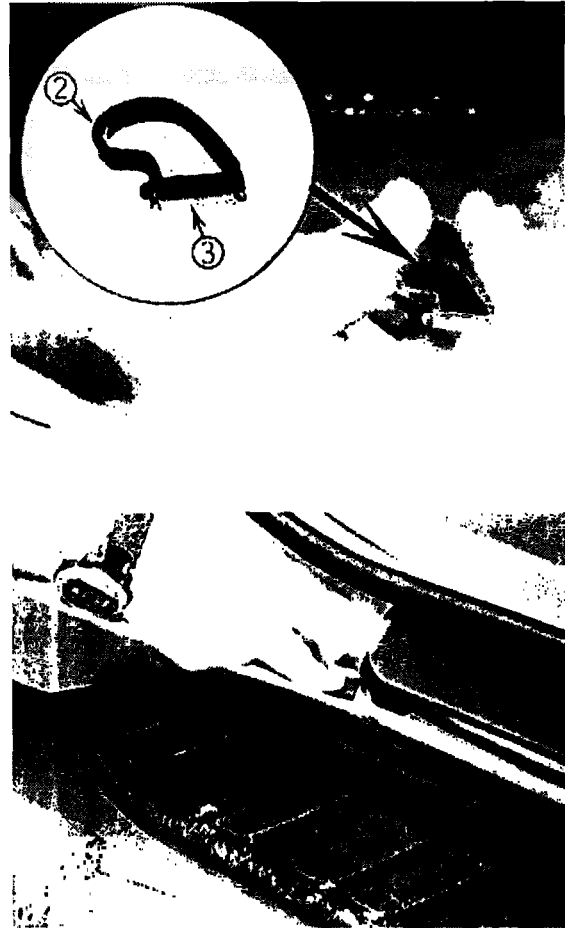
3. Using the line from the china marker (4) as a guide and starting at the sill plate, install the seal along the rear rocker panel with seal bulb (2) toward the door. Flatten the bulb and align it to the china marker line pressing lightly.

4. Close the door and check for the gasket pushing out between the door and the body.
5. If the gasket is pushing out, realign the gasket in that area.
