NTB06-014

## VOLUNTARY RECALL CAMPAIGN FUEL HOSES

**CAMPAIGN I.D. # / NHTSA #:** R0505 / 05V-555

**APPLIED VEHICLES:** 2003-04 350Z (Z33)

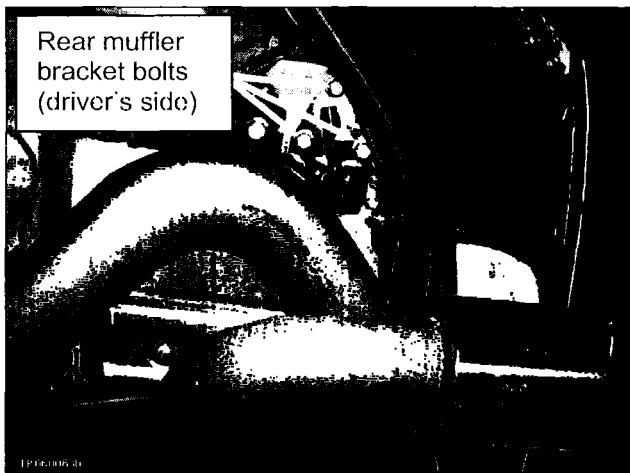
16. Remove the rear muffler bracket bolts (see Figure 13a and 13b).
