Subject: 2003-04 350Z Fuel Hose Voluntary Safety Recall Campaign Update #3

NTB06-014a

## VOLUNTARY RECALL CAMPAIGN FUEL HOSES

**APPLIED VEHICLES:** 2003-04 350Z (Z33)

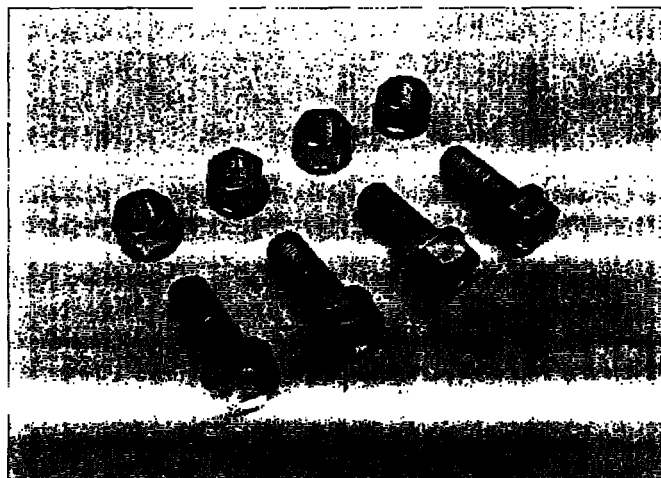
Figure 1b

- Propeller shaft bolt kit (see Figure 1b)

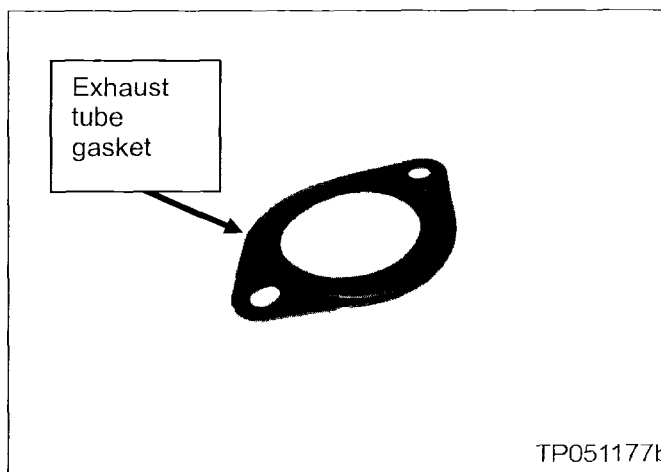
Figure 1c

- Exhaust tube gasket (see Figure 1c)

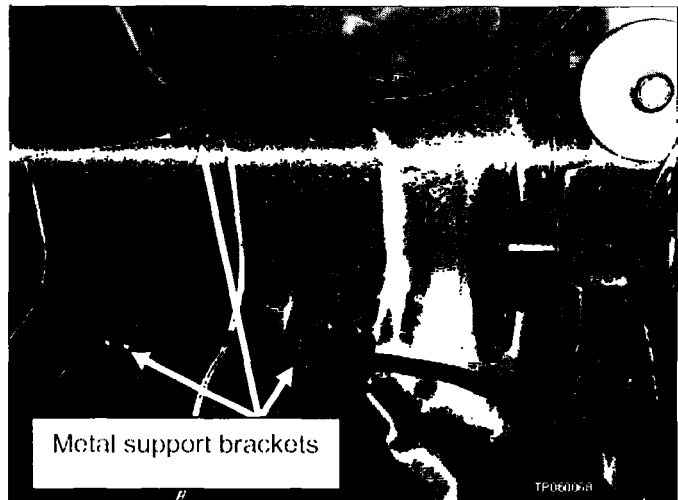
Figure 17

- b. Remove the cables from the metal support brackets (see Figure 17).

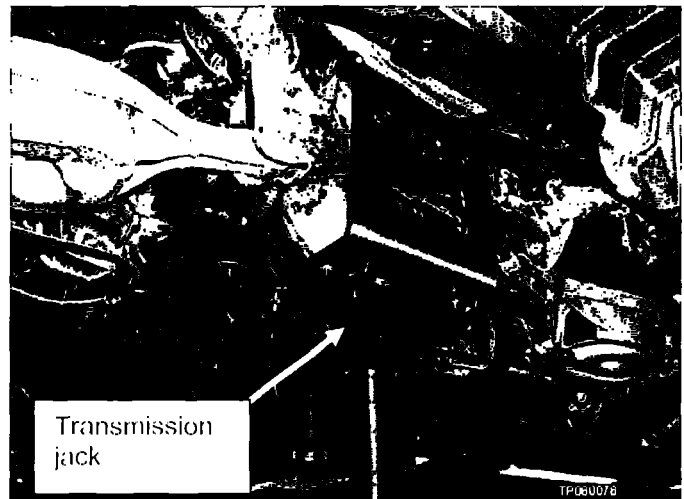
Figure 25

- 25. Use bolts to attach a transmission jack to the adapter tool (see Figure 25).

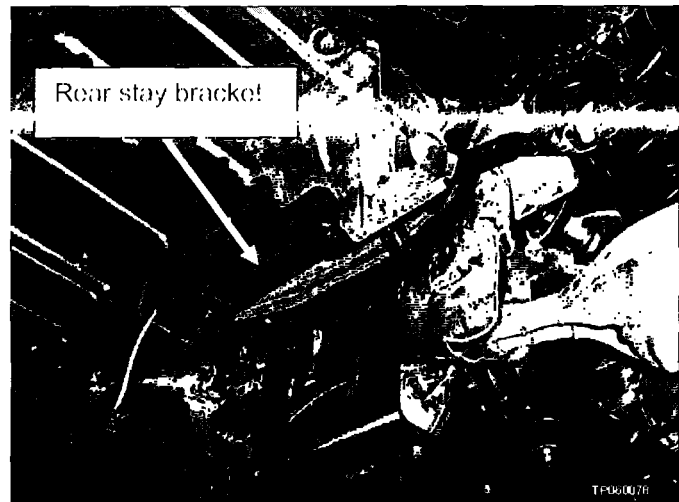
29. Remove the bolts and nuts and remove the rear stay bracket (see Figure 29).
