06V-025

RE: Recall Campaign for VL1500 Fuel Tank

4 - STROKE
VS/VX/VZ/VL BULLETIN NO. 34
DATE: 1/31/2006

**SAFETY RECALL CAMPAIGN
ALL 1998-2005 AND CERTAIN 2006 VL1500
AND C90/T BOULEVARD MODELS
FUEL TANK INSPECTION/REPLACEMENT**

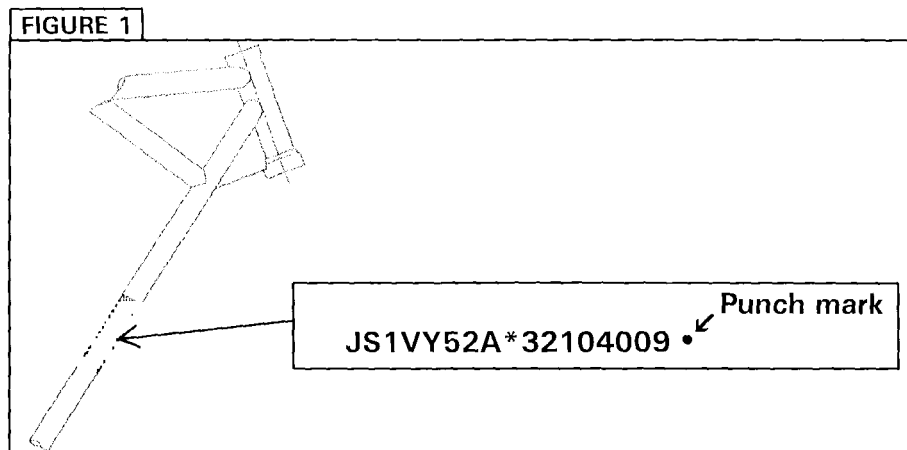
1. Check the repair status by checking the Vehicle History in the SCAT Service Menu. If the inspection needs to be performed to the motorcycle, you will see the message "CAMPAIGN NOT YET PERFORMED" displayed and the fuel tank will need to be inspected. Refer to the inspection procedure starting on page 6 of this bulletin.
2. Inspect the right side frame downtube for an identification punch mark located on the frame label at the end of the Vehicle Identification Number. If a punch mark is present the recall repair has already been performed.

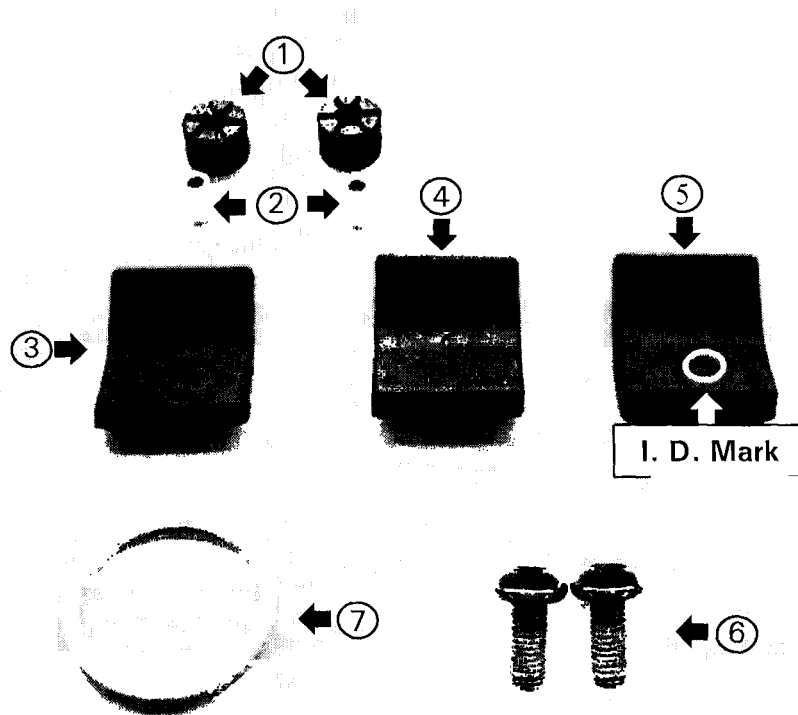
Fuel Tank Cushion Modification Kit Part Number 99103-11207 Dealer Price \$20.00 The Fuel Tank Cushion Modification Kit contains:		
	Part name	Qty
1	Cushion (fuel tank front mount)	2
2	Spacer (fuel tank front mount)	2
3	Cushion (fuel tank support, t 2.0)	1
4	Cushion (fuel tank support, t 4.0)	1
5	Cushion (fuel tank support, t 6.0)	1
6	Bolt (seat front)	2
7	Gasket (exhaust pipe)	1

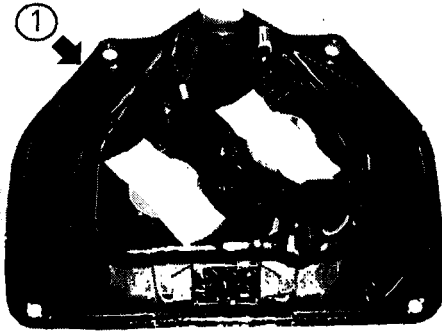
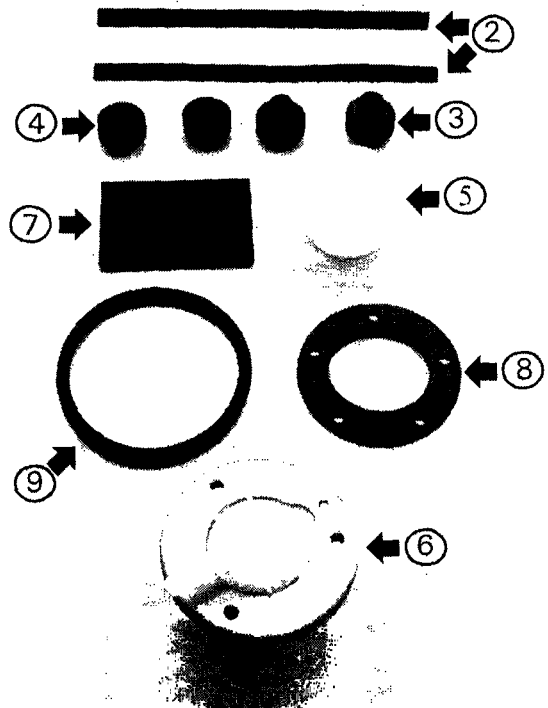
Fuel Tank Replacement Kit Contents				
	Part name	Qty	Remarks	
1	Fuel tank	1	*	
2	Molding (fuel tank)	2	All year models	
3	Cushion, lower (fuel tank rear mount)	2	All year models	
4	Cushion, upper (fuel tank rear mount)	2	All year models	
5	Fuel tank inlet valve	1	All year models	
6	Fuel shut-off valve	1	All year models	
**	7	Cushion (fuel filter)	1	W/X/Y/K1/K2/K3/K4
**	8	Gasket (fuel gauge)	1	W/X/Y/K1/K2/K3/K4
**	9	O-ring (fuel pump)	1	K5/K6

All parts needed to replace the fuel tank are included when a Fuel Tank Replacement Kit is ordered.

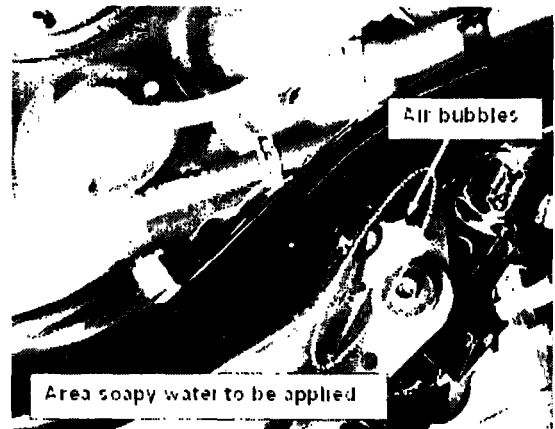
5. Apply soapy water to the welded area at the right front mount area of the fuel tank. Supply air to the fuel tank with a hand-operated pump and inspect for air leakage. The picture shows air bubbles forming on a cracked fuel tank.

If air bubbles do not form on the fuel tank, proceed to Installation of the Fuel Tank Cushion Modification Kit below. If air bubbles do form on the fuel tank, proceed to Installation of the Fuel Tank Replacement Kit on Page 11.

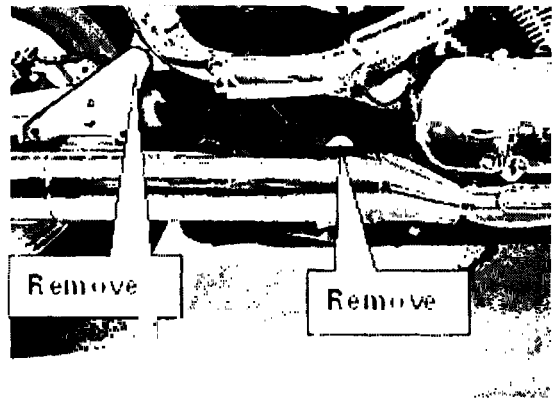
1. Remove the upper muffler. (Refer to Service Manual, Page 3-5)
2. Remove the lower muffler mount bolts for easy removal of the rear exhaust pipe.

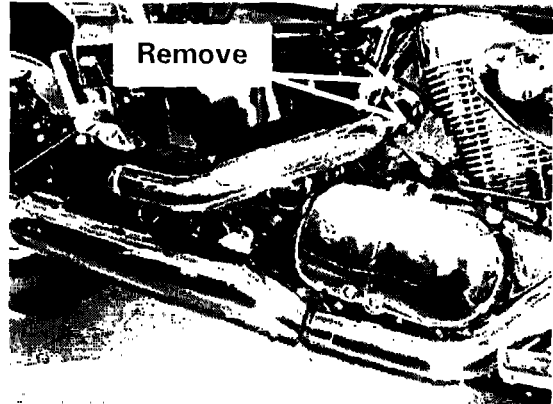
4. Remove the exhaust pipe clamp nuts at the cylinder head. Remove rear exhaust pipe.

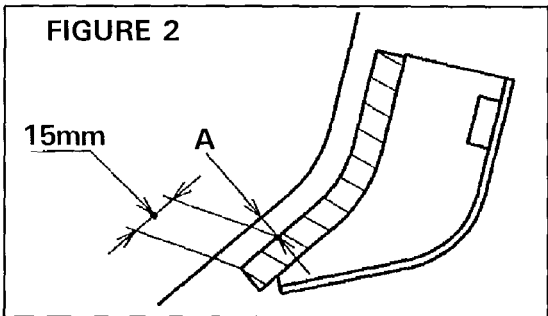
A: Clearance to be measured

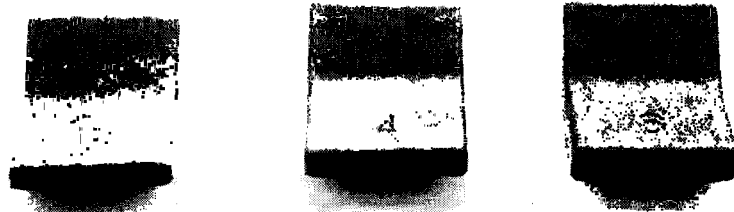
Select the correct fuel tank support cushion to install.

Measured Clearance	Cushion to be used
Less than 1mm	Use the cushion marked "2"
1 to 3mm	Use the cushion marked "4"
More than 3mm	Use the cushion marked "6"

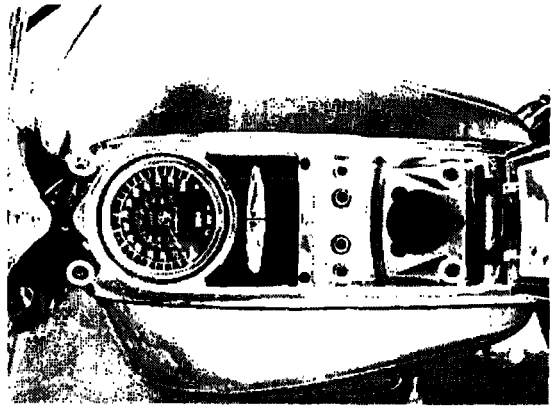
6. Open the fuel lid and remove the four screws at the fuel inlet area and two screws in front of the meter cover.

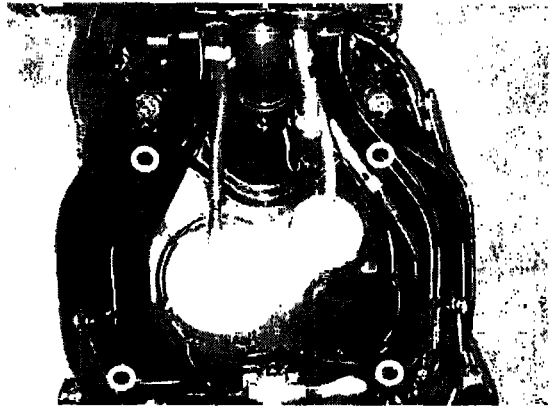
7. Remove the two mount bolts at the front of the fuel tank. Loosen the two bolts at the rear of the fuel tank by approximately 5mm.

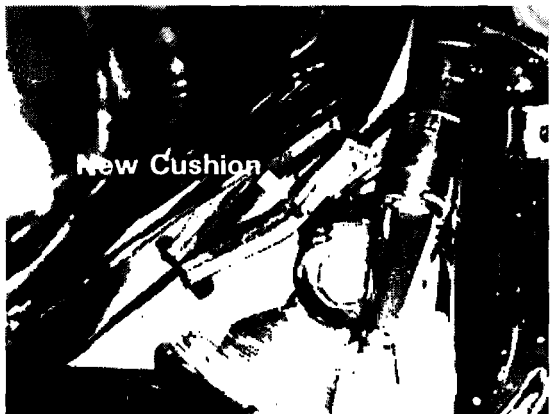
9. Apply soapy water to both sides of the fuel tank support cushion, and slide the cushion into the proper position on top of the original cushion.

Make sure to place the new cushion outer lip over all edges of the original cushion.

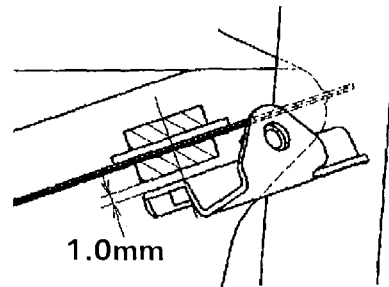
10. Replace the original mount cushions and spacers with the modified ones.

Note: If you install the 2mm or 4mm support cushion, before tightening the front fuel tank mount bolts check for a clearance of 1mm or more between the new mount cushion and the base of the fuel tank mount bracket. If the clearance is less than 1mm, replace the support cushion with the next thicker one to increase the clearance to more than 1mm.

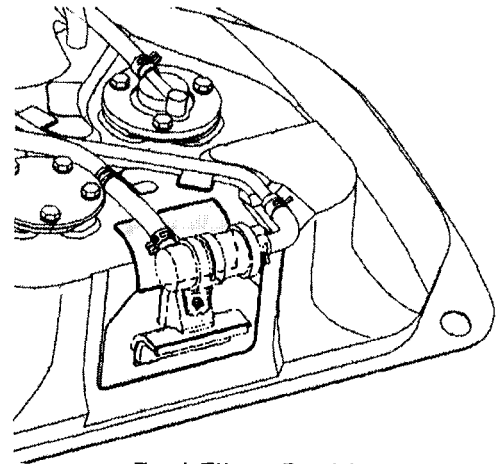
Fuel Filter Cushion
(1998-2004 models only)

1. Replace the fuel tank using the Fuel Tank Replacement Kit (Refer to Service Manual, Page 5-2).
Before installing the Fuel Tank, be certain that the Kit is correct for the model year of motorcycle being repaired. (See Fuel Tank Replacement Kit Application Guide, Page 5 of this bulletin).
2. Install parts #2 through #9 in the Fuel Tank Kit, as the parts from the original fuel tank are not reusable.
3. Install Fuel Filter Cushion on 1998-2004 models only. Remove the protective sheet from the adhesive side and apply to the fuel tank as shown.
